ARCHAEOLOGICAL

WATCHING BRIEF

SUNWIN HOUSE,

NORTHALLERTON

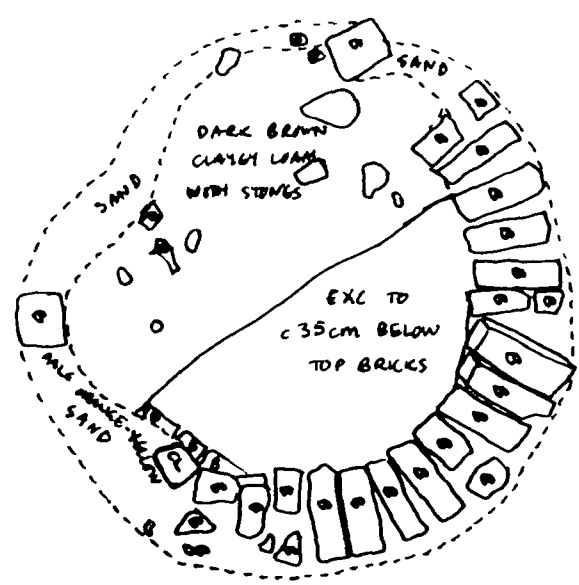
SUNWIN HOUSE NORTHALLERTON FIG 4 WELL HEAD (109)

6 2 Two wells became visible, one close to the northern side of the site and one near the southern side. They were both approximately 20 metres from the eastern or front end of the site, and although within the former building were probably outside the buildings to which they relate. This can be deduced from the probable former rear line of the buildings discussed above (2 3). The more southerly well (108, fig 3, PI 6) was still open and was lined with dark red, curved, very hard bricks 3" thick, similar to engineering bricks. The internal diameter was 93 cm and it was 3.4 metres deep. The northern well (109, fig 3, PI 7) was also brick lined, but with soft, crumbly hand-made bricks 2" thick. The top circle of bricks survived only in part, and the well had been filled in (fig 4). A half section of the well was excavated to a depth of 35 cm (Pis 8, 9), and was found to contain 19<sup>th</sup> century pottery fragments. After recording, the well was left to be covered over once more.

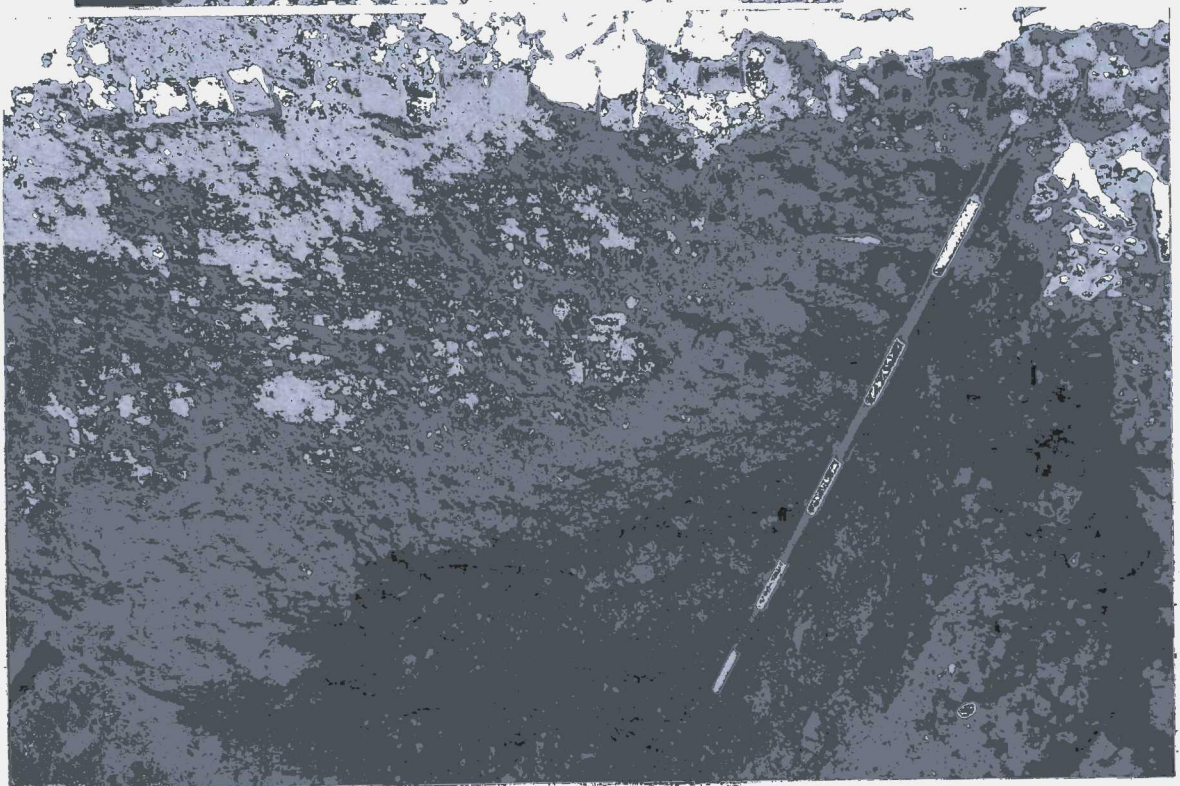
**Plate 2 TH 6 from south**

3 7 TH6 (PI 2), towards the southern side of the site and about half way down it, had a surface of bnck rubble in a brown sandy loam On the northern side was a water service pipe just below the surface, surrounded by dirty brownish yellow sand Beneath this on the western end was orangey brown compacted fine sand, while to the east was a mid-grey-brown loam with frequent mortar or concrete flecks This soil appeared to cut the orange sand, and at a depth of 142 cm it overlay a layer of concentrated bnck/tile rubble including pantile fragments This extended to a depth of 175 cm, and cut into clean pale orangey yellow silty sand The base of the hole was at 230 cm below the surface

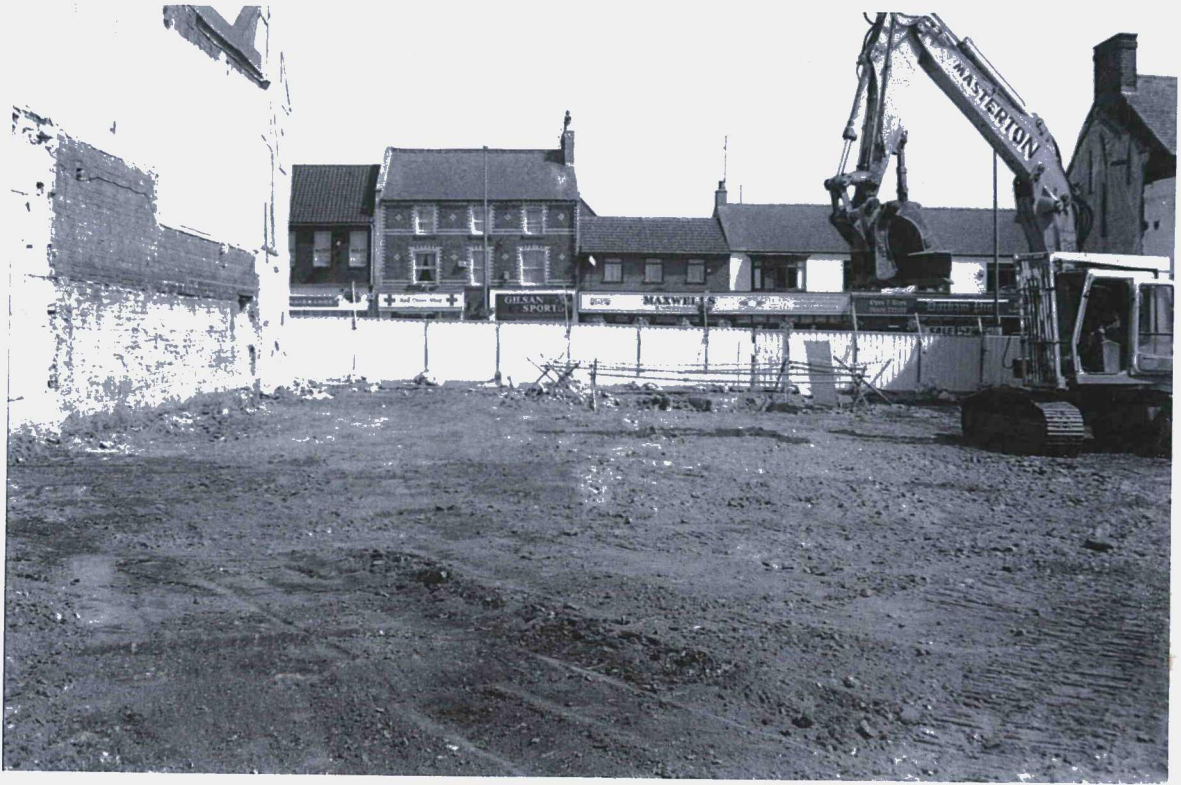
**Plate 5 View to east after first levelling**

4.1 The site was disturbed in numerous places by large reinforced concrete foundation pads, and the removal of these by machine further disturbed the ground around them. The surface was liberally strewn with rubble after the demolition process, consisting of brick, concrete and gravel. The brick, which appeared in places to have been deliberately spread to form a sub-base for the concrete, was very broken up but seemed all to be standard modern brick. The concrete was on average 50 cm thick over the whole site, but had been largely broken up in the demolition phase (PI 5).
