**PRIMARY SCHOOL,
KIRBY HILL,
NORTH YORKSHIRE**

**REPORT ON AN
ARCHAEOLOGICAL
WATCHING BRIEF**

**2000 FIELD REPORT
NUMBER 37**

KIRBY HILL PRIMARY SCHOOL
CHURCH LANE, KIRBY HILL,
NORTH YORKSHIRE

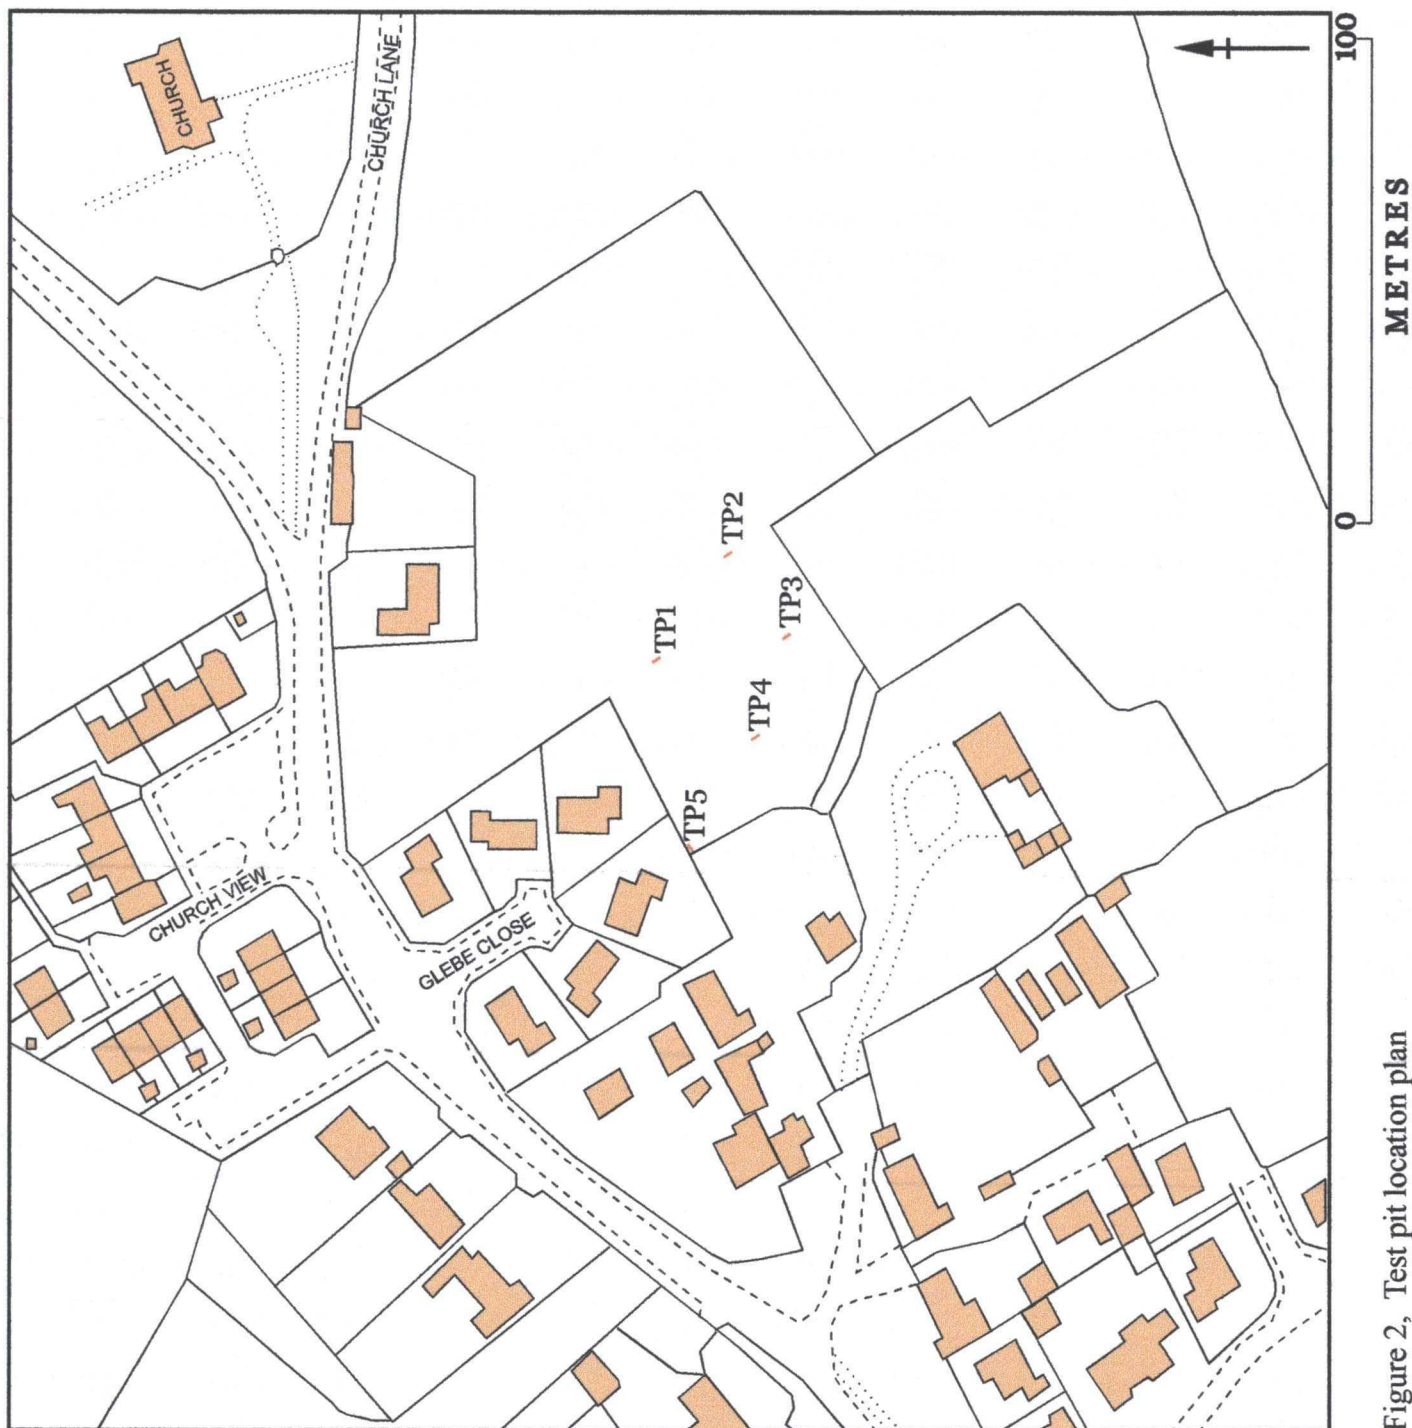
Figure 2, Test pit location plan

Test pit 1 was excavated to a depth of 2.60m BGL. At, and above this level to a depth of 1.40m BGL, context 13, was present. This material was brownish red, soft, fine sand in which quantities of weak, laminated, red sandstone fragments were noted. This was sealed by context 12, mid reddish brown slightly clayey sand which contained occasional cobbles and had an upper limit at 0.45m BGL. The uppermost deposit recorded in the pit was the topsoil, context 11, mid brown, friable, sandy loam whose lowermost parts extended to around 0.45m BGL. The interface between contexts 11 and 12 was not sharp, but one that tended to merge. No finds were recovered from pit 1.

At a depth of some 2.50m BGL the uppermost parts of context 23 were reached. This material was seen to extend beyond the basal limits of pit 2 at 3.10m BGL. Context 23 was brownish red (frequently with a pinkish tinge), soft, fine sand in which quantities of weak, laminated, red sandstone were present. Context 22 sealed 23. This material, which had an upper limit at 0.30m BGL, was brownish red, fairly soft, fine sand that contained a small amount of clay. The uppermost material in pit 2, context 21, was the mid brown, friable, sandy loam topsoil. No finds or other artifactual materials were observed in pit 2.

Context 33, which was observed at the base of the pit at 1.65m BGL, was composed predominantly of shattered, weak, laminated, red sandstone together with lesser quantities of pinkish red sand. Above this, and extending to 0.30m BGL was context 32, a very slightly clayey red sand in which small quantities of sandstone and lesser amounts of cobbles were present. The uppermost material, context 31, was the mid brown, friable sandy loam topsoil. No finds were recovered from pit 3.

Occurring at a depth of 2.0m BGL and extending beyond the basal limits of the pit at 2.20m BGL, was context 44. This was composed in roughly equal proportions of brownish red sand and weak, laminated, red sandstone. Sealing this and with an upper limit at 0.80m BGL was context 43, brownish red, soft, fine sand containing occasional fragments of red sandstone. Context 42 occurred between 0.80m and 0.22m BGL and was essentially reddish brown, slightly clayey sand that contained very occasional cobbles. The mid brown, friable sandy loam topsoil, context 41, sealed 42. A total absence of finds was noted for pit 4.

Context 53 was noted at a depth of 1.40m BGL and was seen to extend beyond the base of the pit at 2.90m BGL. This material was composed of brownish red, soft, fine sand that contained quantities of weak, laminated, red sandstone. Above 53 and with an upper limit at 1.40m BGL was context 52, mid brown (with a slight reddish hue) slightly clayey sand. This was in turn sealed by context 51, the mid brown, friable, sandy loam topsoil. It was noted that the interface between contexts 52 and 51 was one that tended to gradually merge.

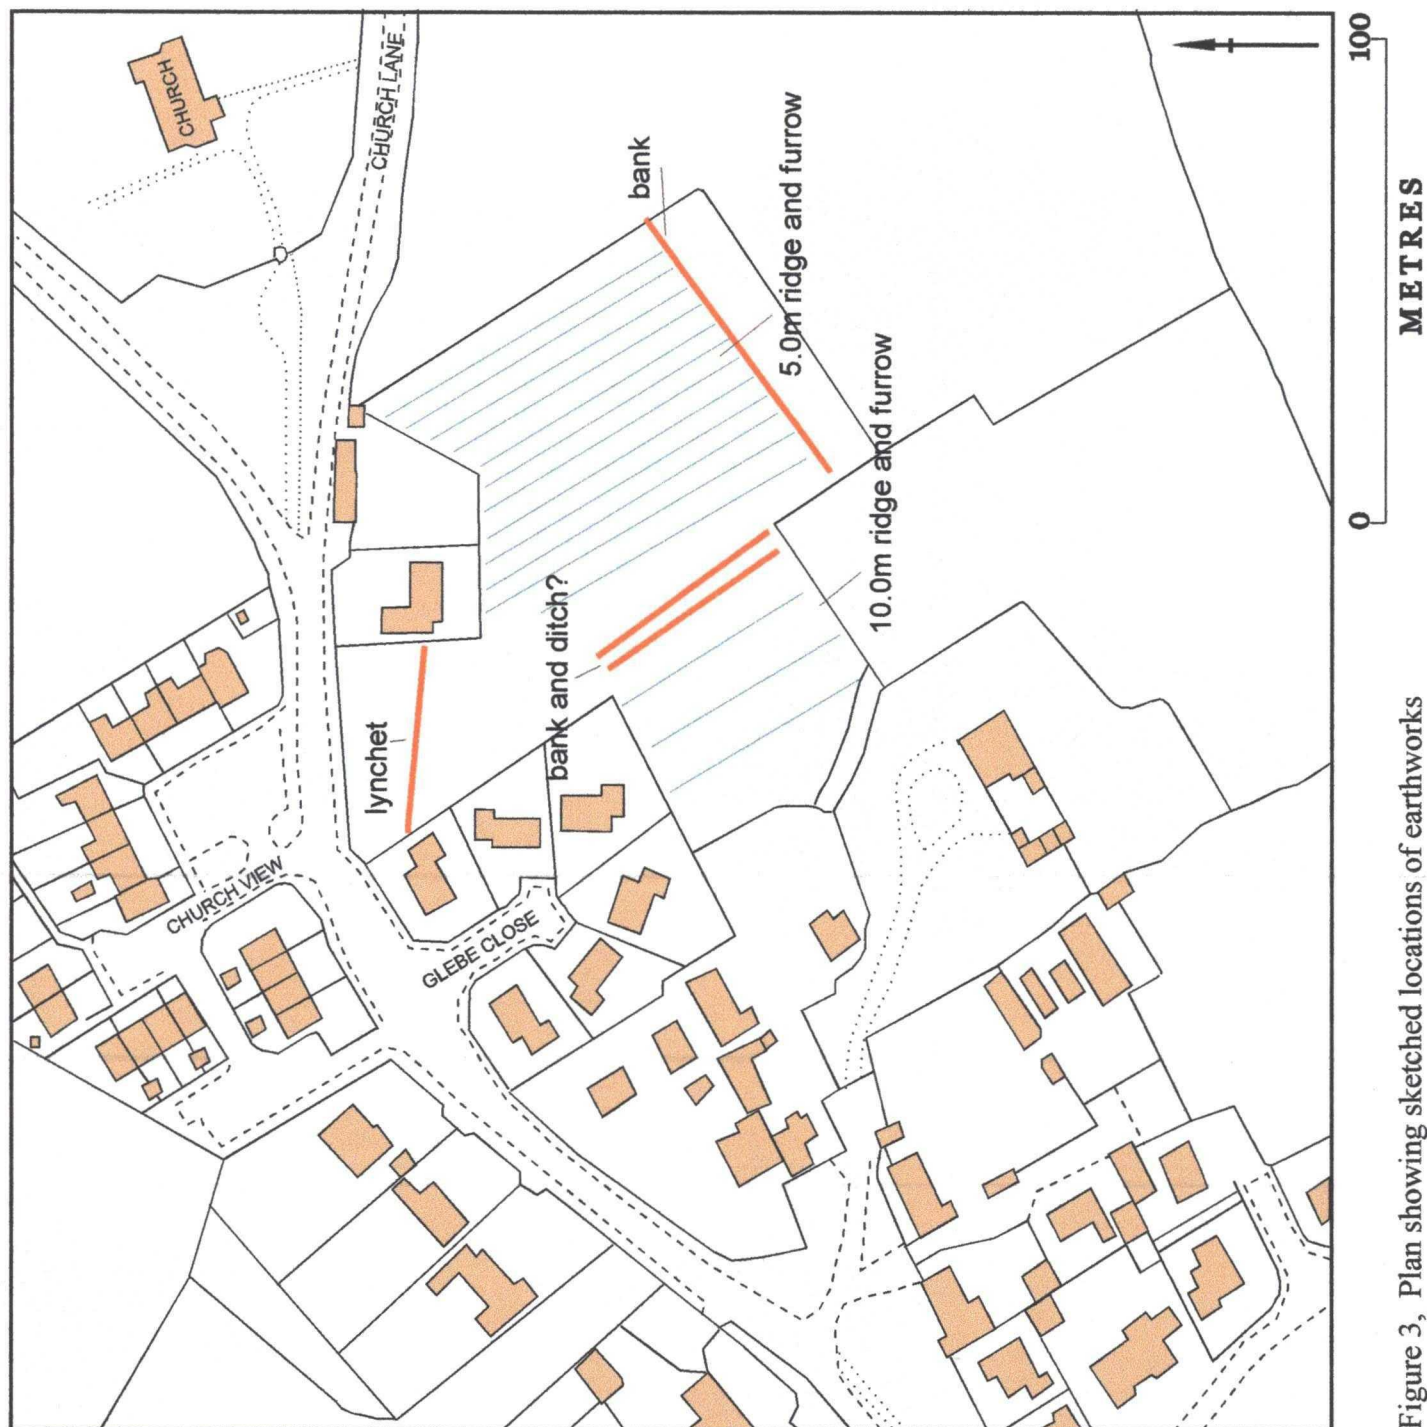
Figure 3, Plan showing sketched locations of earthworks

A number of earthworks are present at the site. The larger, north-eastern part of the recreational grounds contains narrowly spaced ridge and furrow (spacing approximately 5.0m centre to centre of furrow) aligned north-west – south-east, of an arable field system. The south-eastern limits of this are demarcated by a low south-west – north-east aligned bank just within the limits of the grounds. This narrow spaced ridge and furrow survives only shallowly. The field system can be seen to continue into the adjacent pasture field to the north-east. A south-western limit to the system is marked by what appears to be the low remnants of a north-west – south-east aligned bank and ditch. South-west of this boundary traces of a further ridge and furrow system can be observed, again aligned north-west – south-east but this time more widely spaced (approximately 10.0m centre to centre of furrow). Earthworks, parts at least of which may relate to this broadly spaced system, can be seen to be immediately south-east of the grounds in meadow land. Towards the northern end of a tongue of land that abuts Church Lane a lynchet or terrace, standing up to 1.50m high and aligned approximately east – west was noted. Beyond the site boundaries, the pasture field immediately south-east of the narrowly spaced ridge and furrow can also be seen to contain earthworks. Although inspection of this was not possible it is thought that that most or all of this may relate to south-west – north-east aligned ridge and furrow.
