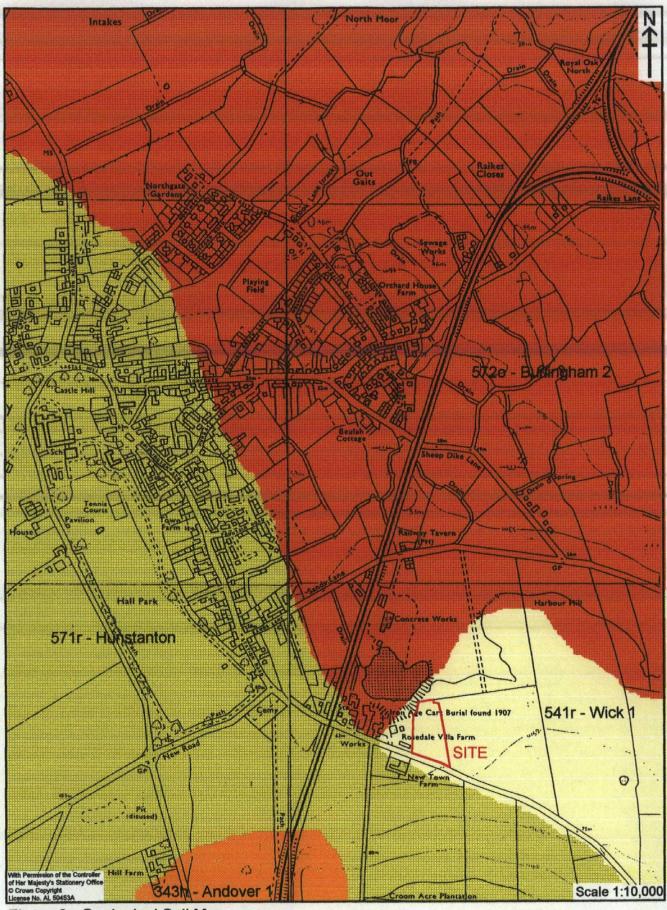
Figure 3. Geological Soil Map.
