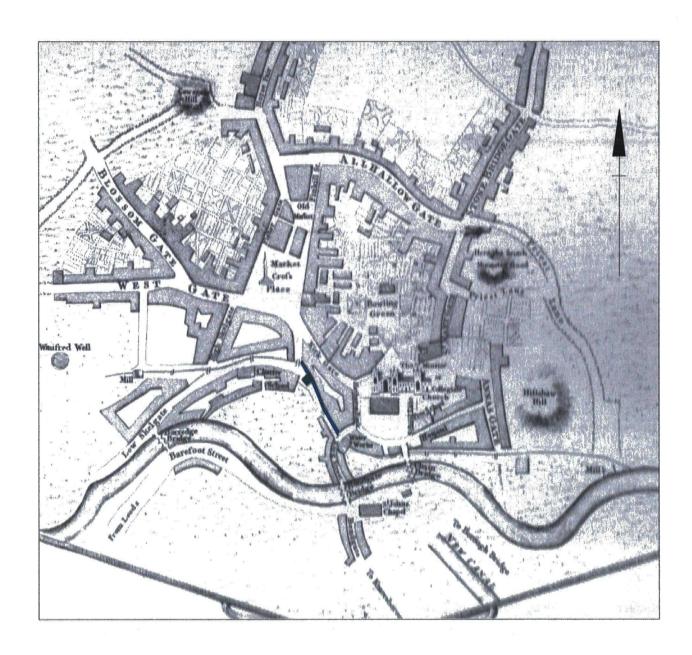
Figure 3, Jeffereys Map of Ripon, 1772, with the millrace and mill at Skellgarths emphasised
