Jervaulx Abbey North Yorkshire

Marcus Jecock

SURVEY REPORT

Surveyed May 1998 - Jan 1999 Surveyed by C. Dunn, M. Jecock, A. Lax and P. Sinton Report by M. Jecock Drawings by P. Sinton and M. Jecock Photographs by R. Skingle

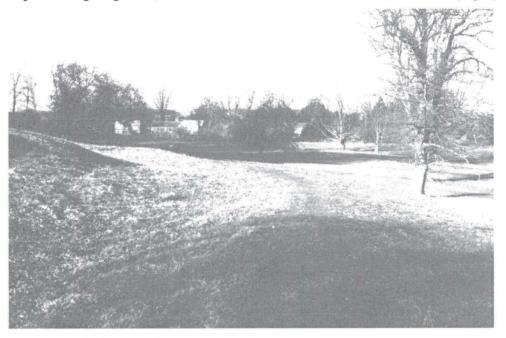
Figure 2. View along track TR1/leat WF2 looking north towards The Old Gatehouse (NMR AA99/03556).

TR1 would seem to represent an earlier course of the Middleham to Masham road (the modern A6108) before it was diverted into its present angular route around the outside of Jervaulx Park. Approaching from the west, the road's initial course is no longer traceable on the surface within the survey area, although it probably entered the Park in the vicinity of the present west entrance. It would then have swung sharply south to keep to the higher ground, and it is here that the line of the old road survives (Fig. 2)

reused by the monks as the route for an aqueduct or leat bringing water to the conventual buildings from the reservoir in the south-west corner of the monastic precinct (WF2 and WF1, section 6.2.4 below). The road bed re-emerges as a slight hollow-way from beneath the leat just north of the reservoir, and swings away east in front of the reservoir dam (DM1, section 6.2.4 below) where a stretch of it seems to have been reused at a later date as local access to a complex of buildings, BC10, situated on its north side (section 6.2.2 below). The road line is truncated at this point by a late field boundary, FB5 (section 6.4.3 below), but formerly continued to the east where its original course now lies buried beneath a large negative lynchet that developed on the downhill side of a furlong of ridge-and-furrow ploughing, PF3 (section 6.4.3 below). The existence of a flat terrace at the foot of the lynchet, raises the possibility that the road was still in use when the lynchet formed and was re-routed

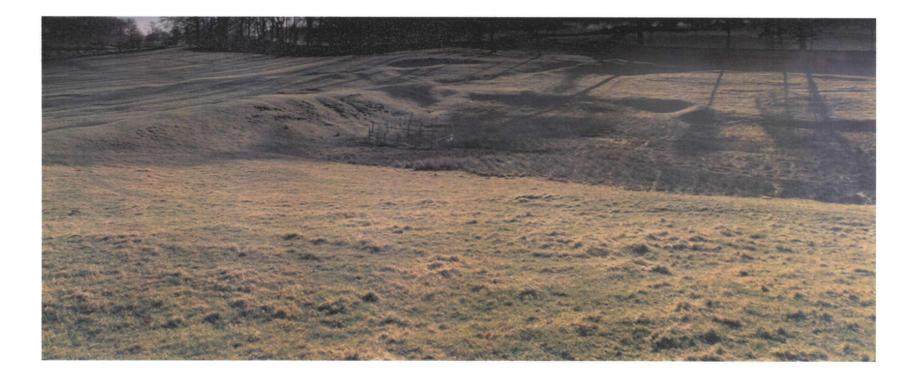
Figure 3. View across the monastic reservoir WF1, showing the dam DM1 (centre left) and to its right garden feature GS16 with building platform BC1 visible in the distance (NMR AA99/03571).

BC1 is a small platform cut into a tongue of higher land projecting out over the rising ground along the south side of the survey area (Fig. 3). It is connected to TR1 to the north, and to TR4 and the springs along the side of the small valley to the west, by a series of small interlinked hollow-ways, TR5 (section 6.1.2 above). Although the

platform could be simply a small yard, perhaps for animals, the intensity of routes leading to it, especially connecting it with the adjacent water supply, suggests it is more likely to be the site of a domestic building contemporary with the period when TR1 and TR4 were in use.
