**Long Street  
Easingwold  
North Yorkshire**

**Archaeological Watching Brief**

**MAP 01-03-01  
February 2002**

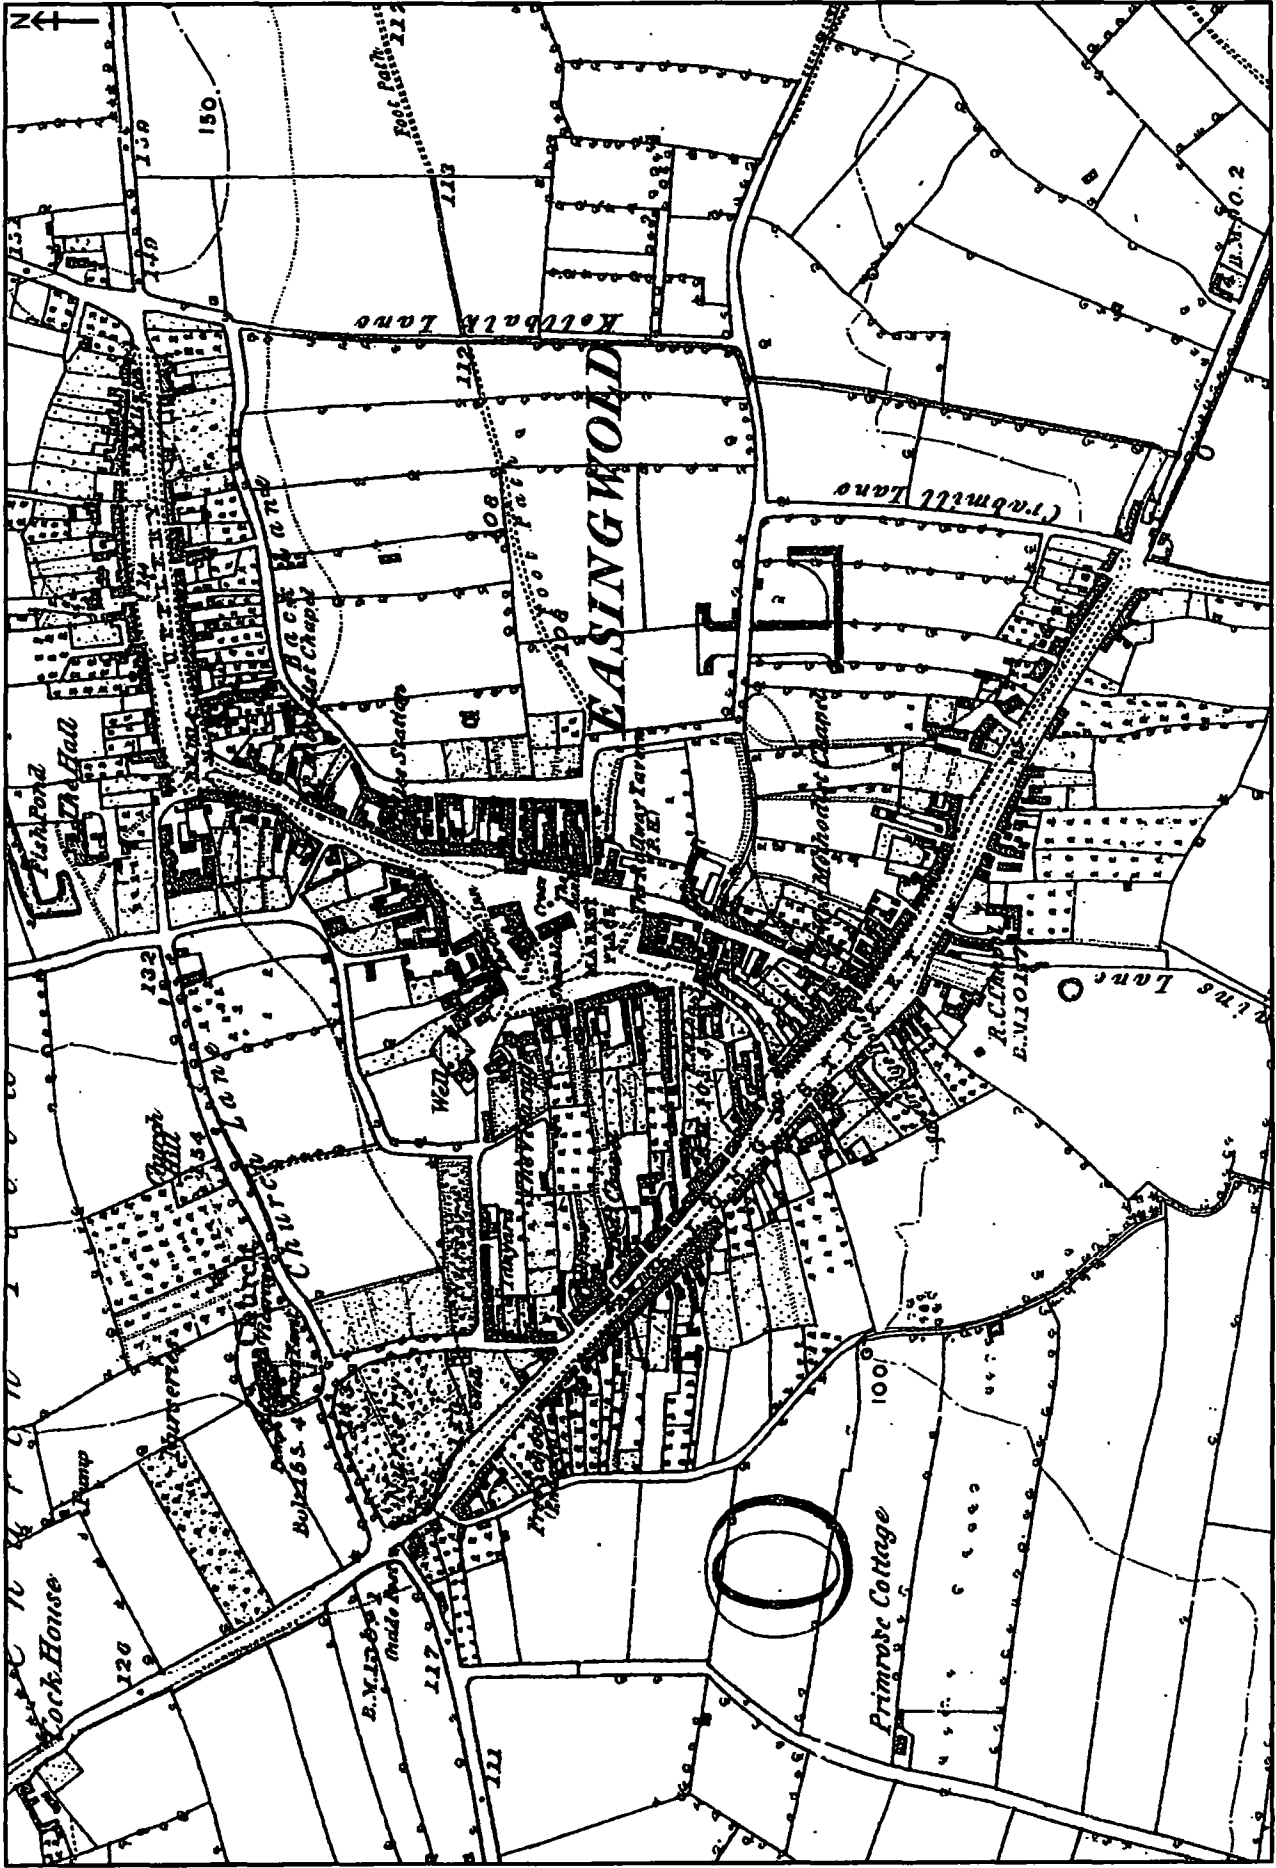
Figure 5. Extract from the First Edition Ordnance Survey Map, 1856.

The First Edition Ordnance Survey of 1856 (Fig. 5) shows a series of buildings fronting onto Long Street and also extending into the rear of two of the plots. By the 1913 edition (Fig. 6) buildings on the rear of the plot have been removed and one of the buildings fronting Long Street has been demolished and rebuilt.
