SE 7946 7080
Archaeological Watching Brief

MAP
September 2002

**127 Langton Road
Norton
North Yorkshire**

Archaeological Watching Brief

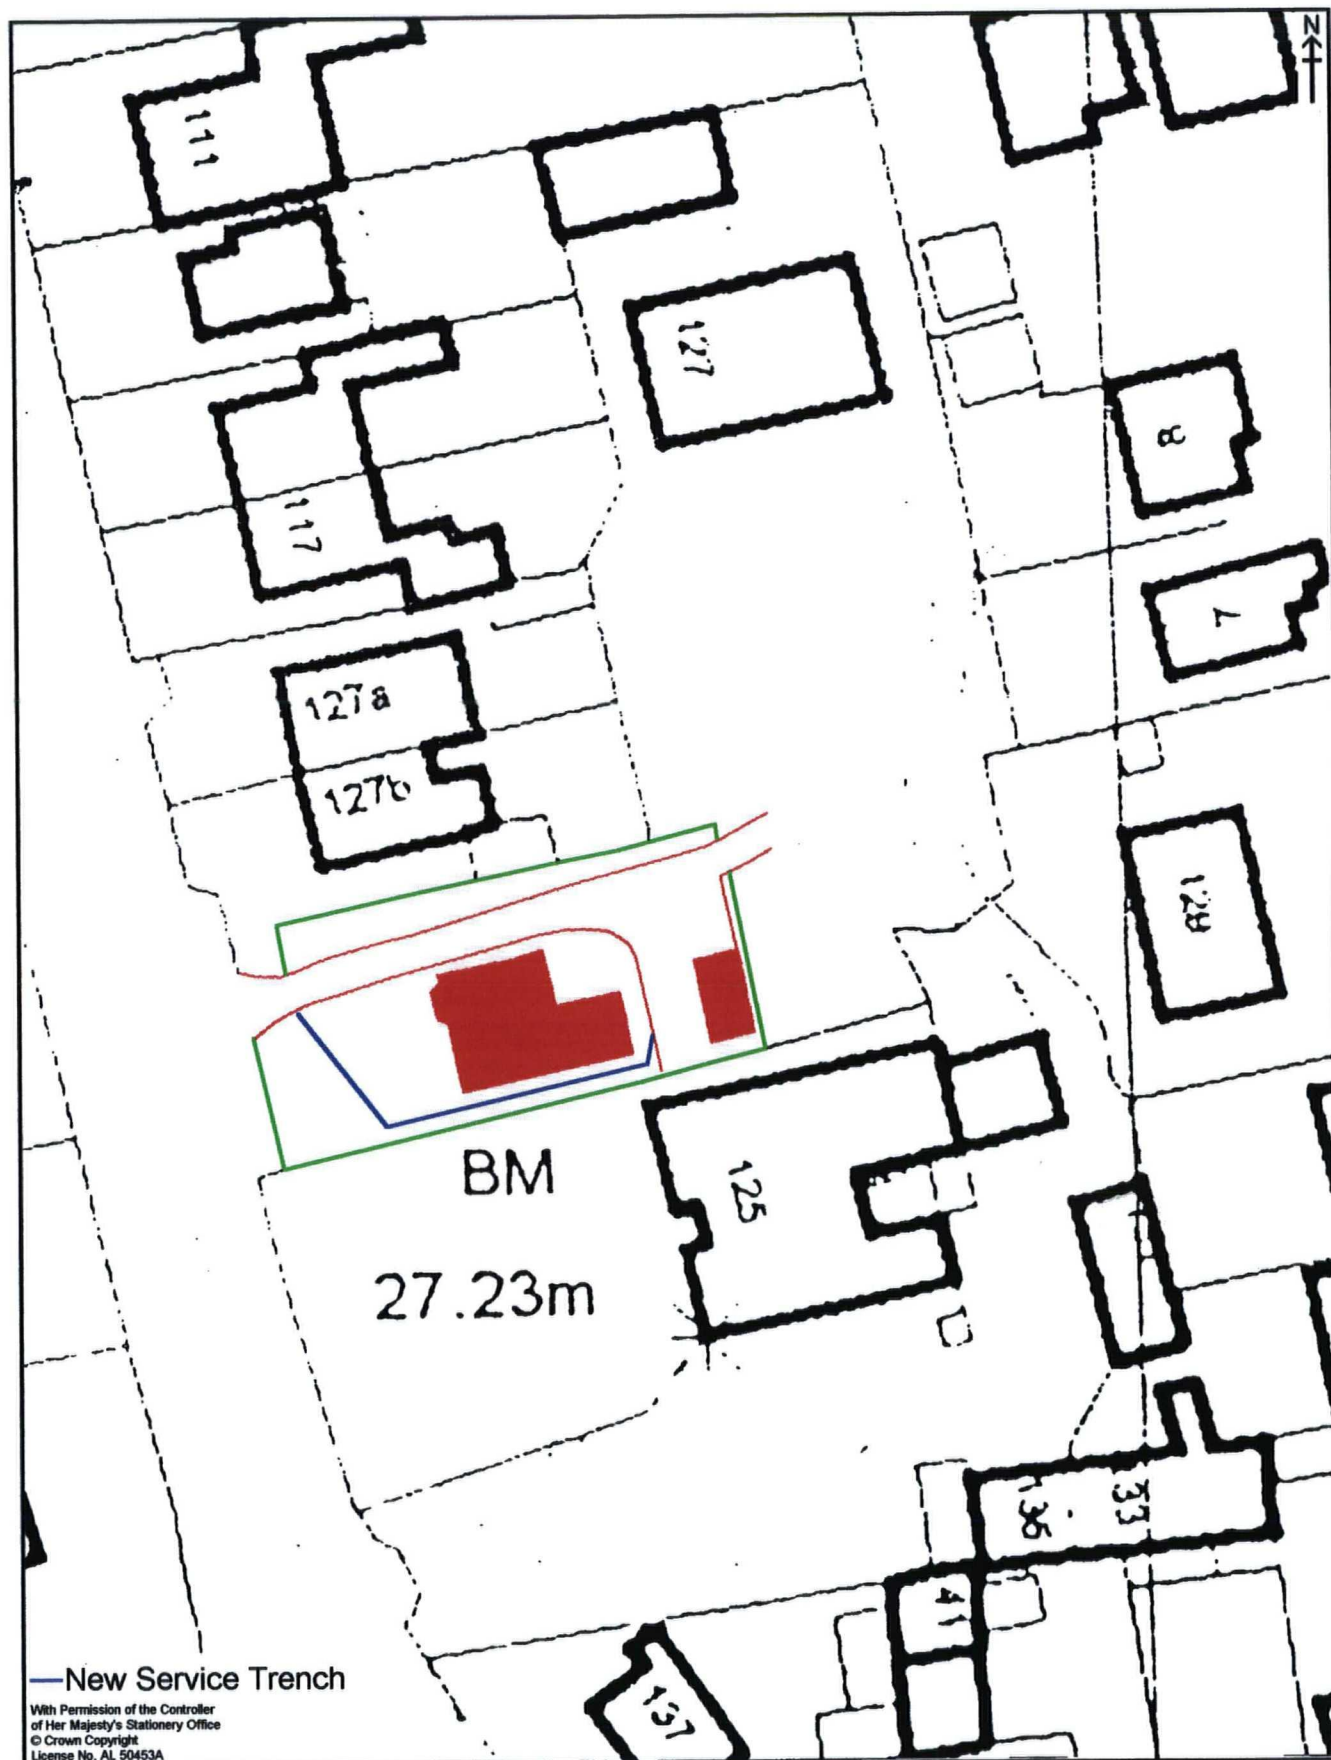
Figure 2. Watching Brief Area.

An Archaeological Watching Brief was undertaken on all groundworks associated with the building of a new house at the site of No. 127 Langton Road (Fig. 2). A back acting mechanical excavator was used to remove all overburden and excavate all trenches under the supervision of an archaeologist.

An area 7m by 11m was topsoil stripped in the area of the new garage block. The garage was to be built on a slab, so this area was reduced by c. 0.30m. Rubble material was removed from the area of the path from No. 125 Langton Road, along the southern edge of the area. No archaeological finds or features were found in the area of the garage.
