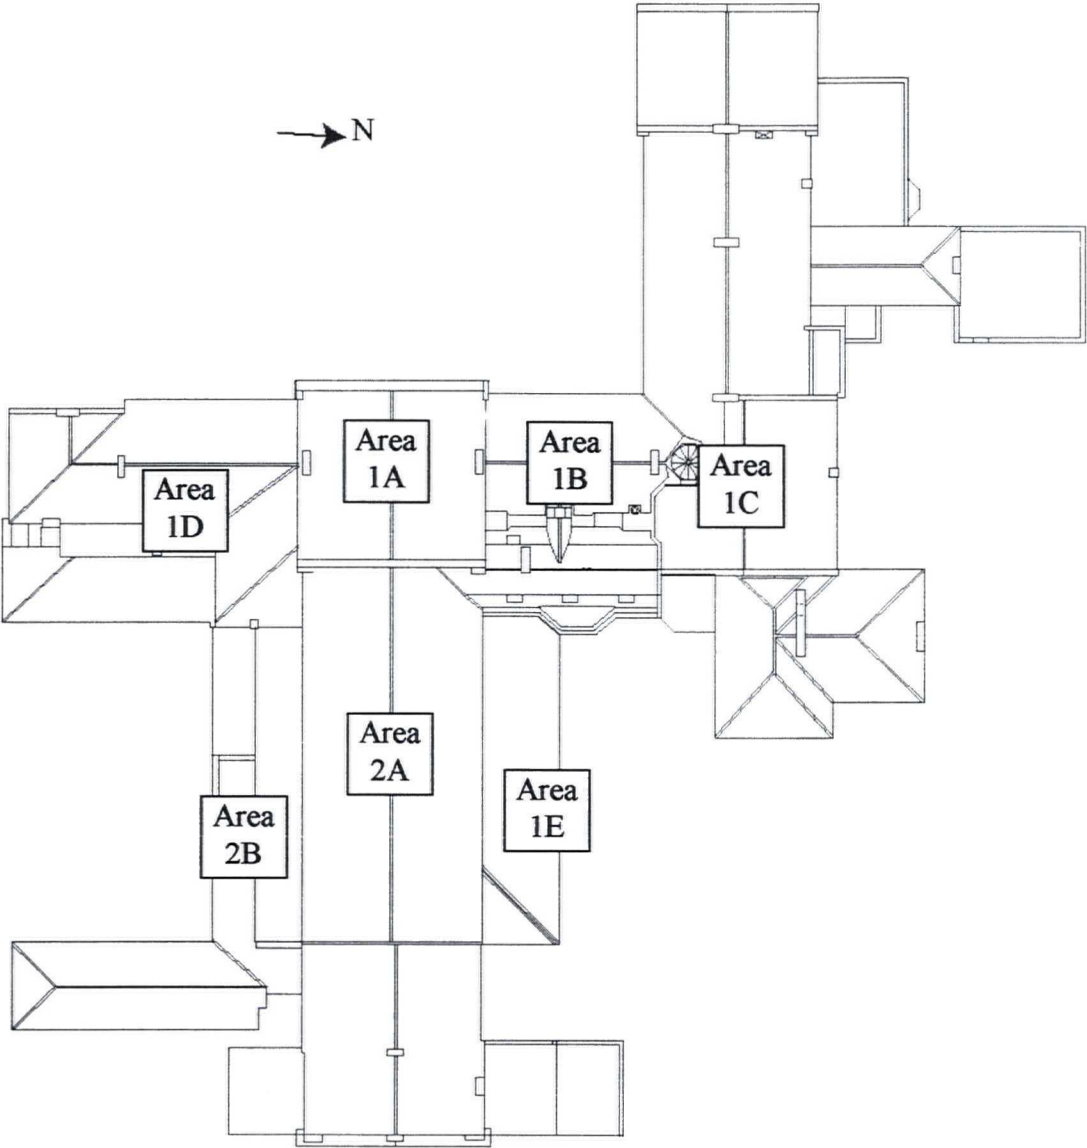
Figure 3 Plan of Hovingham Hall, showing the separate areas of sampling. The plans in Figures 4-9 all use the same alignment (based on a diagram supplied by Martin Stancliffe Architects)

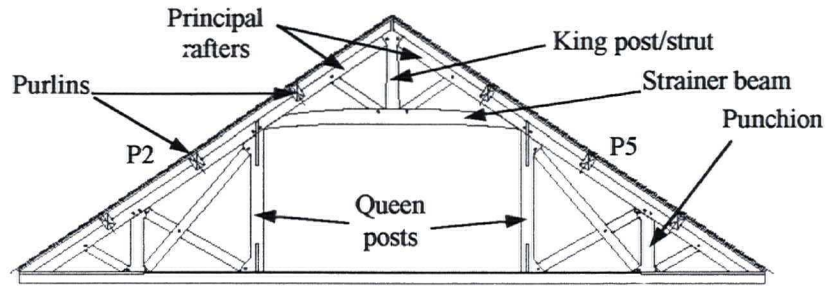
Figure 4a Typical truss from Area 1A, the Ballroom roof, showing the nomenclature used in the report (based on a diagram supplied by Martin Stancliffe Architects)

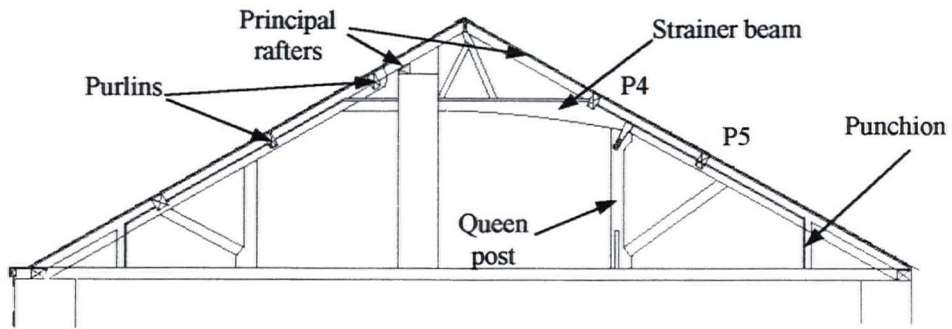
Figure 6a Typical truss from Area 1C, the Dining room roof, showing the nomenclature followed in this report (based on a diagram supplied by Martin Stancliffe Architects)

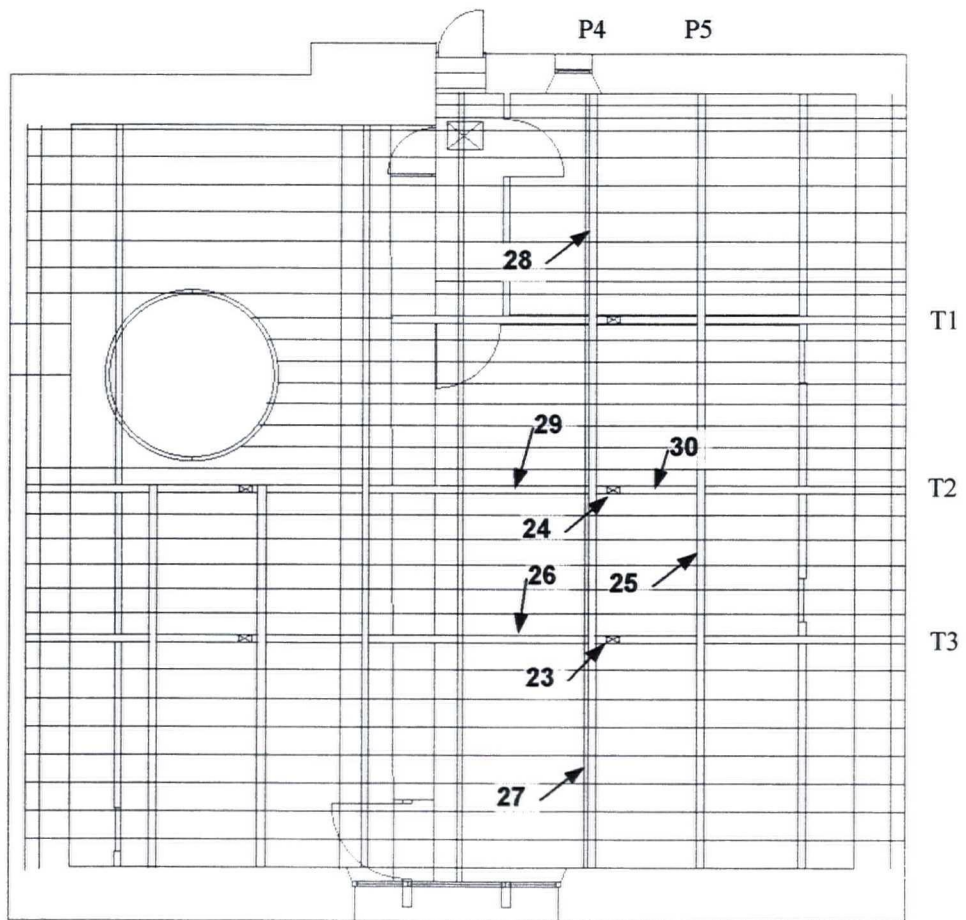
Figure 6b Plan of Area 1C, the Dining room roof, showing the approximate location of samples 23-30 (based on a diagram supplied by Martin Stancliffe Architects)

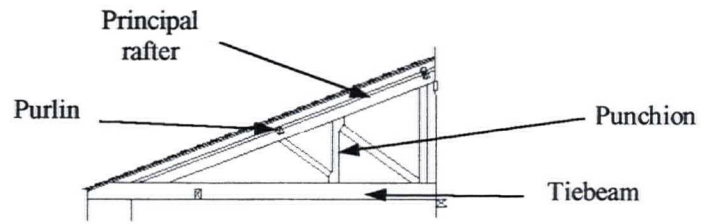
Figure 8a Typical truss from Area 1E, the north side Riding School lean-to, looking south, showing the nomenclature followed in the report (based on a diagram supplied by Martin Stancliffe Architects)

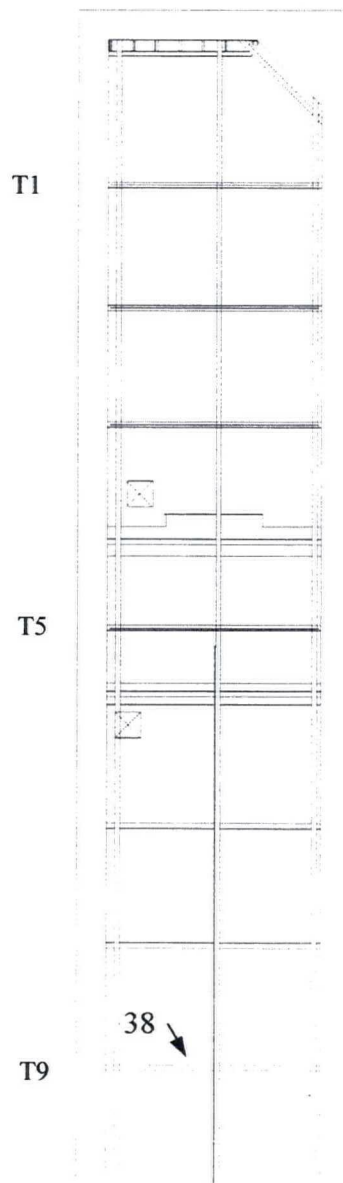
Figure 8b Plan of Area 1E, the north side Riding School lean-to roof, showing the approximate location of sample 38 (based on a diagram supplied by Martin Stancliffe Architects)

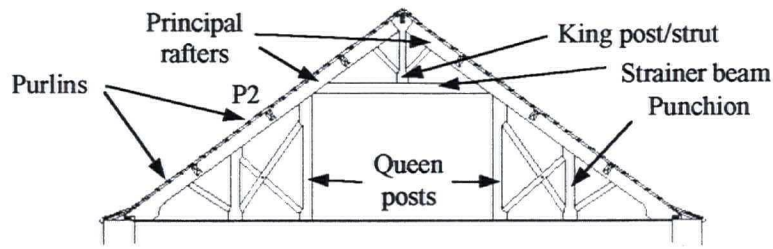
Figure 9a Typical truss from Area 2A, the Riding School roof, showing the nomenclature followed in the report (based on a diagram supplied by Martin Stancliffe Architects)

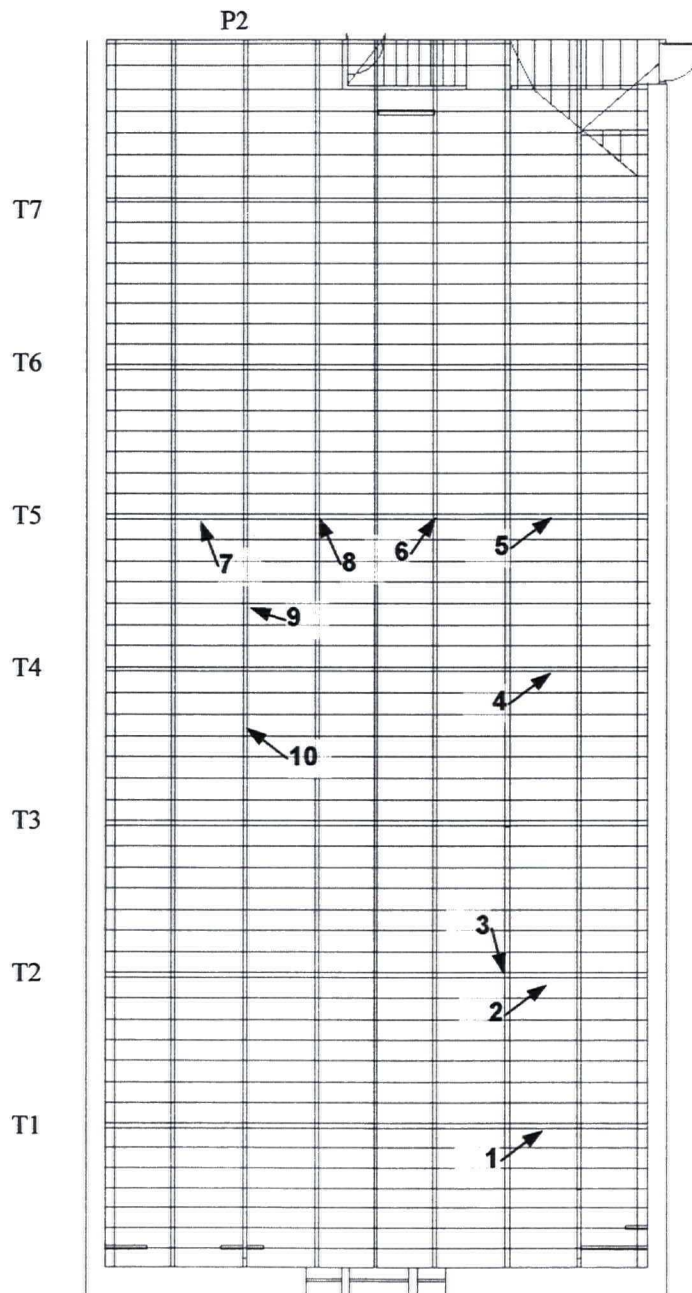
Figure 9b Plan of Area 2A, the Riding School roof, showing the approximate location of samples 1-10 (based on a diagram supplied by Martin Stancliffe Architects)

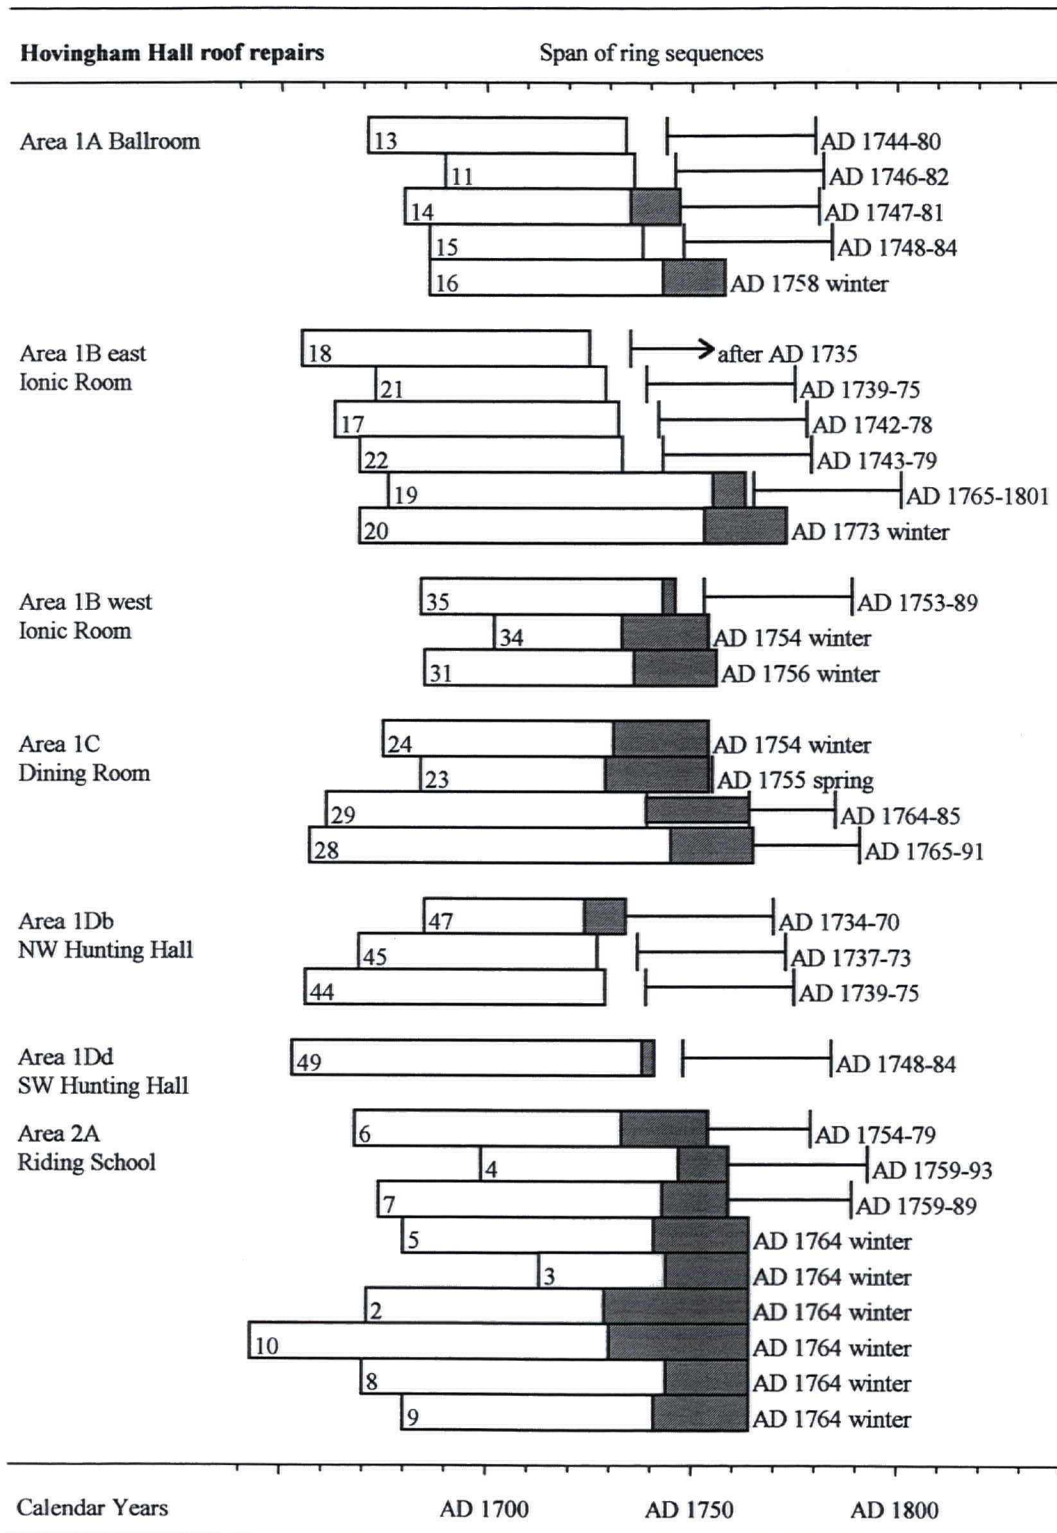
Figure 10 Bar diagram showing the chronological positions of the dated timbers from seven area of roof at Hovingham Hall, Hovingham. The estimated felling period for each sequence is also shown

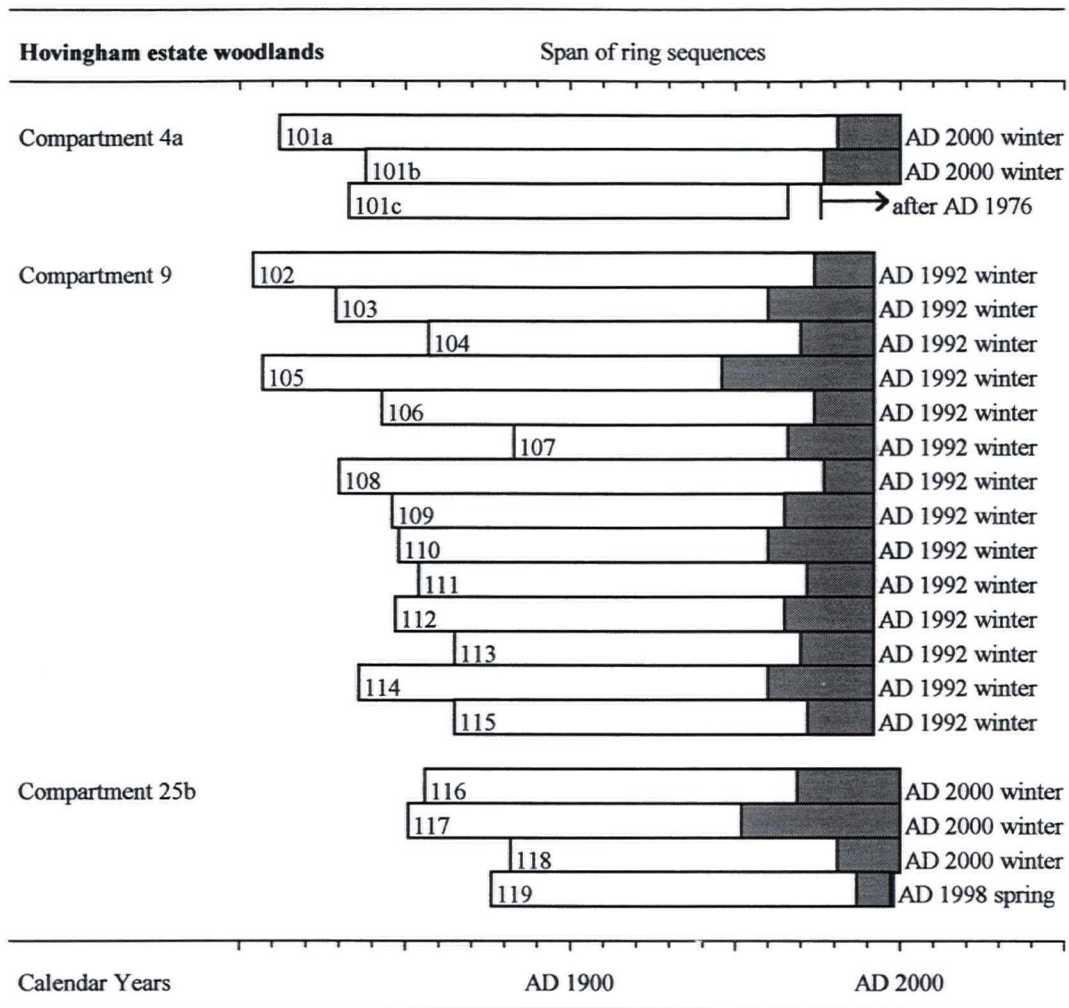
Figure 11 Bar diagram showing the chronological positions of the dated timbers from three compartments of the Hovingham Hall estate woodlands, Hovingham. The felling period for each sequence is also shown

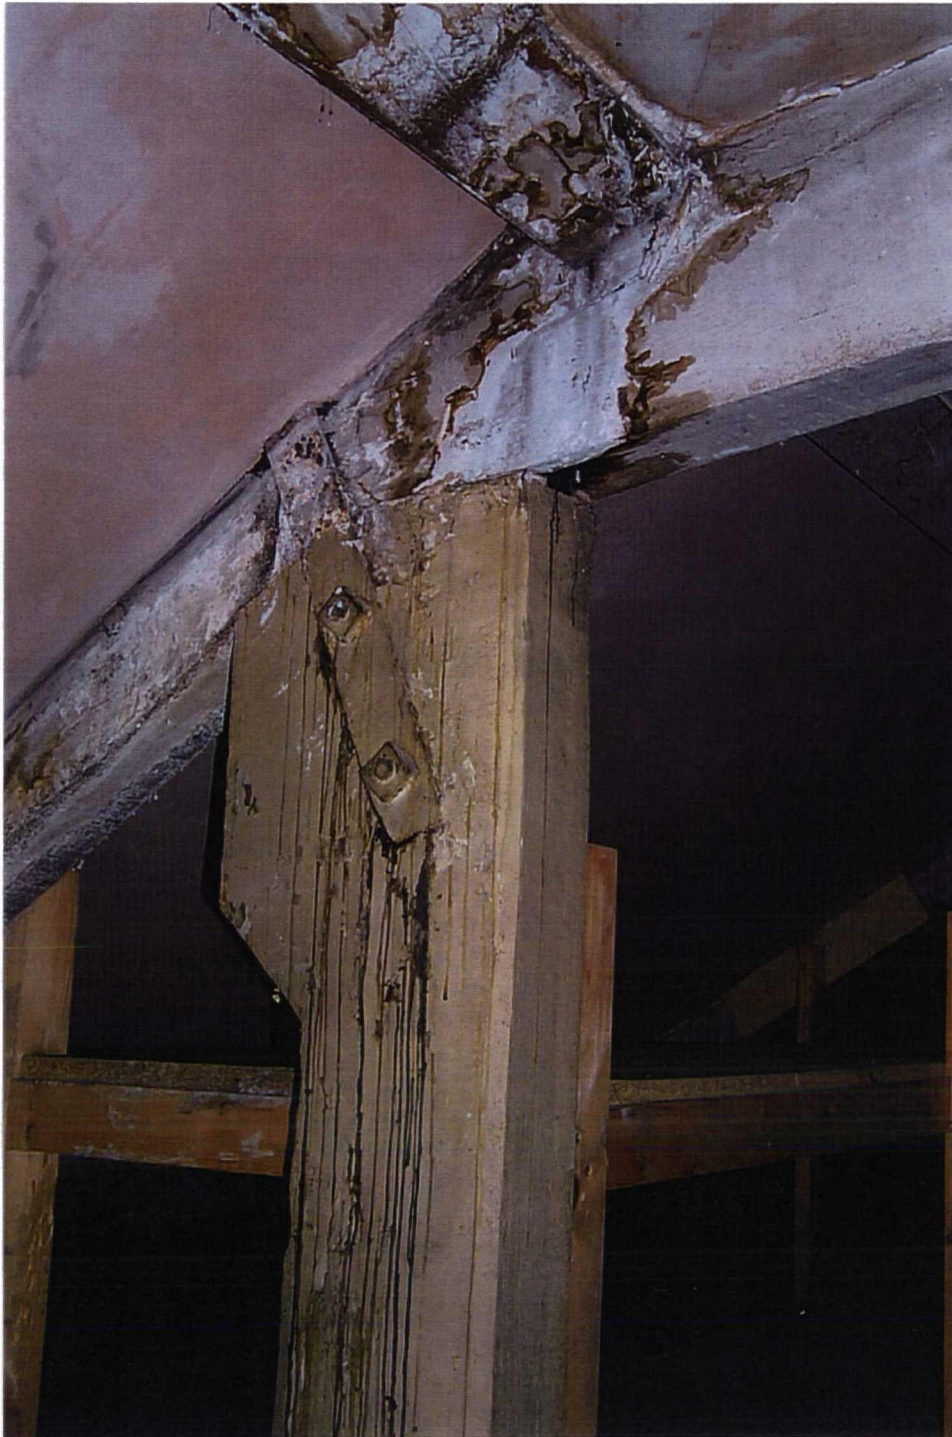
Figure 12 Photograph of the north queen post and strainer beam from Truss 2 of the Area 1C roof. Note the absence of a chamfer and chamfer stop on the strainer beam, although both are present on the post. The timbers are of slightly different thickness, with the strainer beam narrower than the post, the joint is rather loose, and has been filled with plaster. The timbers also have different surface treatments. The convex face on the post is clearly visible, as is evidence of widespread water damage

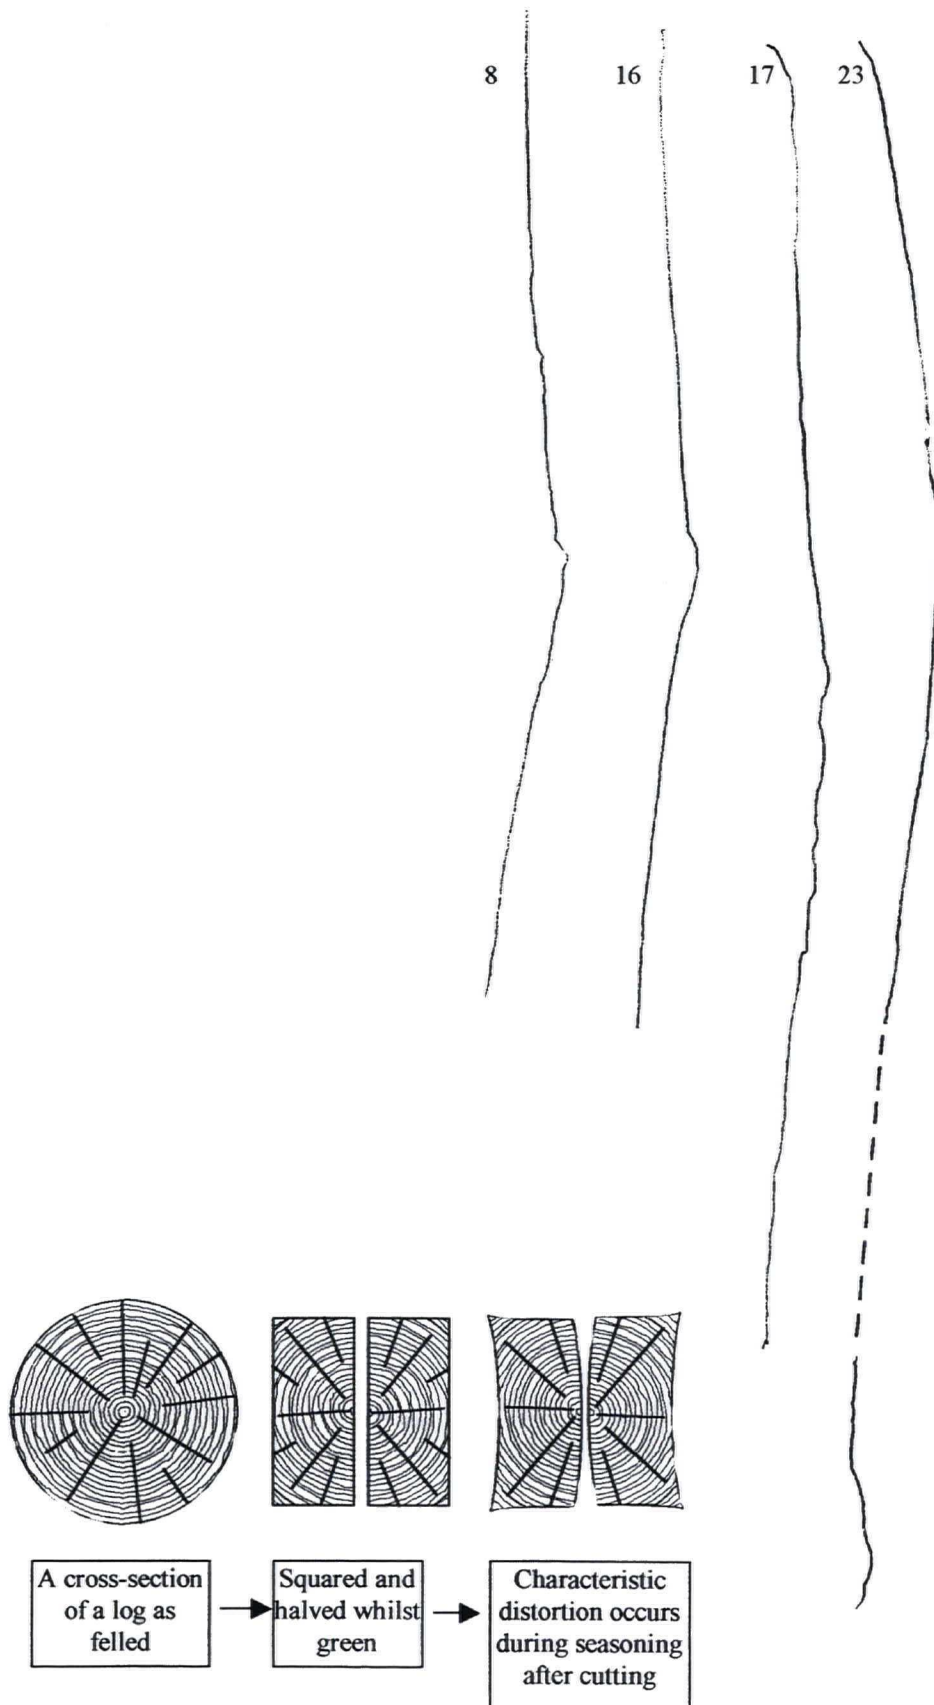
Figure 13 Example profiles of the inner faces of four of the sampled timbers from four different roofs at Hovingham (approximately $\frac{3}{4}$ life-size). In each case the wood is to the left of the line. The dashed line indicates the location of an iron strap. These faces each exhibit saw marks and thus would have been flat when originally cut. The distortion demonstrates these were originally cut whilst the timber was still green. Inset figure provides a schematic diagram showing the effect of seasoning on a cross-section
