## RICHMOND

## TRINITY TOWER ROSE GARDEN

Watching Brief  
14<sup>th</sup> - 16<sup>th</sup> October 2002

## Watching Brief

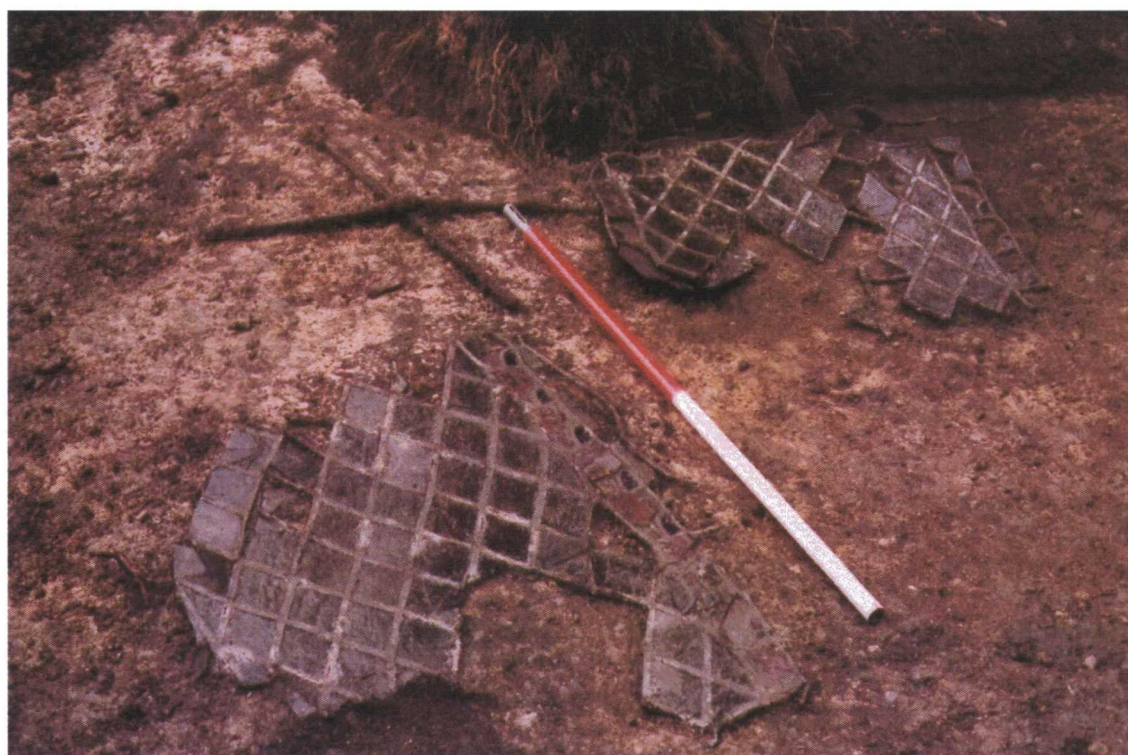
Trinity Tower, Richmond. The two sections of nineteenth century leaded window found below the imported topsoil during the archaeological watching brief on the Rose Garden site. For more detailed views see page 5.

The window lay at the east end of the site, and was in two parts, one of which appeared to be the top half curving round to a shoulder. The central part was made up of diamond-shaped quarries of pale green glass 8.5cm wide by 13.3cm long. This was surrounded by a border of red and amber stained glass and clear glass painted in red with a variety of motifs including tendrils, fleur-de-lis and abstract patterns, in small curvilinear leaded sections. Bordering this again was a thin border of rectangular clear glass strips, typically 1.6cm wide by 8.5cm long. The total width of the leaded glass was approximately 72cm.

Associated with the glass window sections were three horizontal iron glazing bars, with three fragments of copper wire remaining, and a fourth iron bar, approx 2m long and surmounted by a fleur-de-lis, which is probably the vertical bar supporting the three horizontal ones.

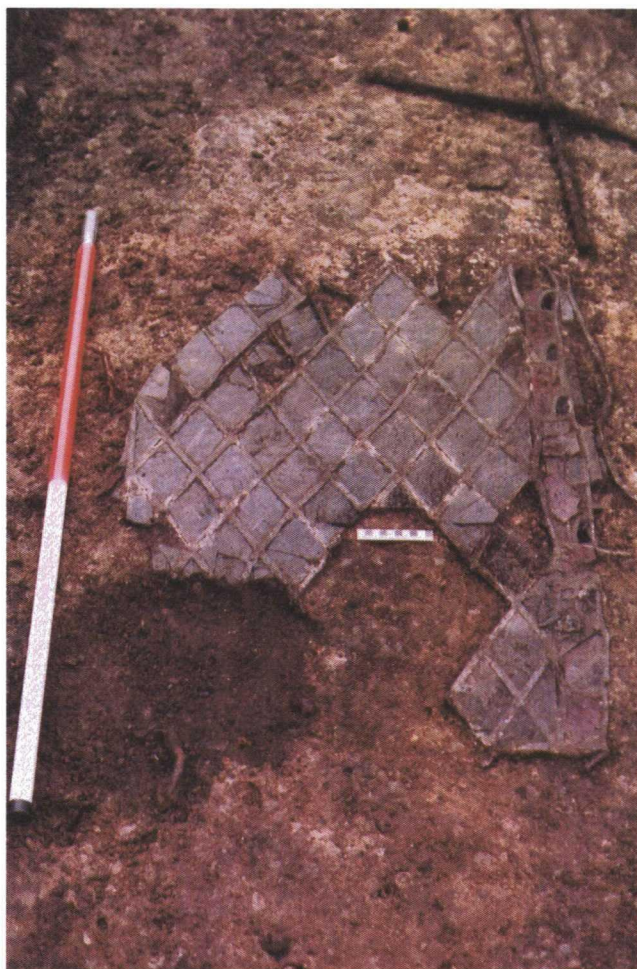
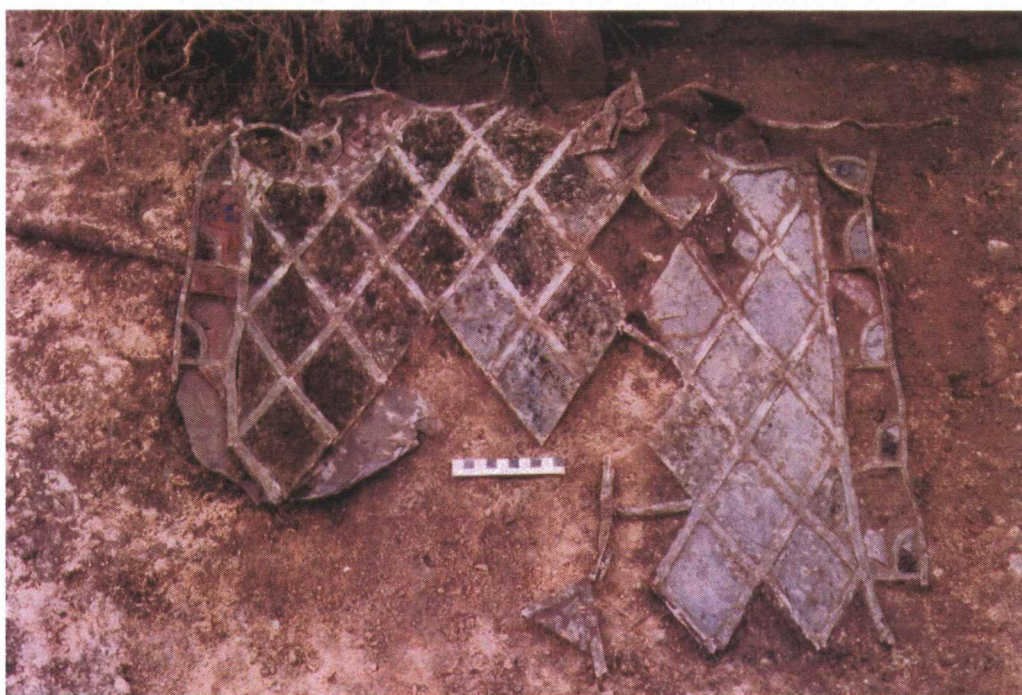
The two sections of leaded nineteenth century window found at the Trinity Tower Rose Garden, Richmond. The lower picture is the top of the window.

Further research into the window is unfortunately beyond the scope of this project. It is unusual to find any sections of leaded glass in this size and condition – even more so as the glazing bars are present, making it possible to reconstruct the size and shape of the window. Dr Willmott recommends careful cleaning with distilled water and cotton buds; he also suggested that Dr Pam Graves at the University of Durham Department of Archaeology should be contacted for further advice and information.

The sections of window were taken from site to the Richmondshire Museum for safe-keeping. After cleaning they could be restored and back-lit for display.
