**ROUGHAM FARM,
ARKENDALE,
NORTH YORKSHIRE**

**REPORT ON AN
ARCHAEOLOGICAL
DESK-TOP STUDY AND
GEOPHYSICAL SURVEY**

**2001 FIELD REPORT
NUMBER 48**

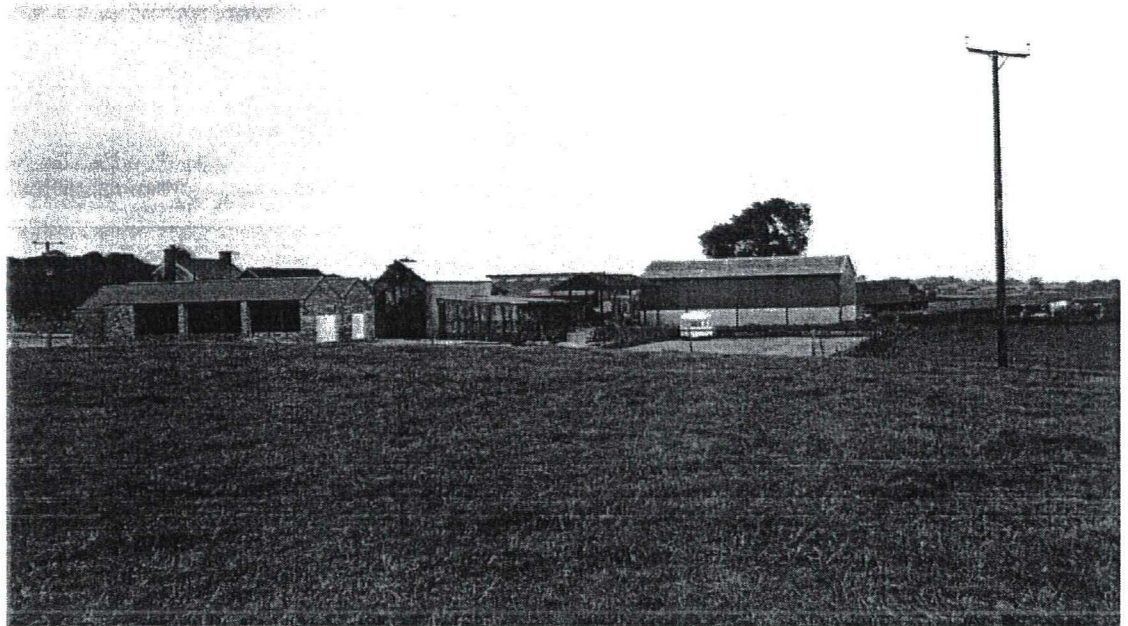
Plate 14.1. Rougham Farm buildings viewed from the south.

On 4th October 2001 a walkover survey of the farm buildings and their surroundings was carried out (Plates 1 and 2).

Three buildings extant at the farm appear to relate to its establishment in the earlier 20th century, the farmhouse and two farm buildings. The two storey farmhouse is constructed of

rendered brickwork, has a large bay window in its west facing frontage and is of earlier 20th construction. The structure has been altered and extended and recently had timber windows replaced with upvc units. A large sub-divided, rectangular, brick built, single storey building is located immediately east of the farmhouse. Behind this is a further single storey brick-built structure of much smaller proportions. Both structures relate to the keeping of livestock and are likely to be of the same age as the farmhouse.

There are a number of more recent farm buildings at the site. These include a small mid 20th century Dutch Barn, two late 20th century steel framed buildings and a recent unfinished steel framed brick building.

None of the farm buildings, including the house and two early farm buildings, are of especial architectural or historical interest.

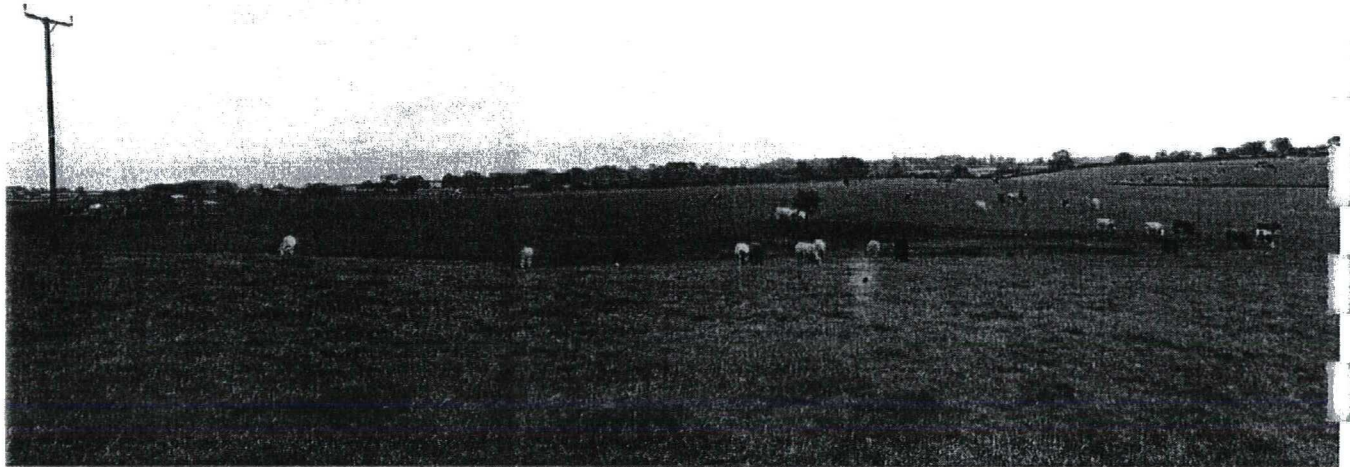
Plate 14.2 Fields to east of Rougham Farm viewed from the south.

All the land immediately surrounding the farm buildings and within the area of proposed development is improved pasture, i.e. has been ploughed and laid to grass for grazing. Of those historic agricultural features visible on later 20th century aerial photographs immediately south and south-east of the farm buildings (see section 14.3.1), namely the ridge and furrow and pond, only the pond survives as an upstanding earthwork. All above ground traces of the ridge and furrow have been lost to plough action.

The former presence of the ridge and furrow was not detected by the geophysical survey but a further indication is given by the east – west aligned field boundary to the south of the pond. This boundary displays a slight, but distinct, reverse “S” in plan-form that is often characteristic of these early field systems. Curiously, the curve of this boundary appears more accentuated on the ground than it does on the Ordnance Survey map.

The sub-rectangular pond, which measures up to 38m x 18m, has to some considerable degree silted up. This pond, which will have been created for the watering of livestock, appears to interrupt the pattern of former ridge and furrow and therefore post-dates the field system.

The only other features noted in the walkover survey were a series of narrow linear grooves, occasionally associated with a slightly elevated area between the grooves, located parallel and immediately to the north of the existing farm track. The morphology of these features and their proximity to the existing track suggest that they have originated as ruts created by wheeled vehicles, perhaps – given the sharpness of their appearance - in the very recent past.

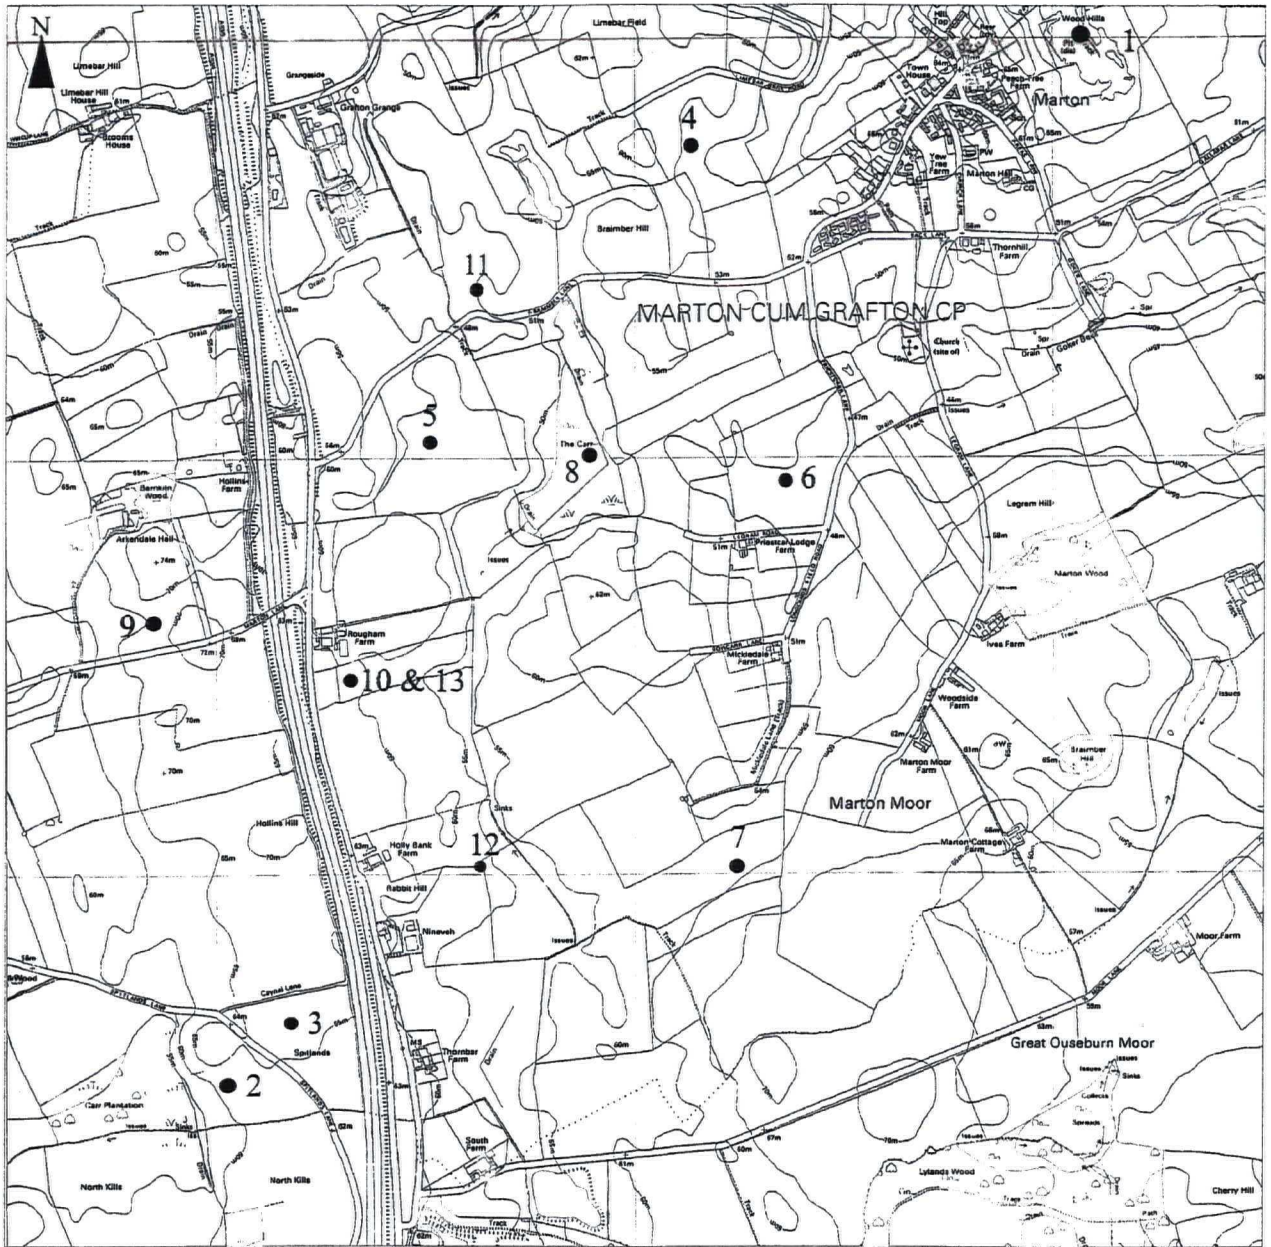
Job Title	
P.Hutton Limited ROUGHAM FARM	
Drawing Title	
MAP SHOWING EARTHWORKS AND CROPMARKS	
Scales	Originator
Checked	Approved Date
Job No.	Drawing No.
67162/00.	Figure 14.1
Rev.

The proposed development site lies within the parish of Marton cum Grafton, some 1.7km south-west of the village of Marton. A number of prehistoric and historic finds and features have been recorded in the locality. These can be detailed on a period by period basis and the majority are shown on Figure 14.1 by site number.

A small Iron Age (circa 700 B.C. - 43 A.D.) hillfort or palisaded enclosure has been recorded at Grafton Hills within Marton village (Site 1). This site had already been largely quarried away prior to a small scale excavation in 1949. As virtually nothing remained of this site it was de-scheduled in March 1998.

Further evidence pointing towards occupation in the locality during the Iron Age/Romano-British period is indicated by a number of cropmarks on aerial photographs (Sites 2, 3, 4, 5, 6 and 7. SMR: SE 46 SW A.P.'s 57, 53, 54, 38, 37 and 39 respectively). Typically these show a variety of enclosures and probable trackways. Slightly further afield Iron Age features have been positively identified and excavated near Flaxby 1.0km north-west of the A1/A59 junction.

A log or plank boat was dug up by labourers in 1797 whilst digging in the Carr approximately 700m north-east of Rougham Farm (Site 8). Subsequently destroyed, this craft was located in an area likely to have once formed a lake or drainage area. The date of the boat is uncertain and may, for example, be of medieval rather than prehistoric origin.
