**RYTHERGATE/RYTHER ROAD, CAWOOD.**

**A DESKTOP ARCHAEOLOGICAL STUDY.  
OSA REPORT No: OSA03DT01.**

FEBRUARY 2003.

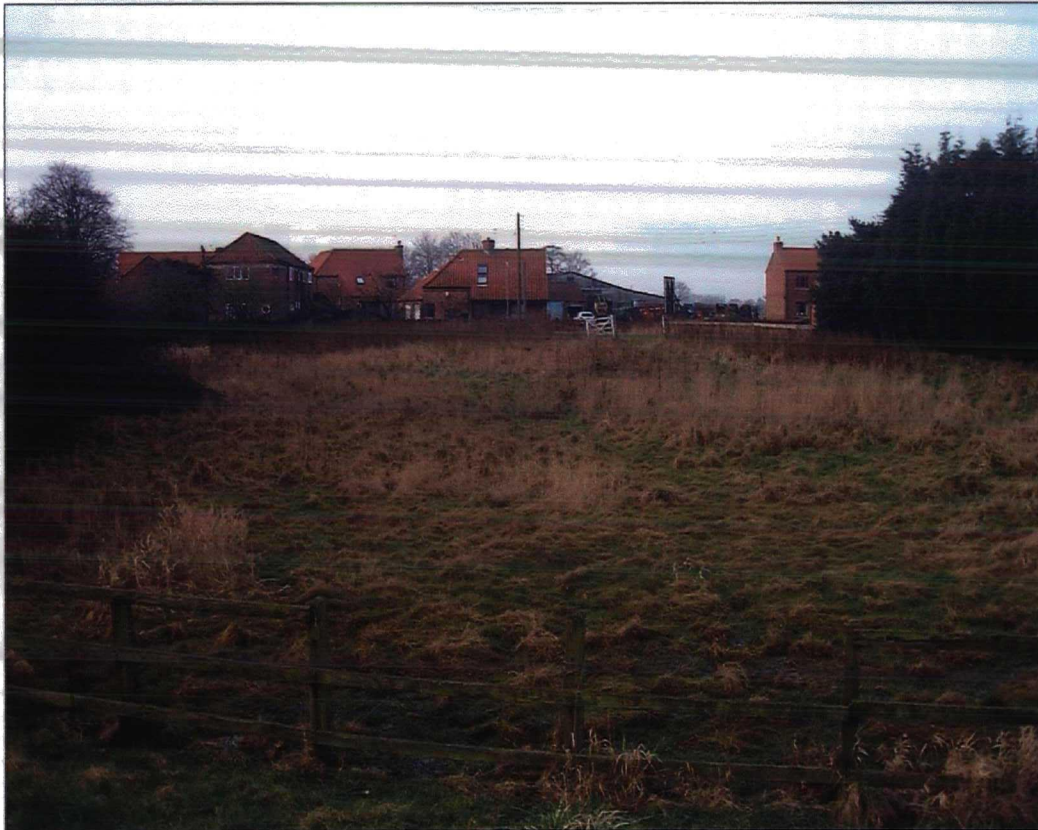
*Plate 1. Southeast part of site, looking southwest.*

The southernmost part of the site is currently a rough grass paddock (Plate 1). The northern area is occupied by White Cross Ski Club, comprising three brick and breeze-block built buildings, areas of gravel hardstanding and several static caravans (Plate 2).

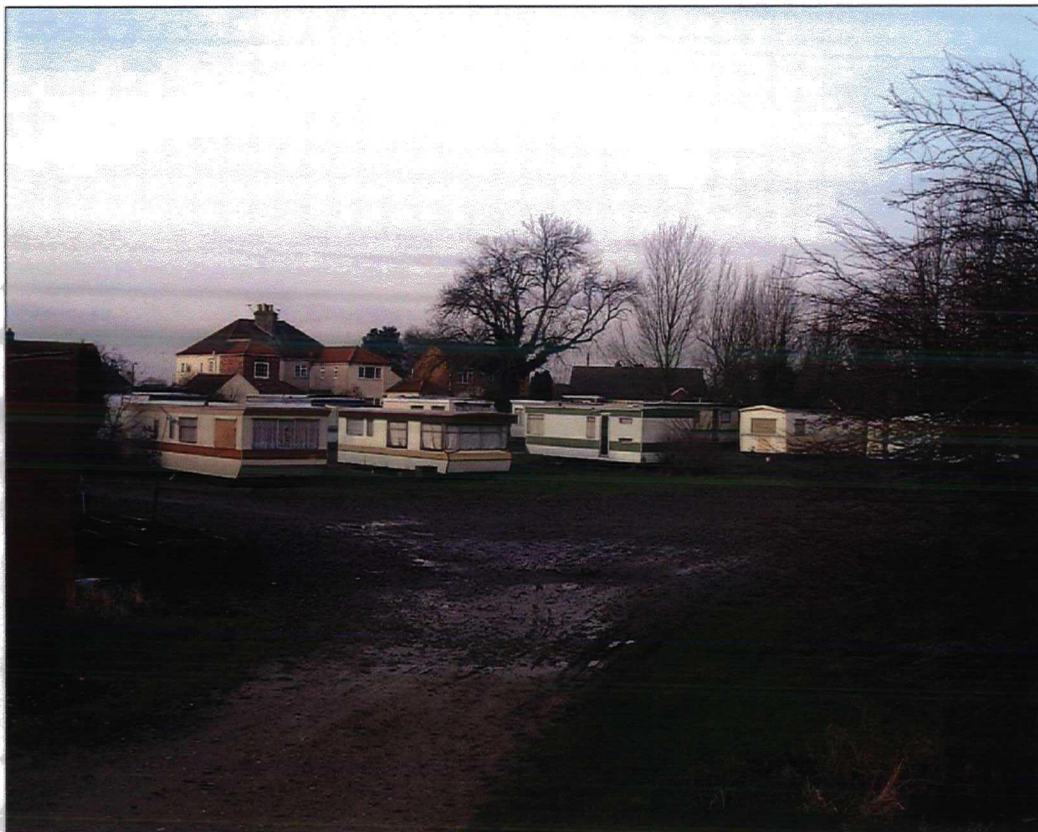
*Plate 2. Northwest part of site, looking southwest.*
