KEVIN CALE
 ARCHAEOLOGICAL WATCHING BRIEF

MOATED SITE

DALTON - ON - TEES

DECEMBER 1998

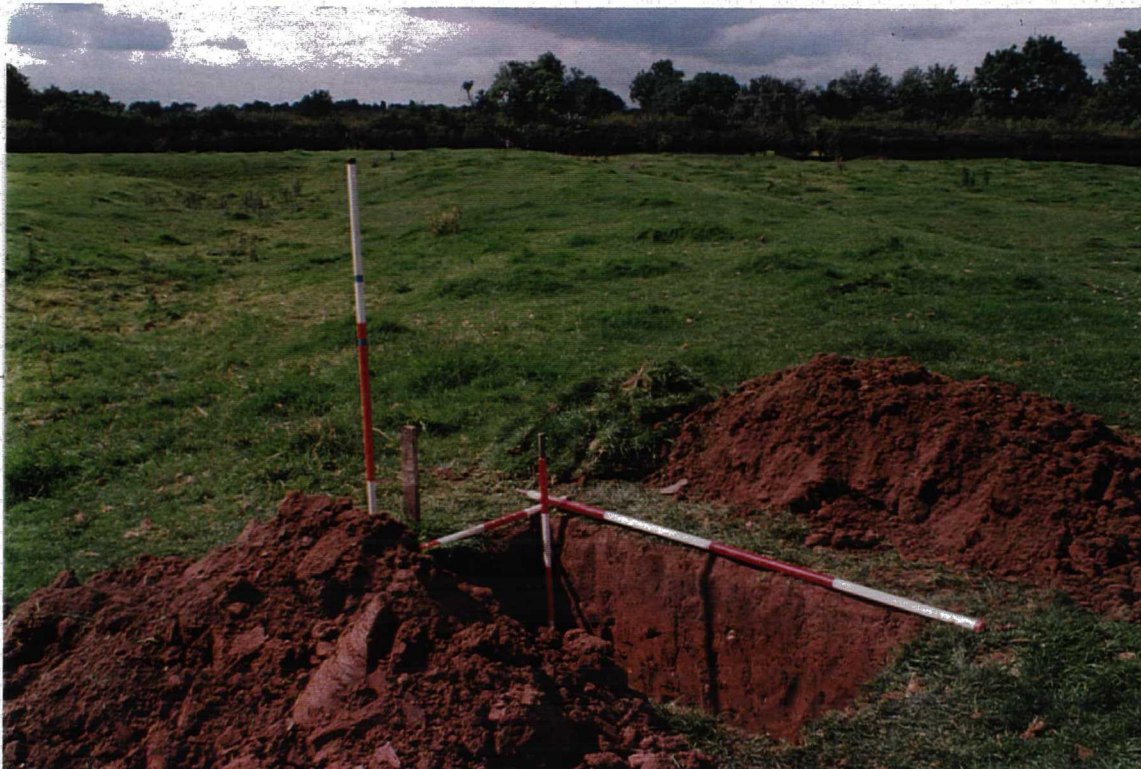
Plate 1

Placement A - Location shot, facing south south west

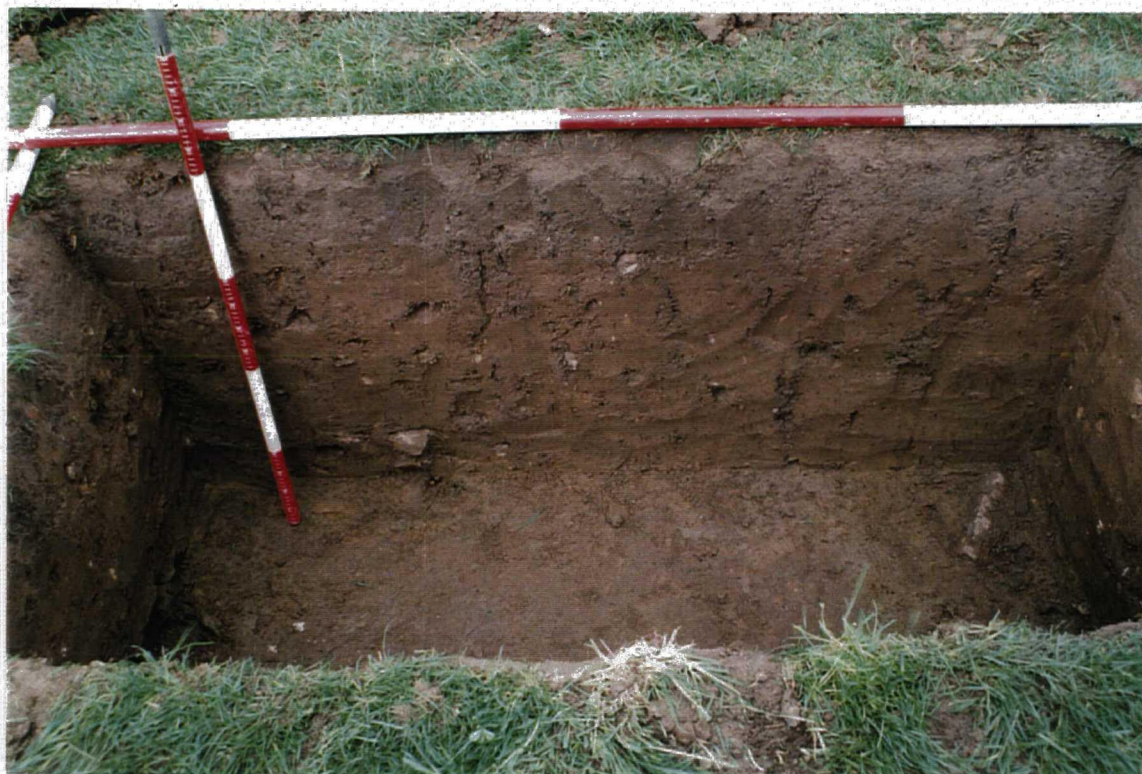
Plate 2

Placement A - On completion of hand excavation

The turf (context 1000) was bedded on a layer of topsoil (context 1001), this dark grey brown (10YR3/3) loam was dry and friable with a low quantity of inclusions, dominated by root with occasional coal and cinder fragments, it is suspected that these may have originated from repeated night-soiling activities.

At 0.16m below the existing ground level a cultivated soil (context 1002) was identified, this medium brown (10YR4/3) sandy clayey loam was well compacted and dry with a friable texture. The layer contained a low quantity of inclusions, these were dominated by sandstone blotching, charcoal flecking, sand blotching and sandstone fragments. It was initially suspected that this layer was the principal make up of the perimeter bank, however, upon excavation it was revealed to be only 0.16m in depth and contained a small assemblage of 19th century pottery. It is likely that this soil was formed during farming activities that have been continuous across the site since the late medieval period.

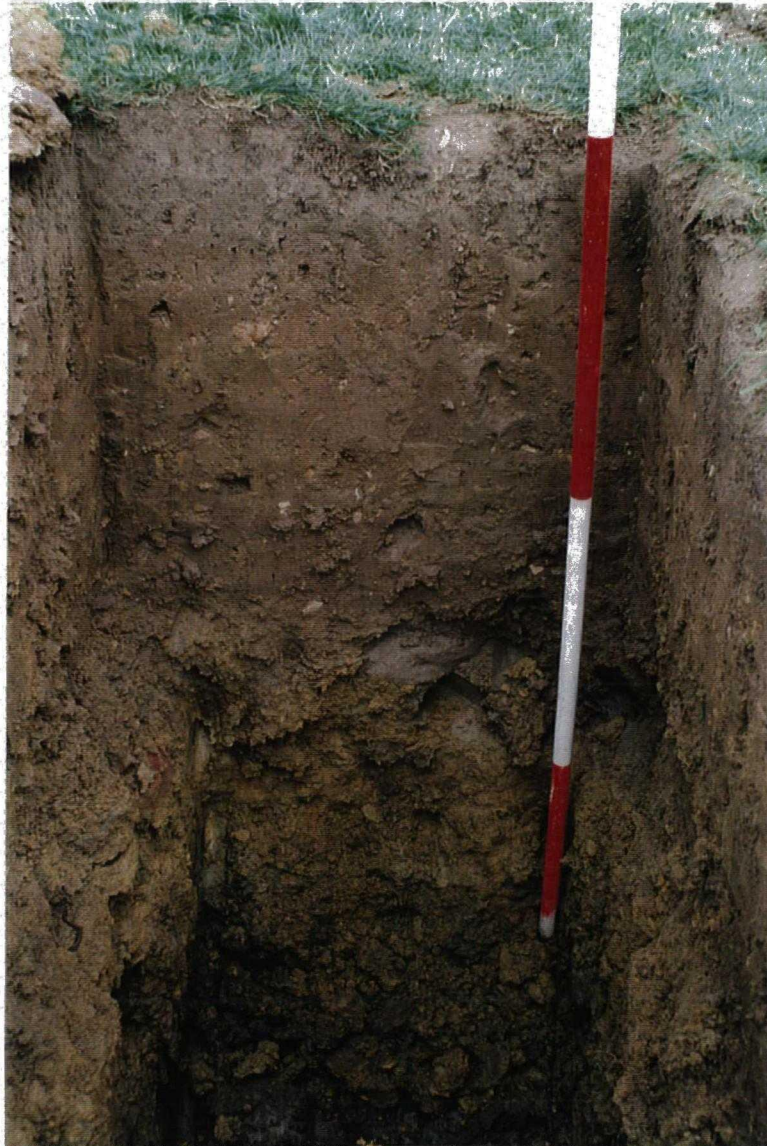
Plate 3

Placement A - On completion of machine excavation

The buried profile of the perimeter bank was identified at 0.32m below the existing ground level, the aspect and gradient of which appeared to mirror that of the existing earthwork. The bank was made up of a medium brown (10YR4/3) loamy clay (context 1003). This layer was moist and well compacted and contained a low quantity of inclusions, namely sand blotches, Iron Stone fragments, limestone fragments and magnesian limestone fragments, these were evenly mixed throughout the matrix of the soil. The layer measured upto 0.58m in depth.

At 0.85 below the existing ground level the surface of the sub soil (context 1004) was identified. This yellow brown (10YR5/6) sandy silty clay was found to be moist and well compacted, the upper levels of which had a crumbly texture becoming increasingly plastic towards the base of excavation. The layer contained a low to moderate quantity of inclusions these were predominantly limestone fragments, sandstone fragments and sand blotching.

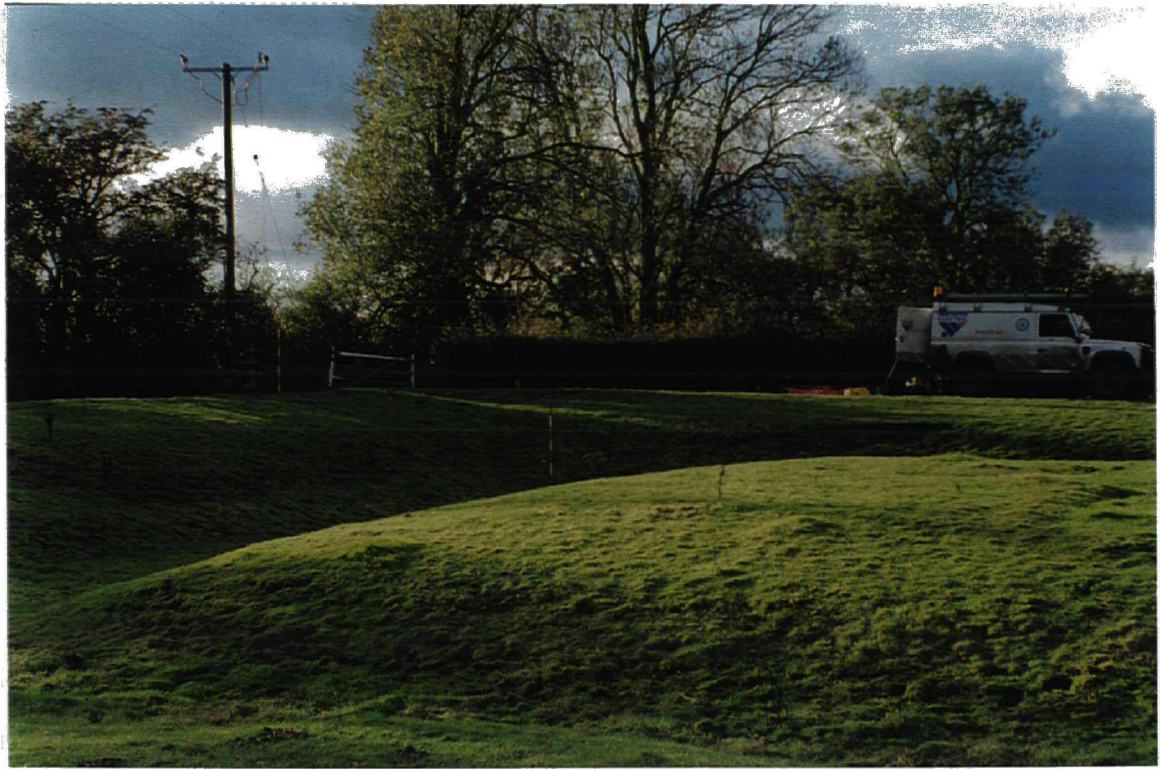
Plate 4

Placement B - Location shot, facing south

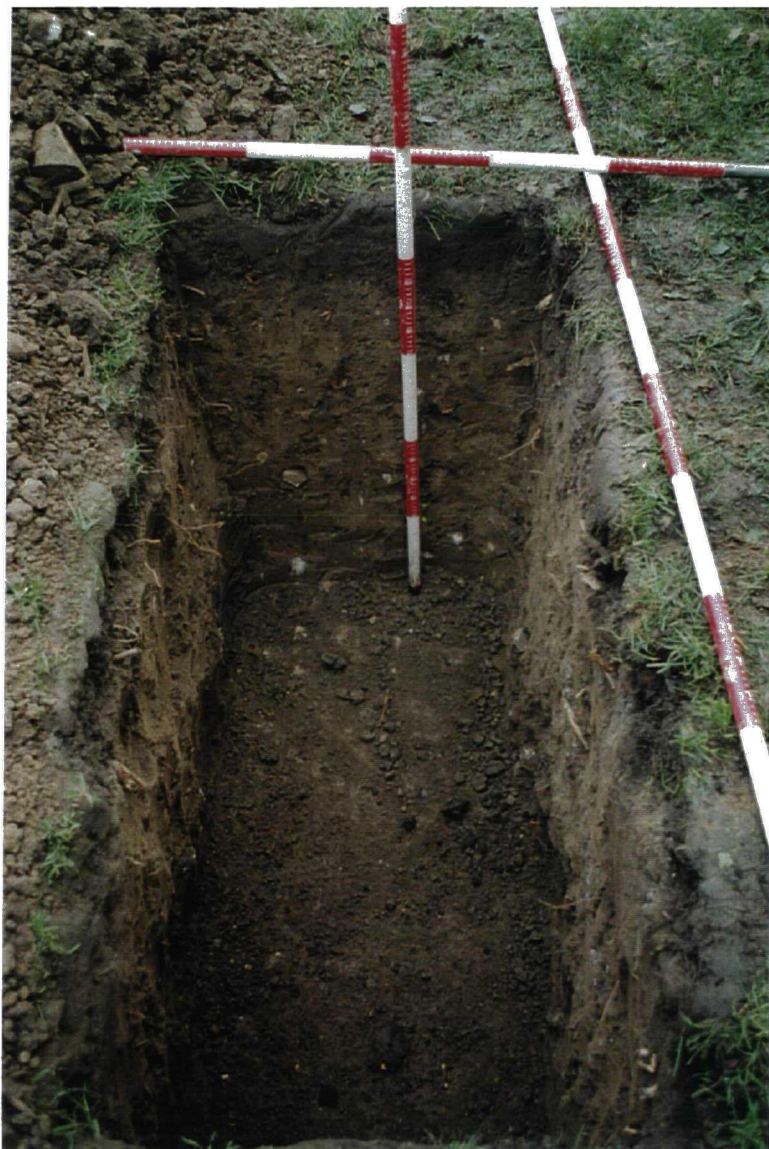
Plate 5 Placement B - On completion of hand excavation

The turf (context 2000) was bedded on a layer of topsoil (context 2001), this dark brown (10YR3/2) loam was extremely dry and friable, these arid conditions were enhanced by the close proximity of a mature hedge with Ash trees. The layer contained a low quantity of inclusions, dominated by root with occasional coal fragments, it is suspected that these may have originated from repeated night-soiling activities.

The buried profile of the perimeter bank was identified at 0.16m below the existing ground level, the aspect and gradient of which appeared to mirror that of the existing earthwork. The bank was made up of a medium orange brown (10YR4/3) sandy clayey loam (context 2002). This layer was moist and well compacted and contained a low quantity of inclusions, namely sand blotches, shale, limestone fragments and charcoal flecking, these were evenly mixed throughout the matrix of the soil. The layer measured upto 0.64m in depth. A single sherd of Tees Valley Ware was recovered from this layer, this tentatively dates the construction, or repair, of this section of bank to the early 14th century.

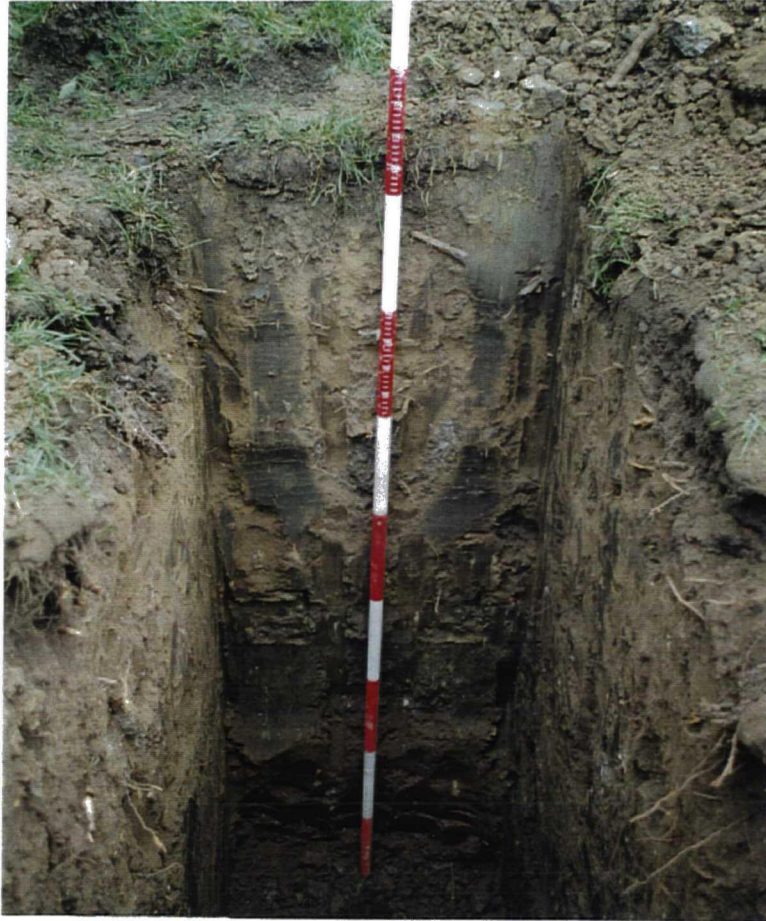
Plate 6

Placement B - On completion of machine excavation

At 0.80m below the existing ground level the surface of the sub soil (context 2003) was identified. This orange brown grey (10YR5/6) sandy clay was found to be moist and well compacted, the upper levels of which had a crumbly texture becoming increasingly plastic towards the base of excavation. The layer contained a moderate quantity of inclusions these were predominantly limestone, sandstone fragments, Iron Pan mottling and sand blotching.
