ARCHAEOLOGICAL WATCHING BRIEF
AT
SKIPTON CASTLE
RESTAURANT
FOR
WALES, WALES AND RAWSON

JANUARY 1999

SKIPTON CASTLE – ARCHAEOLOGICAL WATCHING BRIEF ON GROUND WORKS ASSOCIATED WITH NEW RESTAURANT

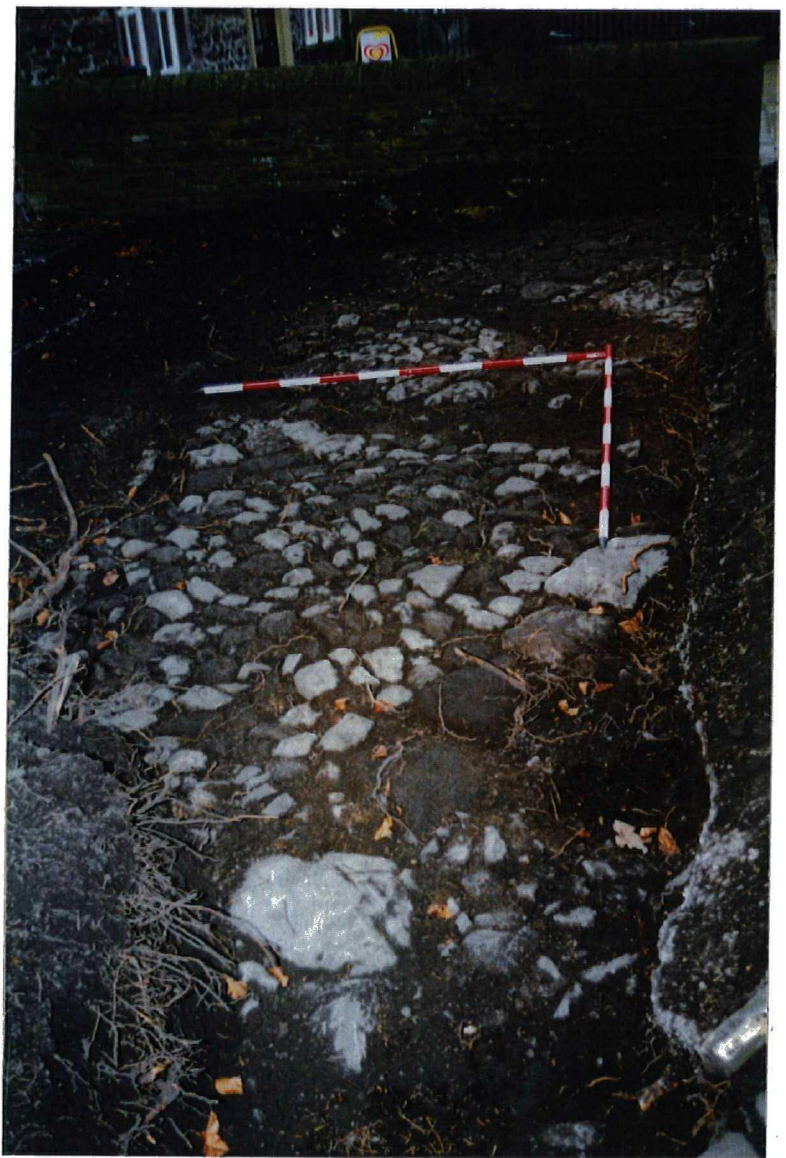
To the northeast of the area, the cobbles butted up to a line of very large, water-worn stones of roughly rectangular shape, aligned east-northeast (Plate 1). North of this line the stones were more scattered and had the appearance of tumble rather than laid cobbles. The large stones may represent cobble wall foundations and the scattered stones tumble from such a wall.

PLATE 1
COBBLE SPREAD
WITH WALL
FOUNDATIONS
IN FOREGROUND

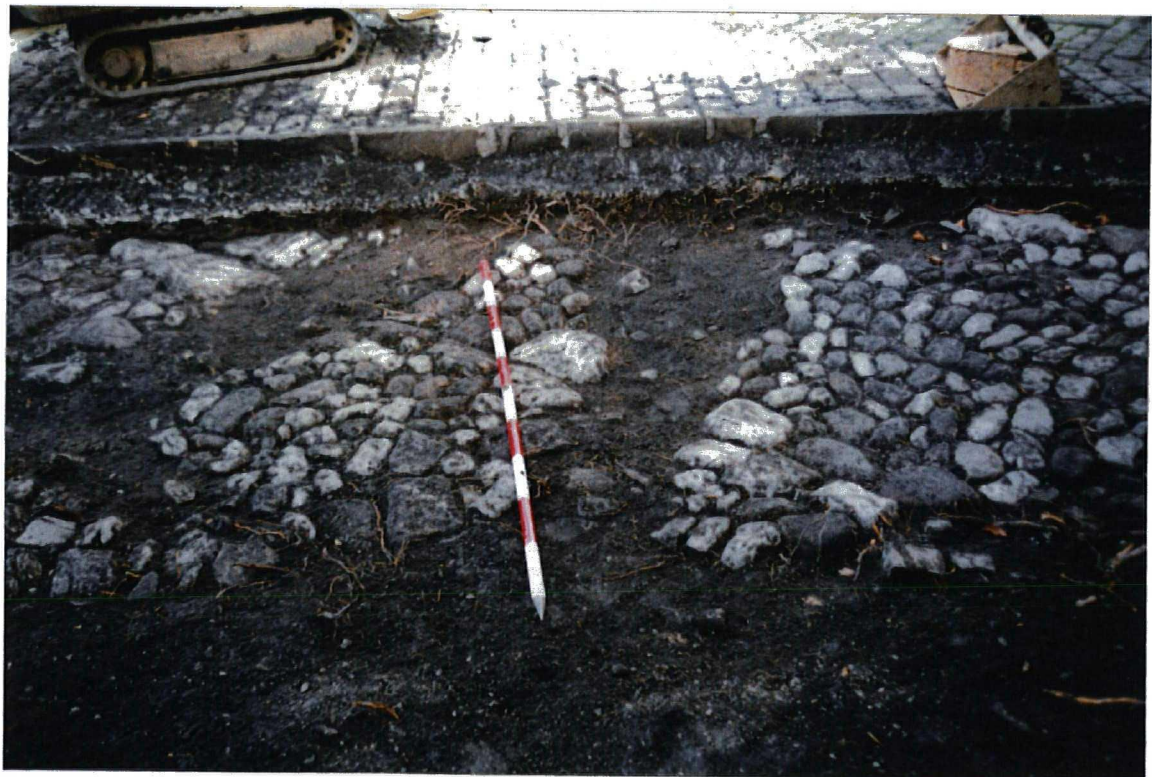
Beneath the clayey loam over the northern half of the area was a spread of cobbles set in pale orangey brown loamy clay with pea-grit (Plan 2, Plates 1-4). The cobbles were variable in nature, some parts being closely and regularly spaced, and other areas less even with a variety of sizes. There were two areas where the cobbles were largely absent (Plates 2, 3). These were two strips of brown clayey loam running southwest to northeast across the centre of the cobbled area, each approximately 50cm wide. They were irregular in shape, and it was impossible to determine without further excavation whether they were later features cut through the cobbles, part of the original layout or merely where the cobbles have been subsequently removed through wear or disturbance.

PLATE 2 COBBLE SPREAD

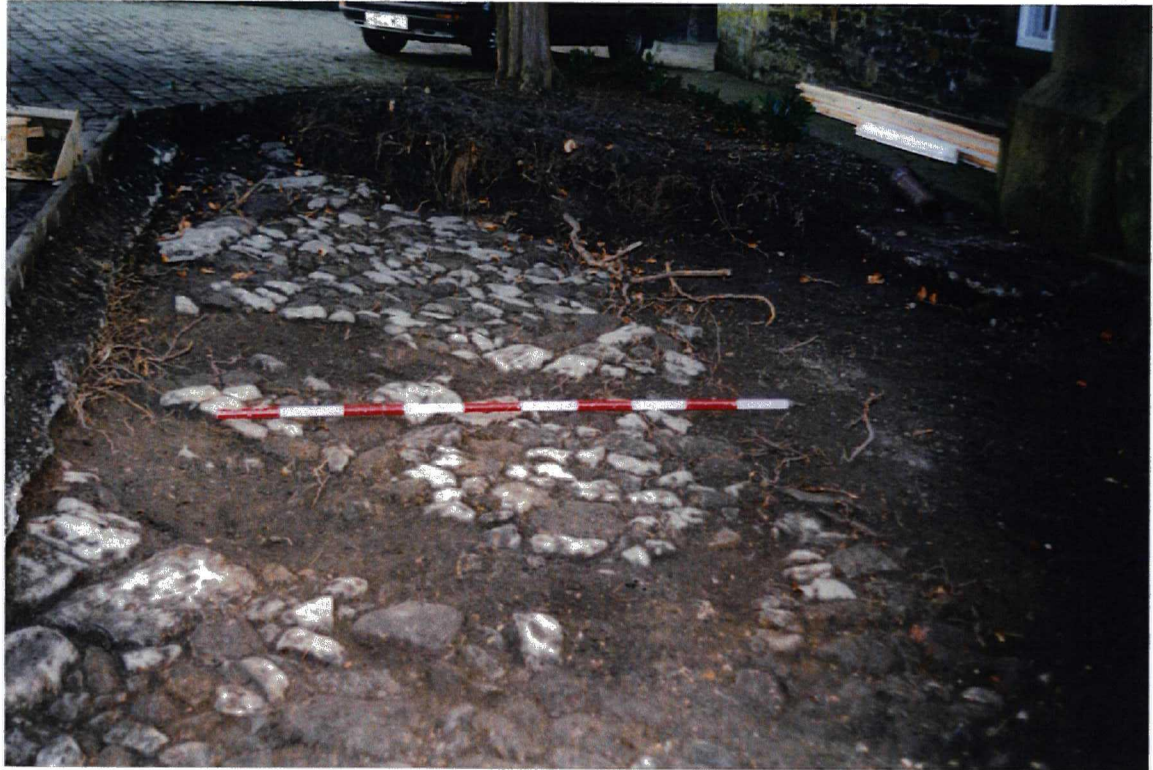
PLATE 3 COBBLE SPREAD WITH GREY GRIT TO RIGHT

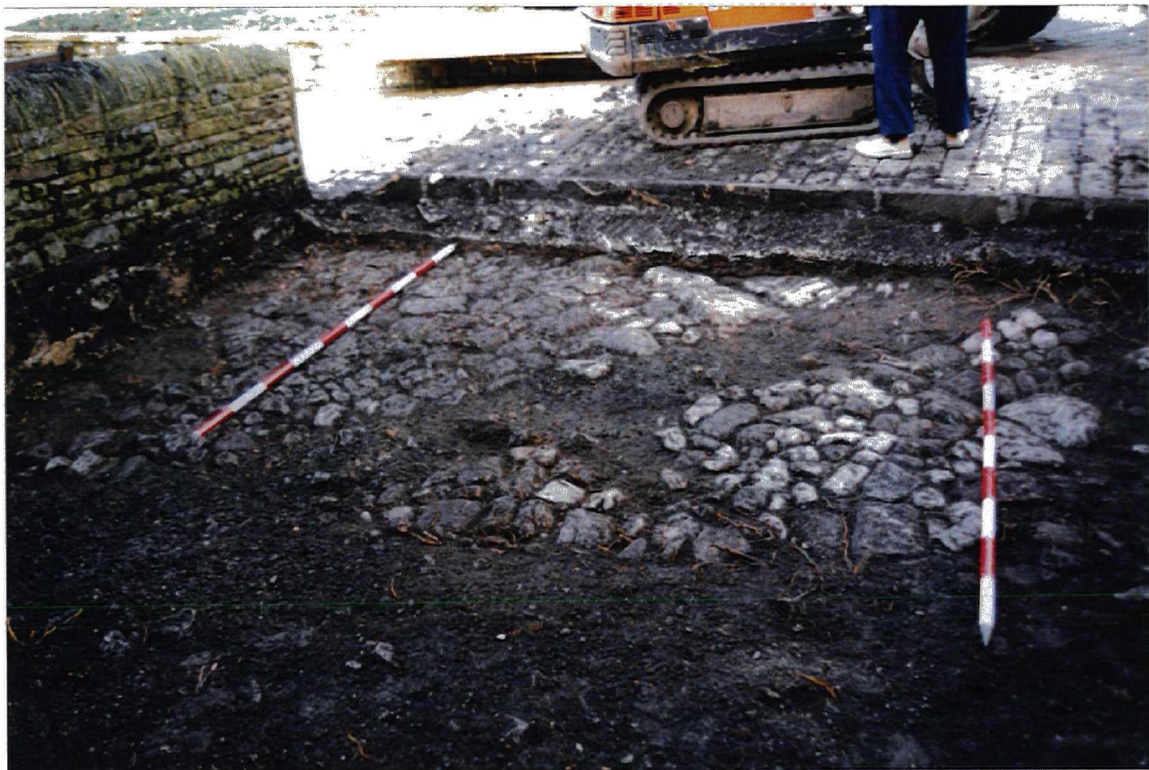
To the west, the cobbles appeared to cease just before the retaining wall separating this area from that lowered previously (Plate 4). This may reflect the disturbance caused by the building of the wall, but as cobbles were not encountered immediately to the west of the wall, it seems that the gap is real. Cobbles were revealed immediately around and to the east of the well head uncovered in 1995.

PLATE 4 COBBLE SPREAD, NORTH-WEST CORNER

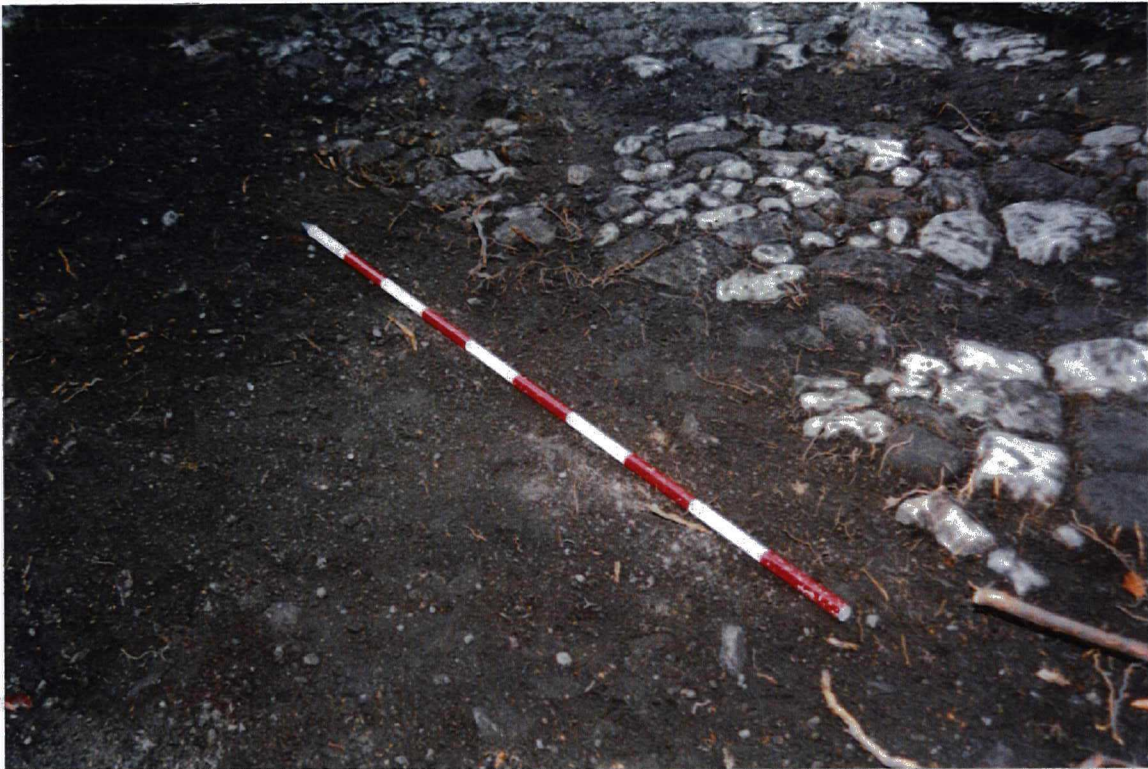
To the south of the cobbled area the ground was disturbed and the cobbles were replaced by brown loam. The surface of the cobbles was sloping down to the south towards the building, and it is possible that they continued below the level required in the current works, but it seems more likely that they did in fact come to an end. Approximately 60cm south of the southern edge of the cobbles was an intermittent layer, up to 20cm wide, of pale grey grit emerging through the brown loam (Plates 3, 5), possibly representing the top of a feature running east-west below the level of the current excavations.

PLATE 5 GREY GRIT TO SOUTH OF COBBLE SPREAD

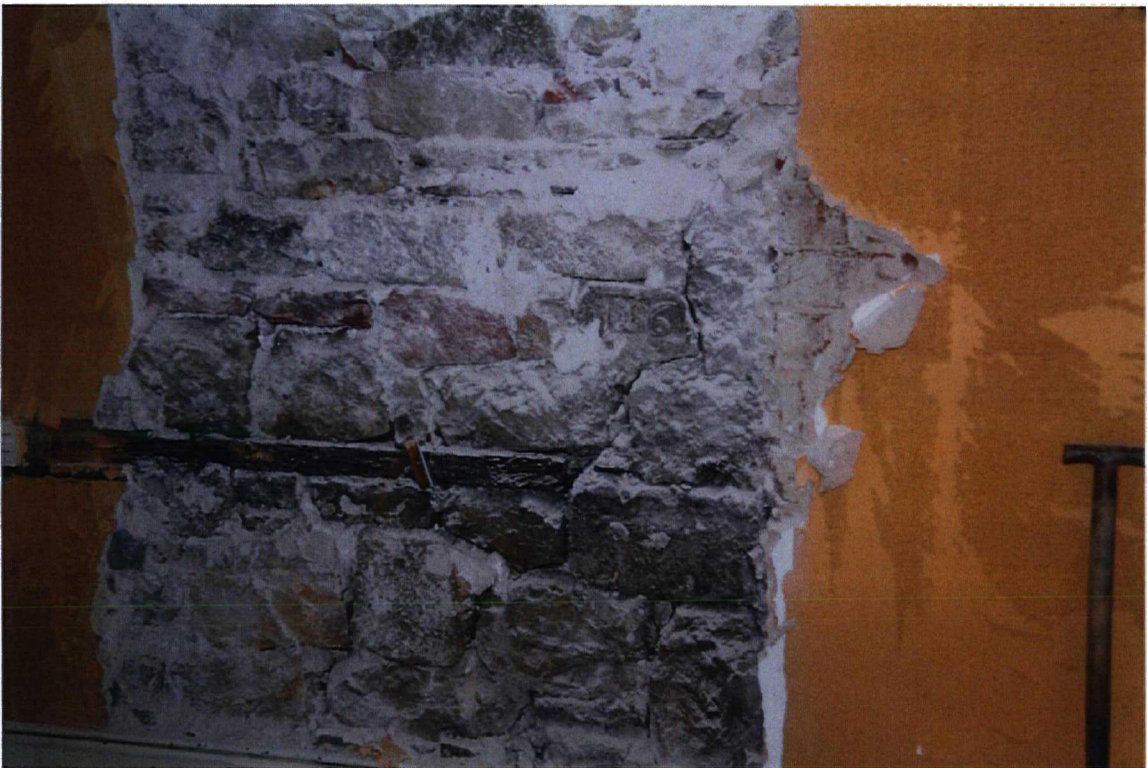
Inside the building which was being converted from offices to a cafeteria, an internal north-south wall, which already had two openings in it, had a third opening made through it, south of the existing ones (Plan 3). A blocked up fireplace stood between the new opening and the southernmost of the existing openings. The wall, 73cm thick, was plastered and papered, with a dado rail at a height of 71-76cm above the floor (Plate 6). Beneath the plaster was a rough masonry wall consisting of a mixture of stones, mainly sandstone, with occasional brick and timber fragments. The stones were of very variable size but were generally larger on the outer faces with smaller pieces in the core. Some of the stones were dressed, and where this was so the dressed faces generally fronted the wall, but not all the fronting stones were shaped. The form of several stones showed that they were re-used from other contexts, and outstanding among these were part of a stone mullion from a substantial window (Plates 7, 8), and part of a date stone with the numbers 1 and 6 in a panel on it (Plates 6, 9, 10). The backing timber of the dado rail, which was within the wall structure (Plate 6), was also re-used, having formerly been a window frame or similar.

PLATE 6 NEW OPENING FROM EAST WITH DADO RAIL AND DATE STONE

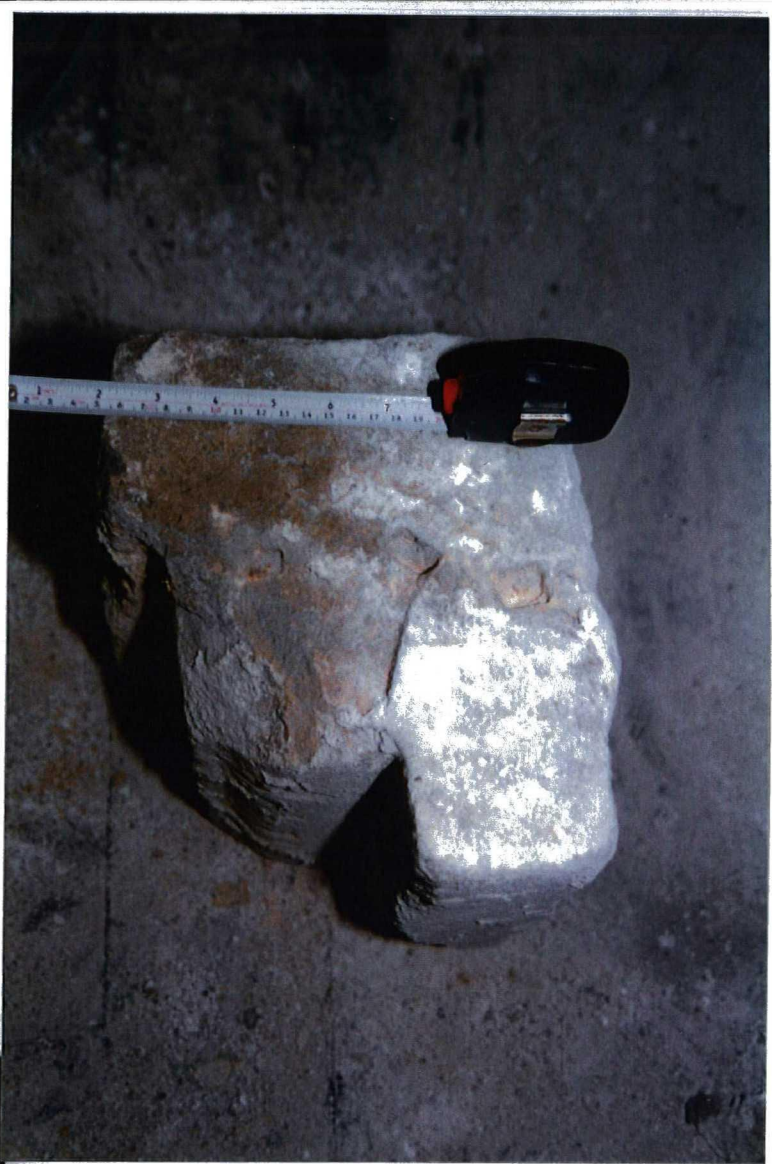
The stone window mullion piece (Plates 7, 8) could conceivably have originated from the chapel which was not in use as a religious building in the seventeenth century, and whose east window was certainly removed at some point. It is not certain however, as the stone, like the date stone, could have come from elsewhere.

PLATE 7
PART OF
STONE MULLION

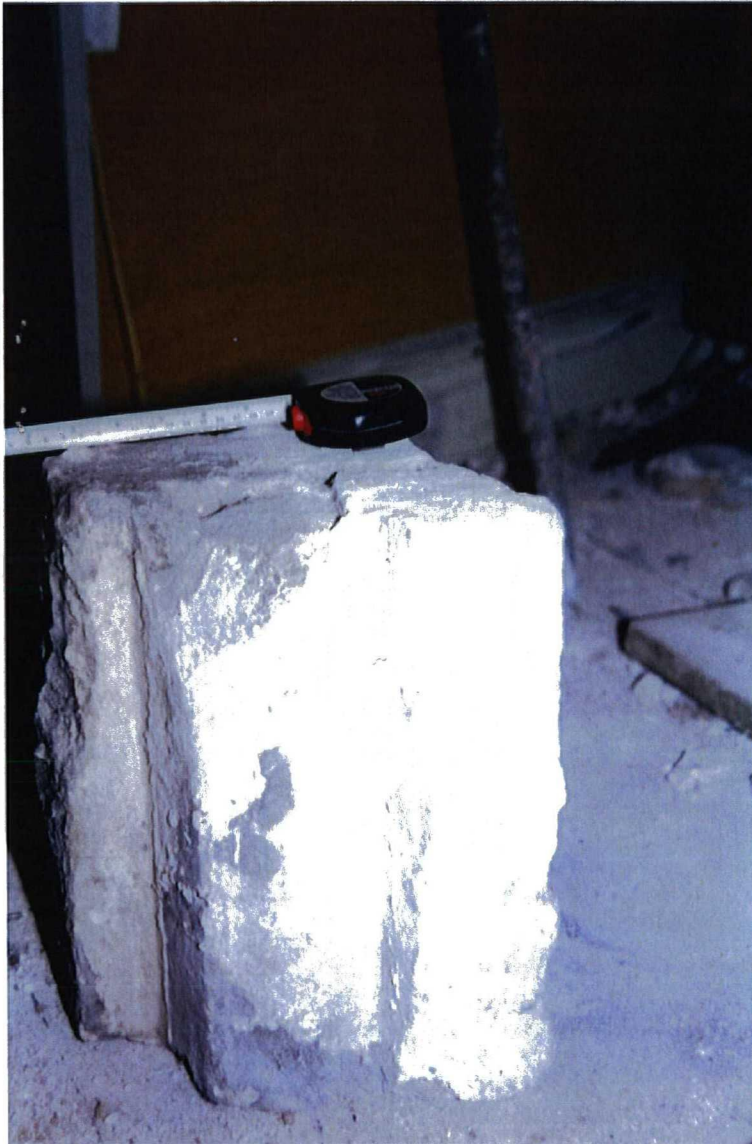
PLATE 8
PART OF
STONE MULLION

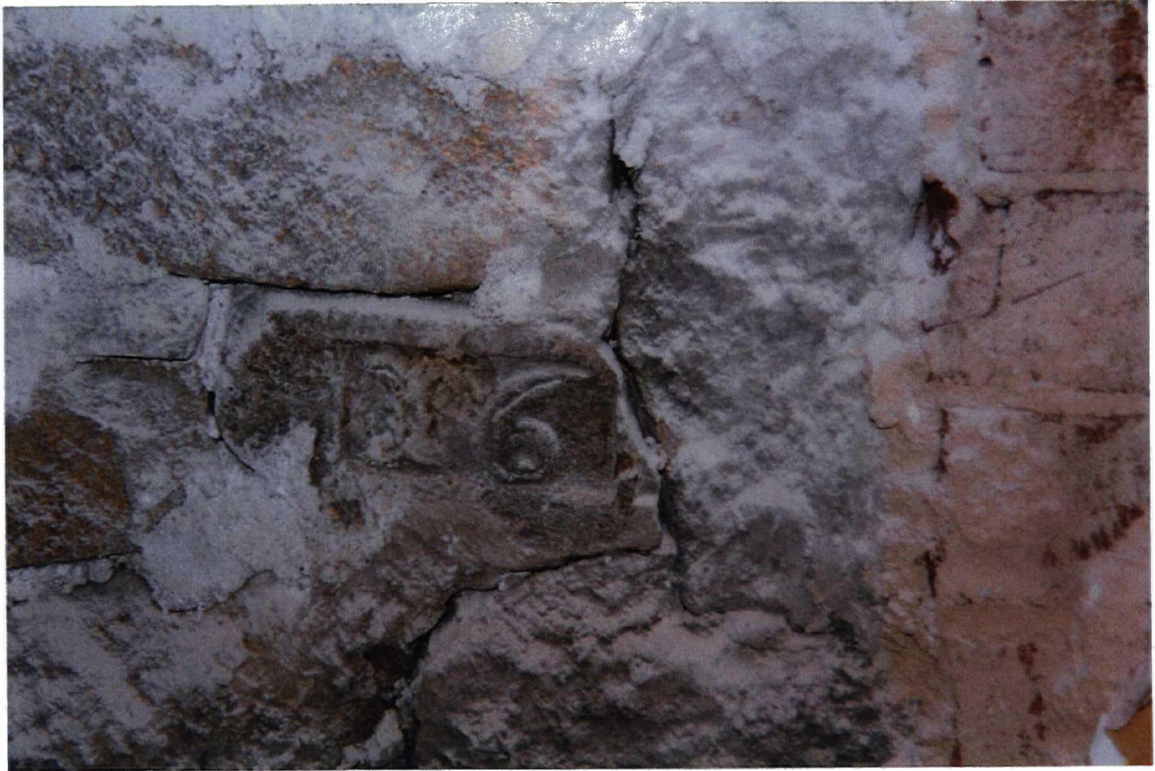
The internal wall within the range could be original. Its composition, of roughly shaped, re-used and unshaped stones, is rougher than that of the external walls, but this could be explained by the fact that it was probably always meant to be plastered. The date stone is tantalising. It was first assumed to be the first part of the date, and the style of the lettering is consistent with the seventeenth century. However, when it was removed from the wall, a piece of moulding to the left of the date panel was visible (Plate 10). This is similar to what would be expected at the top of the right hand side of the door jamb, which would make the numbers in the panel relate to the second part of the year recorded. 1616 or 1716 could then be equally likely. It is also impossible to trace the original use of the stone, which may not have come from the castle at all.

PLATE 9 DATE STONE SET INTO WALL

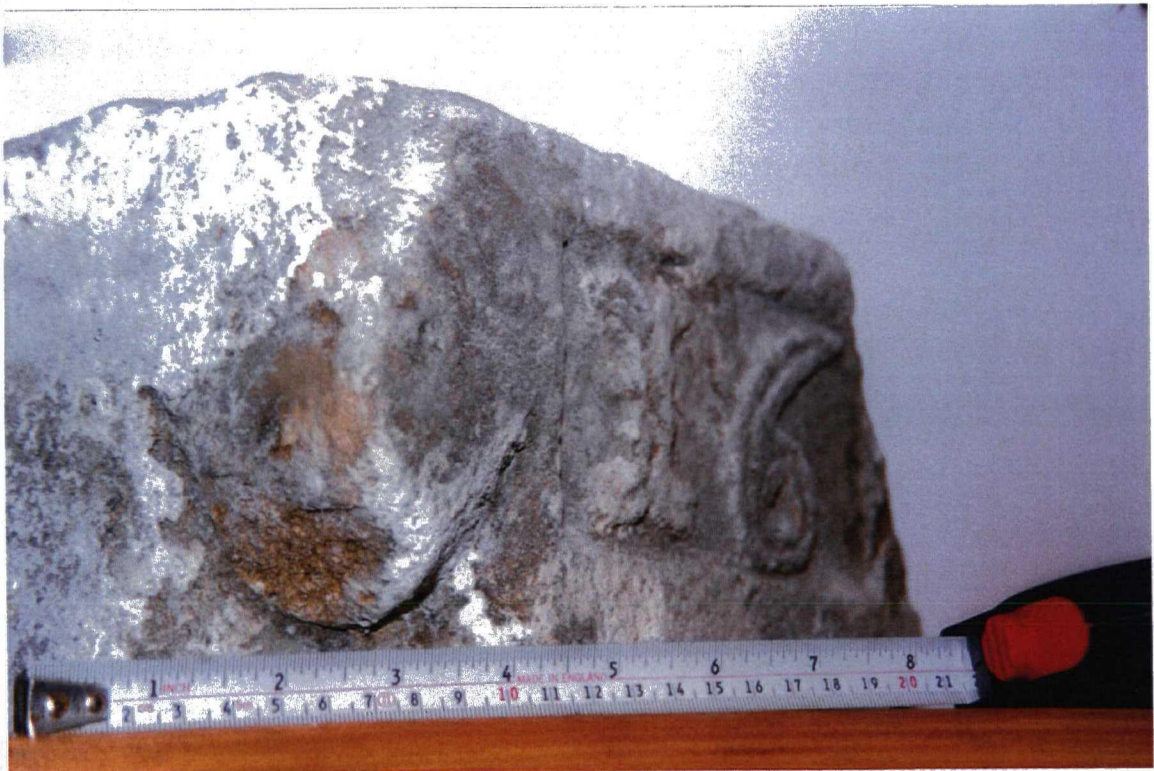
PLATE 10 DATE STONE WITH MOULDING TO LEFT
