**Thrintoft Grange Farm  
Thrintoft  
North Yorkshire**

**Archaeological Watching Brief  
Phases 1 & 2 Interim Report**

**February 1999**

**MAP Archaeological Consultancy Ltd**

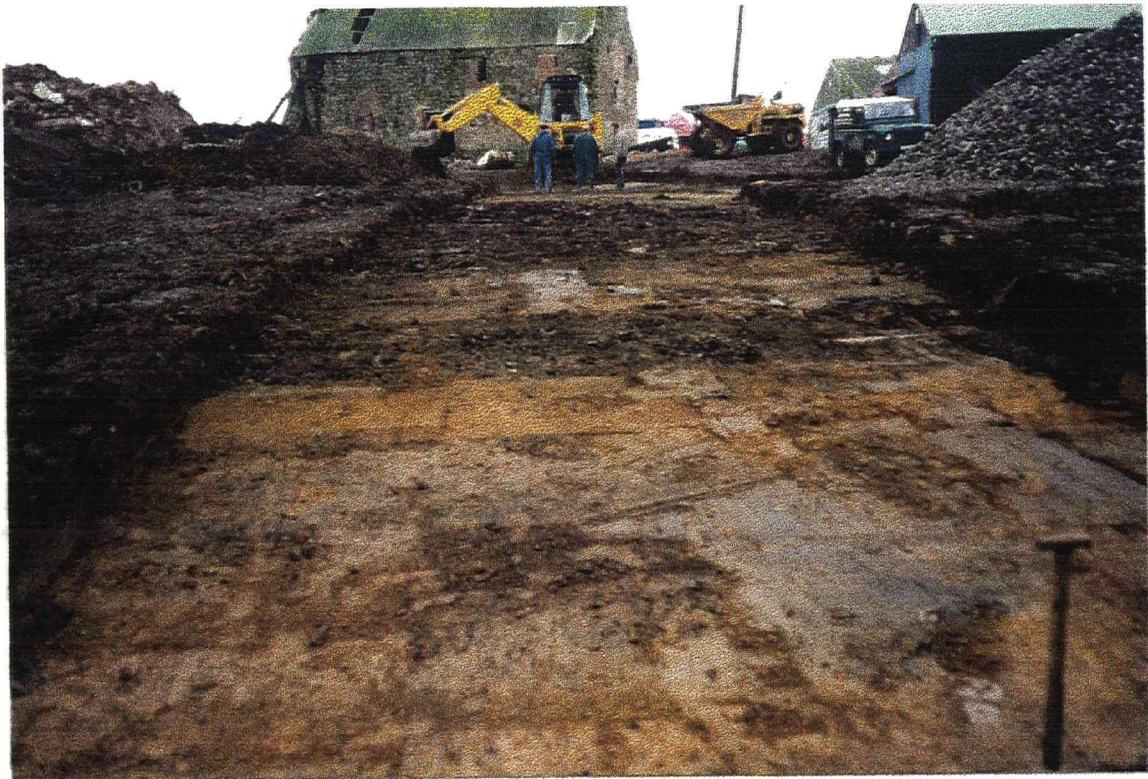
Plate 1. View of access road, after stripping. Facing north.

An archaeological watching brief was undertaken by MAP Archaeological Consultancy Ltd during the excavation of the access road for the development (Fig. 1). Under a thin layer of topsoil were deposits of brick rubble and concrete of varying depth. In places these deposits sealed a thin layer of black silty material again with modern inclusions of brick and tile fragments. This deposit lay directly on to the natural sands and small patches of compact clay (Pls. 1 & 2).

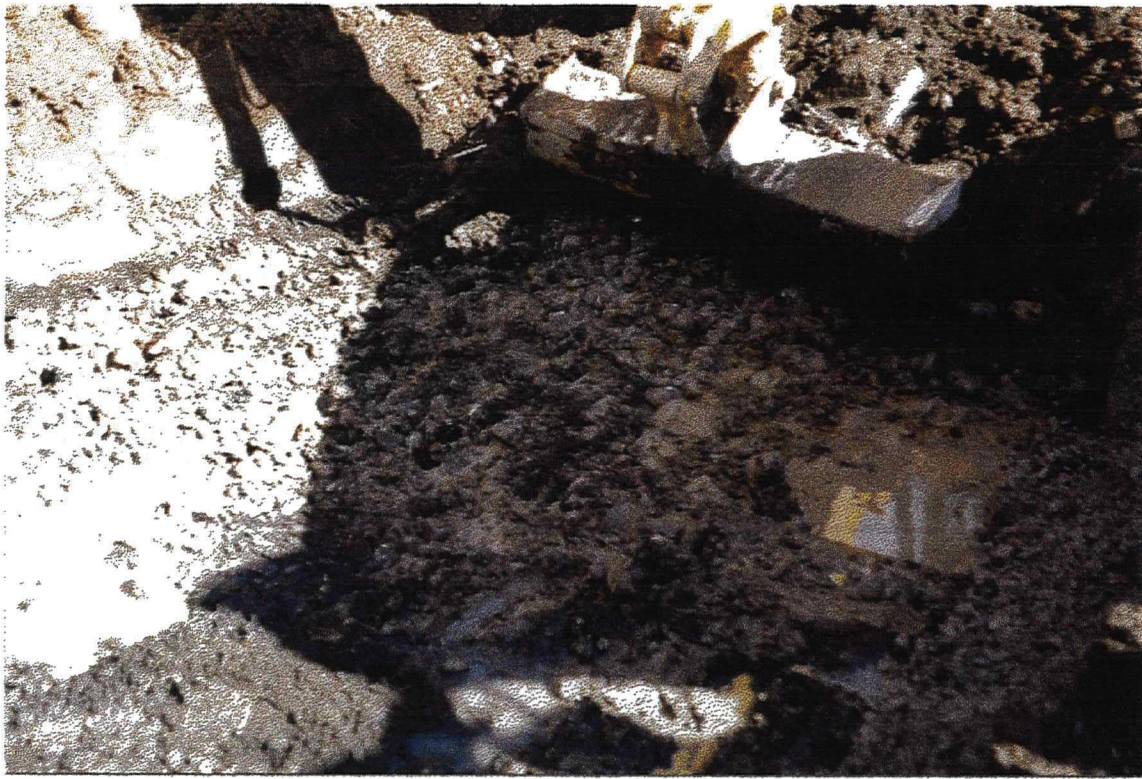
Plate 3. Plot 2. Cobbled surface. Facing north-east.

Excavation located an area of cobbling (Pl. 3), which may be part of an earlier road into the farm and a linear feature possibly representing the western boundary of the farm range.

Pottery of post medieval date was recovered from the surface of the cobbles and within the fill of the linear feature.

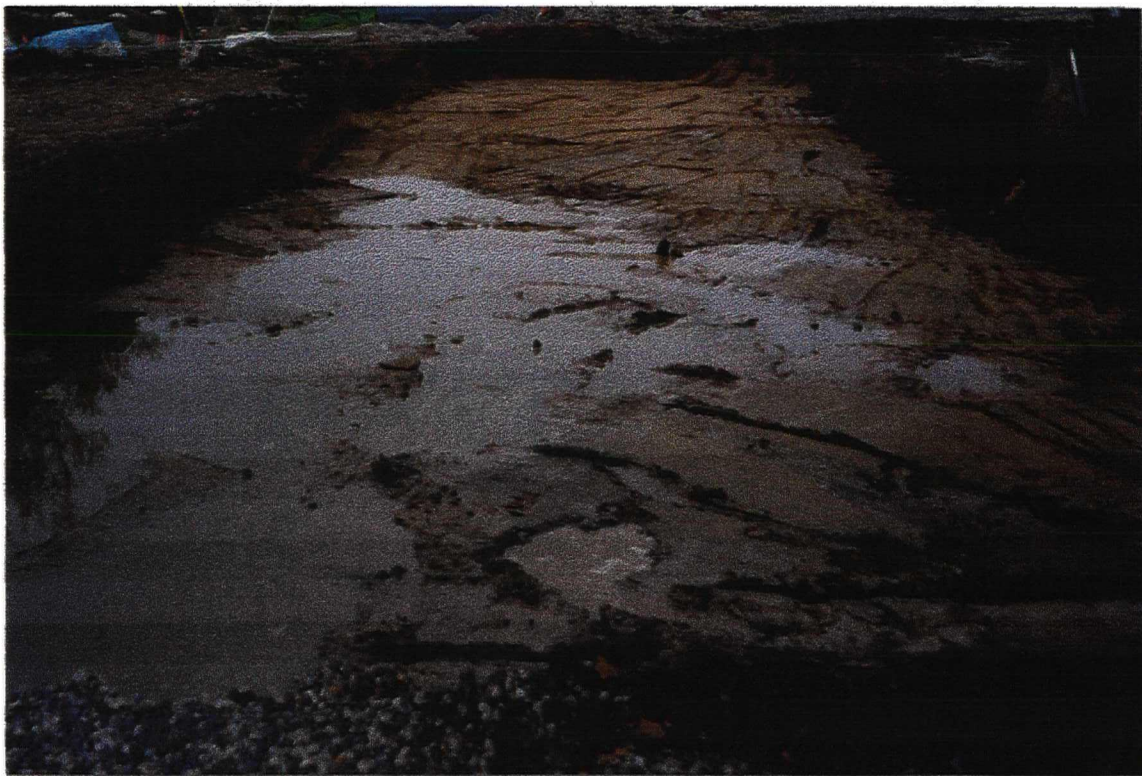
Plate 4. General view of Plot 3. Facing east.

An area of compacted rubble may represent an area of hard standing associated with the farm buildings which were demolished as part of the initial site works. Over the remainder of the plot overburden was seen to be directly above the natural sands (Pl. 4).

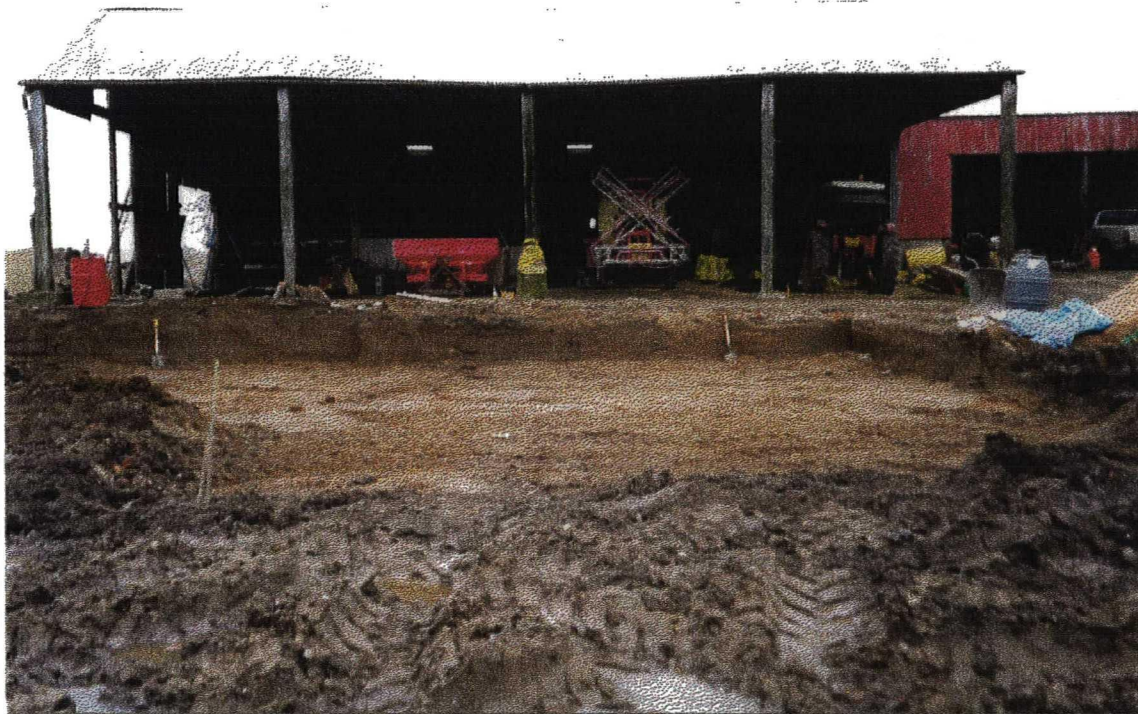
Plate 5. General view of Plot 8. Facing north.

Deposits of modern overburden were less substantial in the northern area of this plot (Pl. 5). The only features observed were pits of recent date containing the skeletal remains of cattle (Pl. 6), three such pits were observed all containing articulated and disarticulated remains. Ceramic finds were restricted to a single residual sherd of Brandsby type ware pottery found in the fill of one of the pits.
