Report on an Archaeological Evaluation

Proposed Route of the A19 Easingwold By-pass

York Archaeological Trust
1991

ARCHAEOLOGICAL SURVEY
OF THE PROPOSED ROUTE OF THE
A19 EASINGWOLD BY-PASS

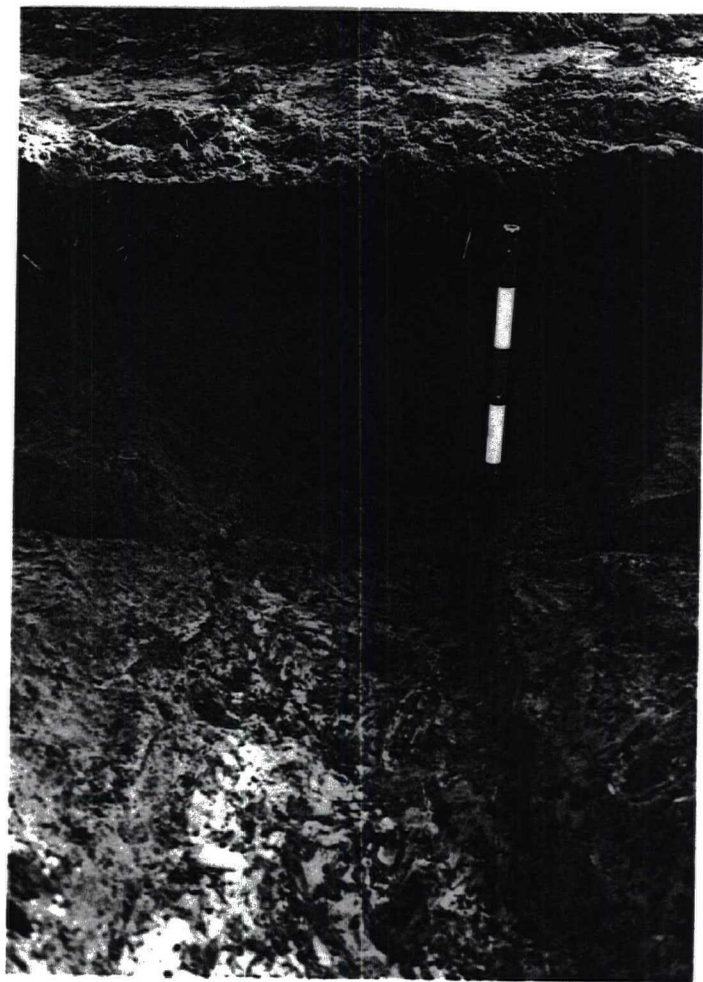
Plate 1 Area 39: profile of ditch 3910

4.2.1 - Work in 0027 began with the excavation of two 2m.x 2m. squares, Areas 38 and 39 (Fig.5). In the process of excavating these it became clear that the tiny quantities of artefacts retrievable from the ploughsoil in such small units rendered any thoughts of quantitative comparability redundant. Whilst Area 38 revealed nothing other than plough-scarred natural below a depth of c.40 cms of ploughsoil, Area 39, having been extended to the east by 1 metre, proved to straddle a north-south aligned ditch (3910), approximately 1 metre wide and 25 centimetres in depth (Fig.6 : Plate 1), from the fill of which were retrieved four small sherds of hand-made coarse-tempered pottery.

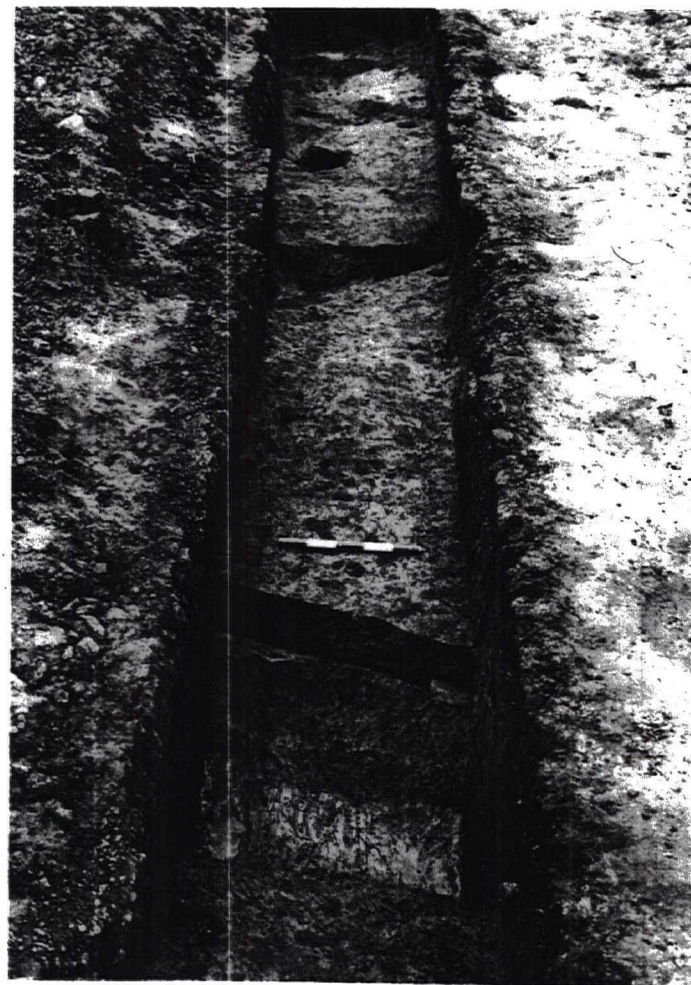
Plate 2 Area 41 from the east: original ditch 4118 in foreground

4.3.1 - The earliest feature in Area 41 was a north north-east/south south-west aligned 'U'-profiled ditch 4118 (Figs 7/I & 9a : Plate 2), approximately 0.80 metres wide and 0.40 metres deep, located towards the eastern limit of the excavation. Comparable to 3910 (4.2.1) in profile and dimensions, it probably simply defined an area of land, and possibly also served to improve drainage; like 3910 its fill contained a few small sherds of hand-made coarse-tempered ware. The rather amorphous feature 4127 has been attributed to this phase on the basis of its stratigraphic relationship with 4121, which is analogous to that of 4118 with 4114.

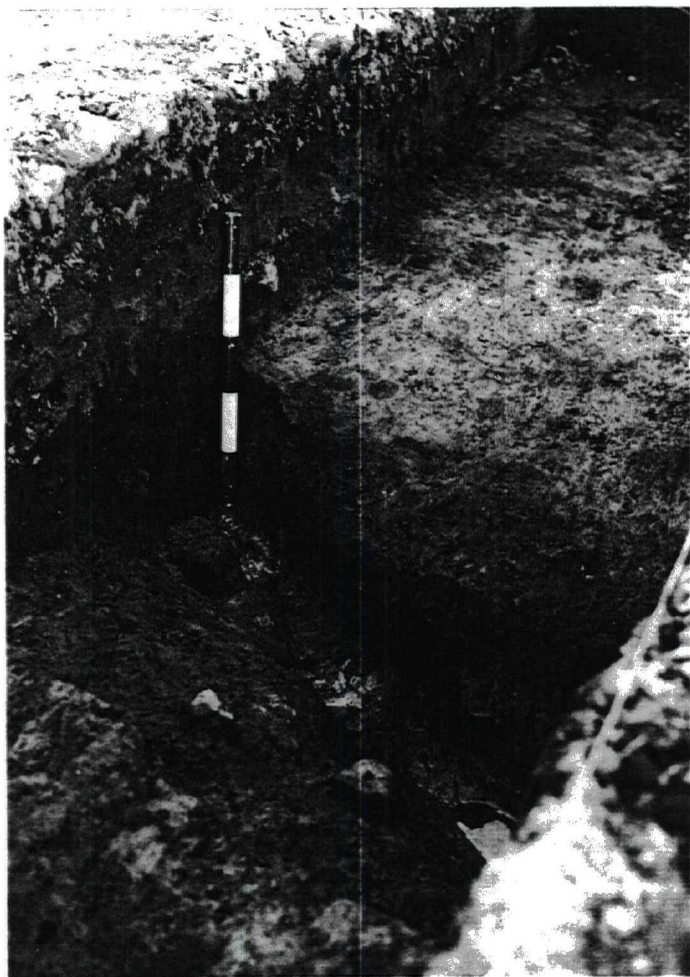
Plate 3 Area 41: profile of post-in-trench slot 4114

4.3.2 - After 4118 had been backfilled (largely the result of silting), a north-east/south-west aligned steep-sided slot (4114) with post-impressions in its base and sides was cut through the backfill 4117 (Figs 7/II and 9a : Plate 3). The alignment of this feature betrays a slight curve, bowing outwards slightly to the south-east. Some 3.5 metres to the west a feature of similar characteristics and dimensions, 4121 (Figs 7/II & 9a), was excavated, this being aligned north-west/south-east and bowing outwards to the south-west. Viewed together (Fig.7/II : Plate 4) the two features can be seen as arcs of a circle with a diameter of c.4.5 metres, its central point being approximately 0.60m. north of the excavation. They therefore appear to be segments of the wall-trench of a roundhouse, a structure which was clearly erected after the ditch 4118 had ceased to function.

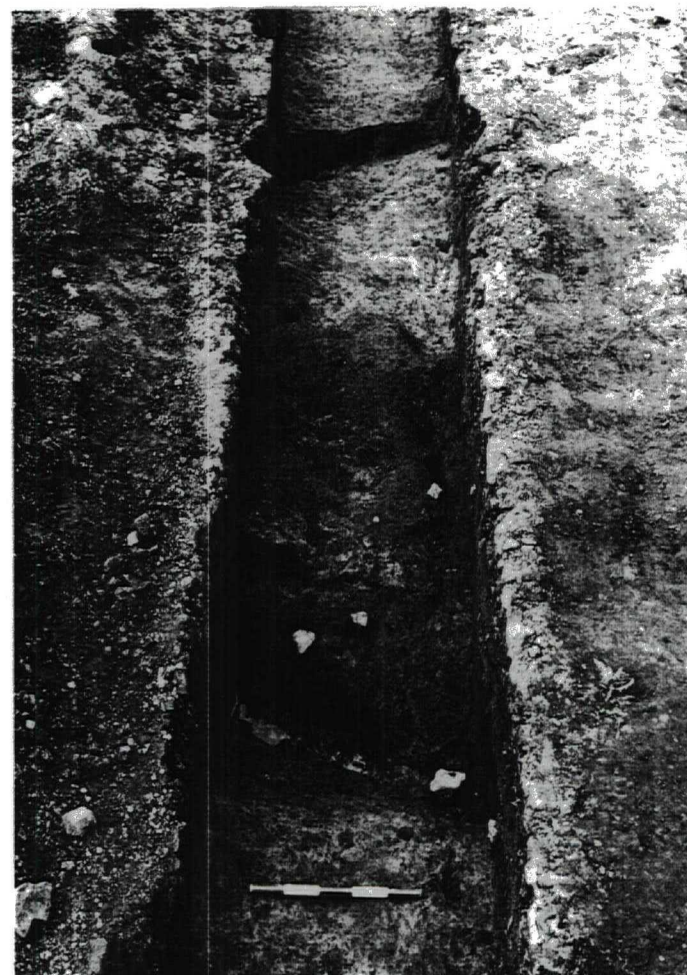
Plate 4 Area 41 from the east: post-in-trench slots 4114 (foreground) and 4121

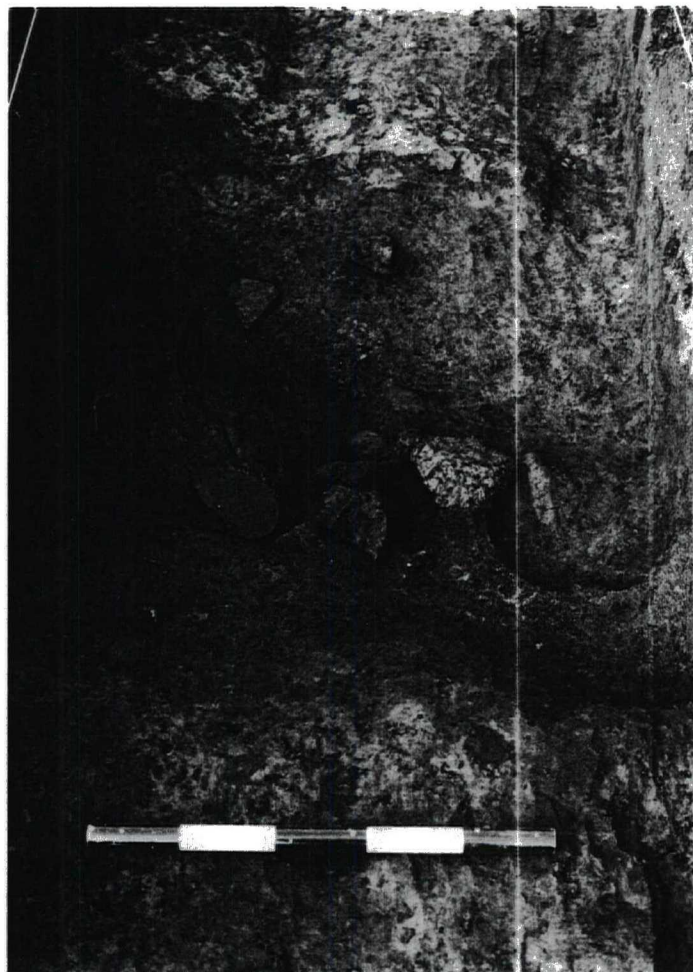
Plate 5 Area 41: re-modelling of 4114, involving the interruption of the post-in-trench wall by an ?entrance 'causeway'

4.3.3 - Modifications to 4114, the eastern segment of the wall, are clearly evident. The original wall posts appear to have been removed, 4114 backfilled (4110), and new posts inserted with their bases at a slightly higher level (4111 : Fig.9a). The post-impressions, however, extend only c.0.40m. north-eastwards

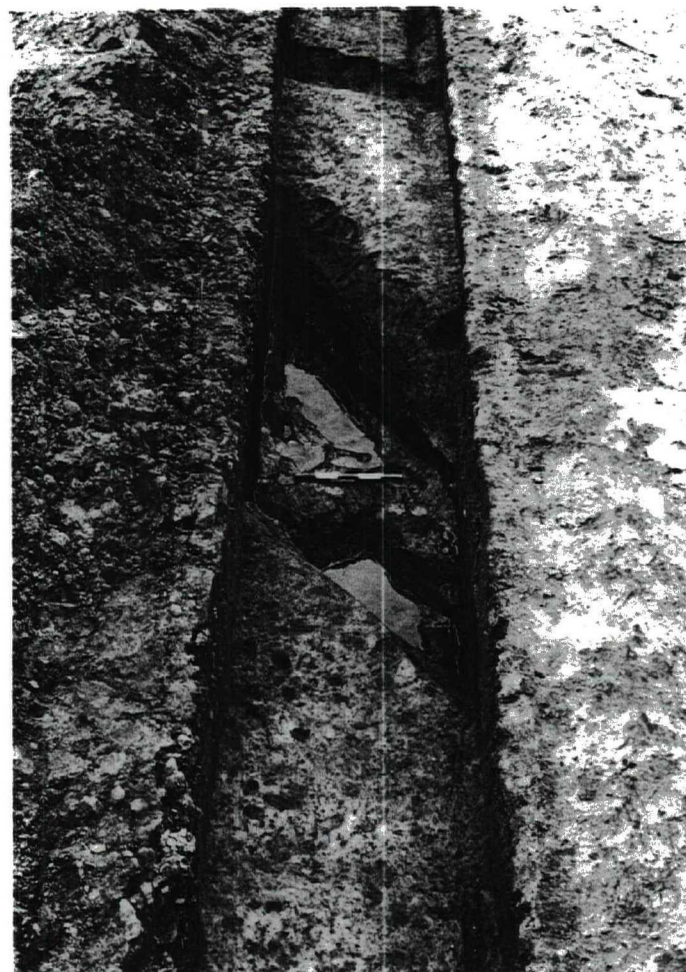
Plate 6 Area 42 from the east: major ditch 4235

4.4.1 - Area 42 proved to have been located so as to cross obliquely the line of a north-east/south-west aligned ditch (4235 : Figs 8/I & 9b : Plates 6 & 7) of substantial proportions; about 2 metres wide at the top, with a depth of c.0.70, and with a deeper, rectilinear component at the base of the south-eastern edge (Fig 8/I). Its purpose is unclear, but it can hardly have been anything less than a major land division, possibly in some respects defensive and certainly defensible. After having been partially filled (4232), probably in large part the result of natural accumulation, it appears to have been re-cut along a similar alignment (4231 : Figs 8/II & 9b : Plate 8). 4222 (Figs 8/III & 9b : Plate 9) may be another re-cut; however, the shift in the axis of the ditch closer to true north-south suggests that it may be a later and quite distinct feature, indicating a change in the layout of the site at this point. The fills of these various phases of ditch produced a number of sherds of hand-made coarse-tempered pottery, including a near complete profile.

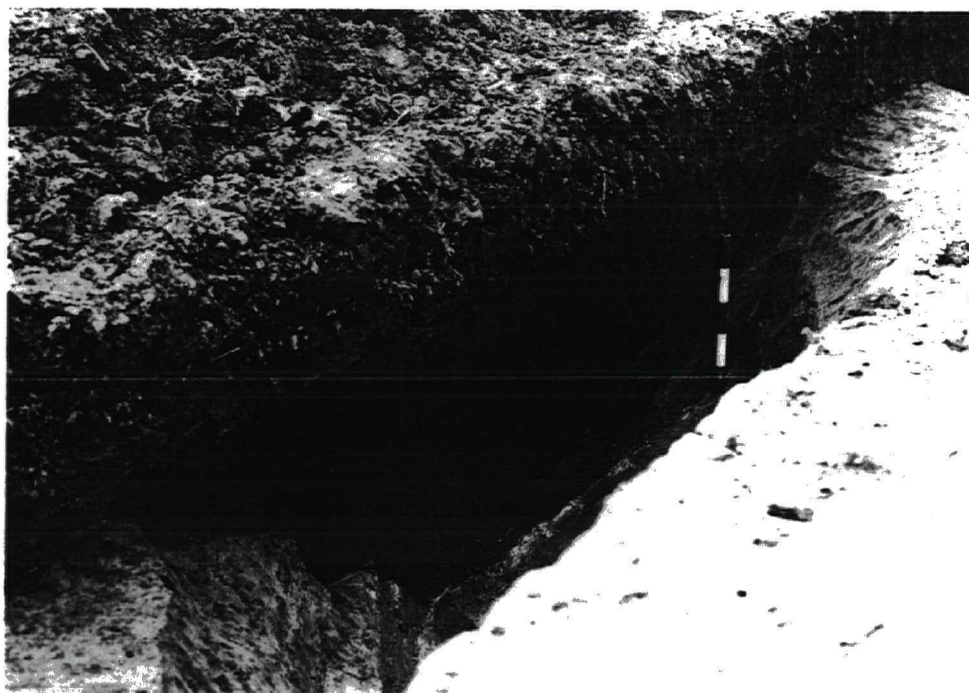
Plate 7 Area 42: profile of 4235

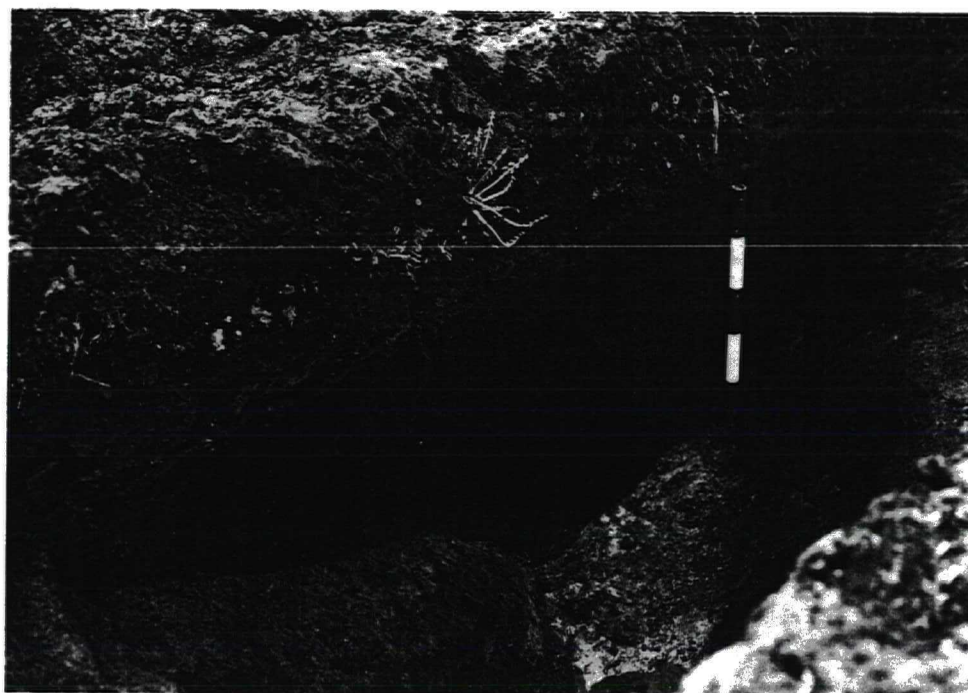
Plate 8 Area 42: profile of first re-cut 4231

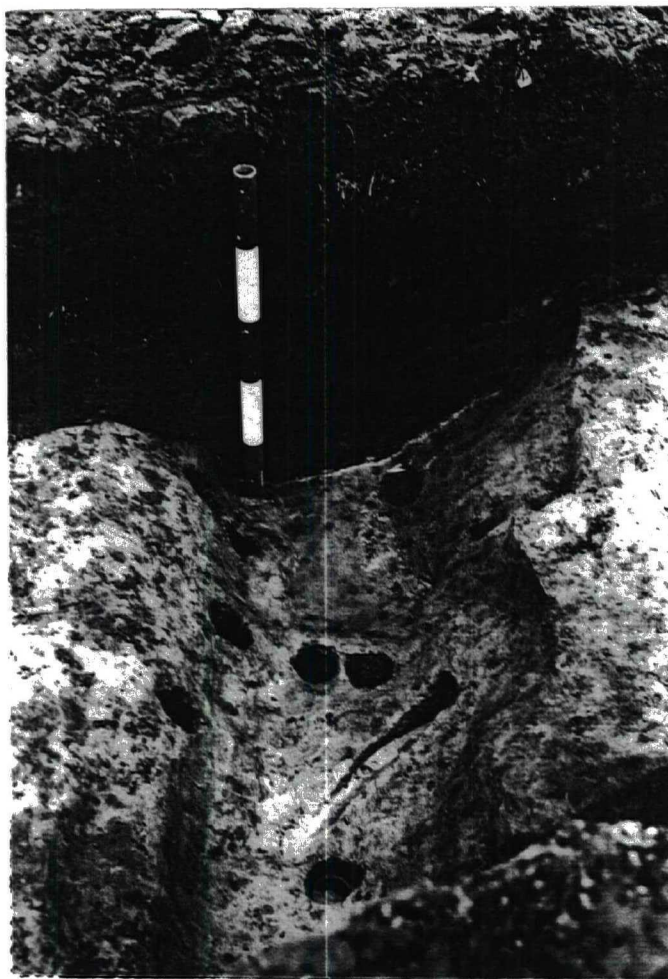
Plate 11 Area 42: profile of 4207

4.4.2 - To the west of the 4235 ditch complex a north-east/south-west aligned slot, slightly curved and bowing outwards to the south-east (4207 : Fig.8/I : Plate 10), was excavated. Approximately 0.70m. wide and 0.20m. in depth, and with a shallow 'U'-shaped profile (Fig.9b : Plate 11), it is suggested that, although differing in a number of ways from 4114 and 4121 (compare Plates 3 and 10), the curving plan form and the possible faint traces of post-impressions in the side of the feature (Fig.8/I and Plate 9; these are analogous to characteristics of 4114, see Fig.7/I, Plate 3 and 4.3.2) indicate that 4207 is also a segment of the wall trench of a roundhouse. The uppermost fill of this feature (4202 : Fig.9b) contained a

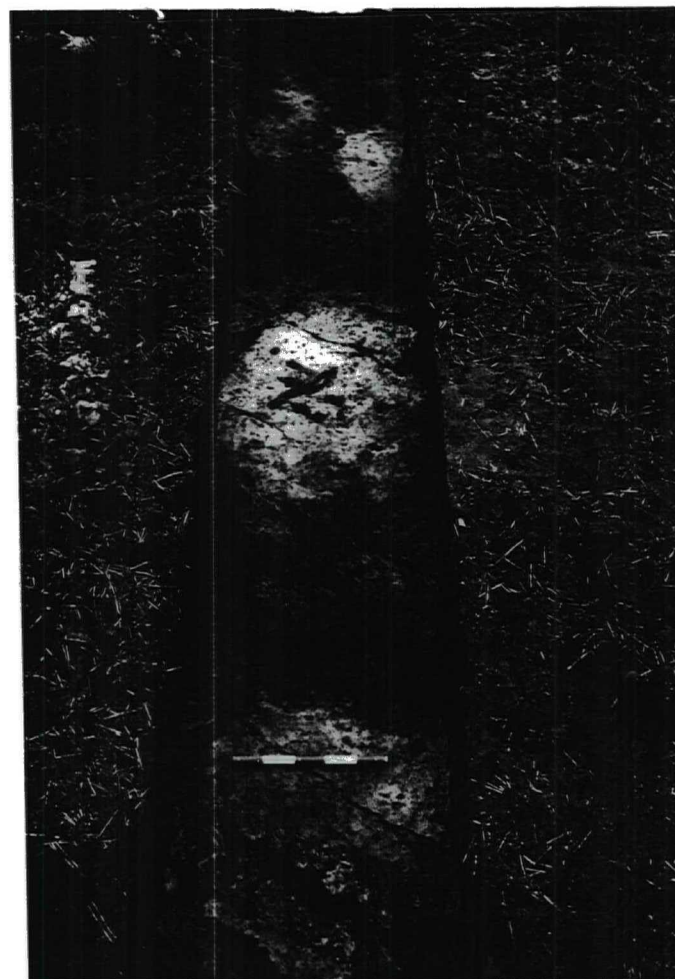
Plate 12 Area 27: natural subsoil

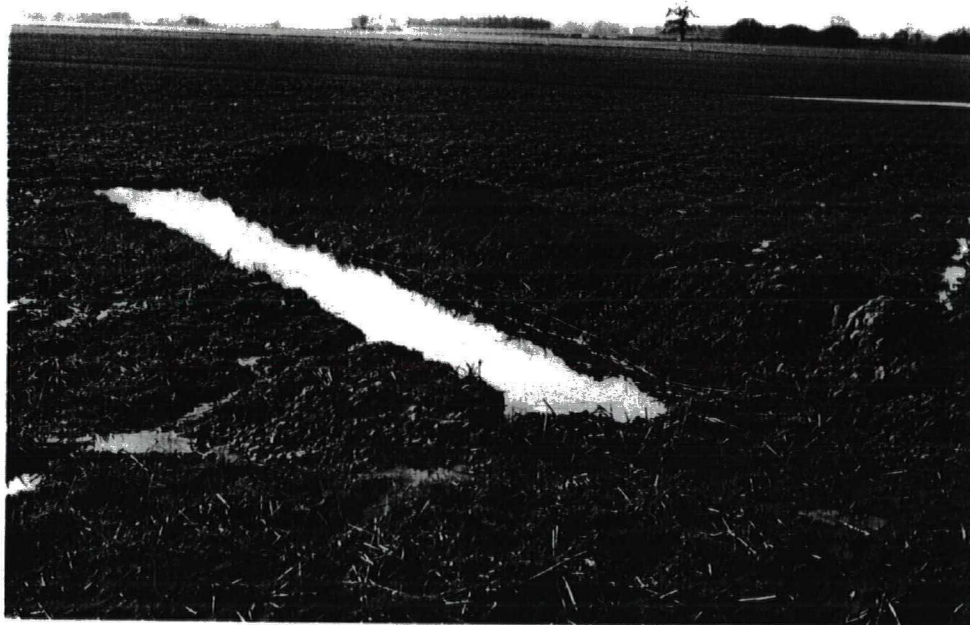
Plate 13 Area 28: 15/03/91

4.6.2 - Area 28 (Fig.10) was excavated to the level of the natural subsoil, revealing a similar picture to that encountered in Area 27. It was, however, impossible to investigate this in more detail due to overwhelming problems with groundwater following snow-melt and heavy rain (Plate 13).

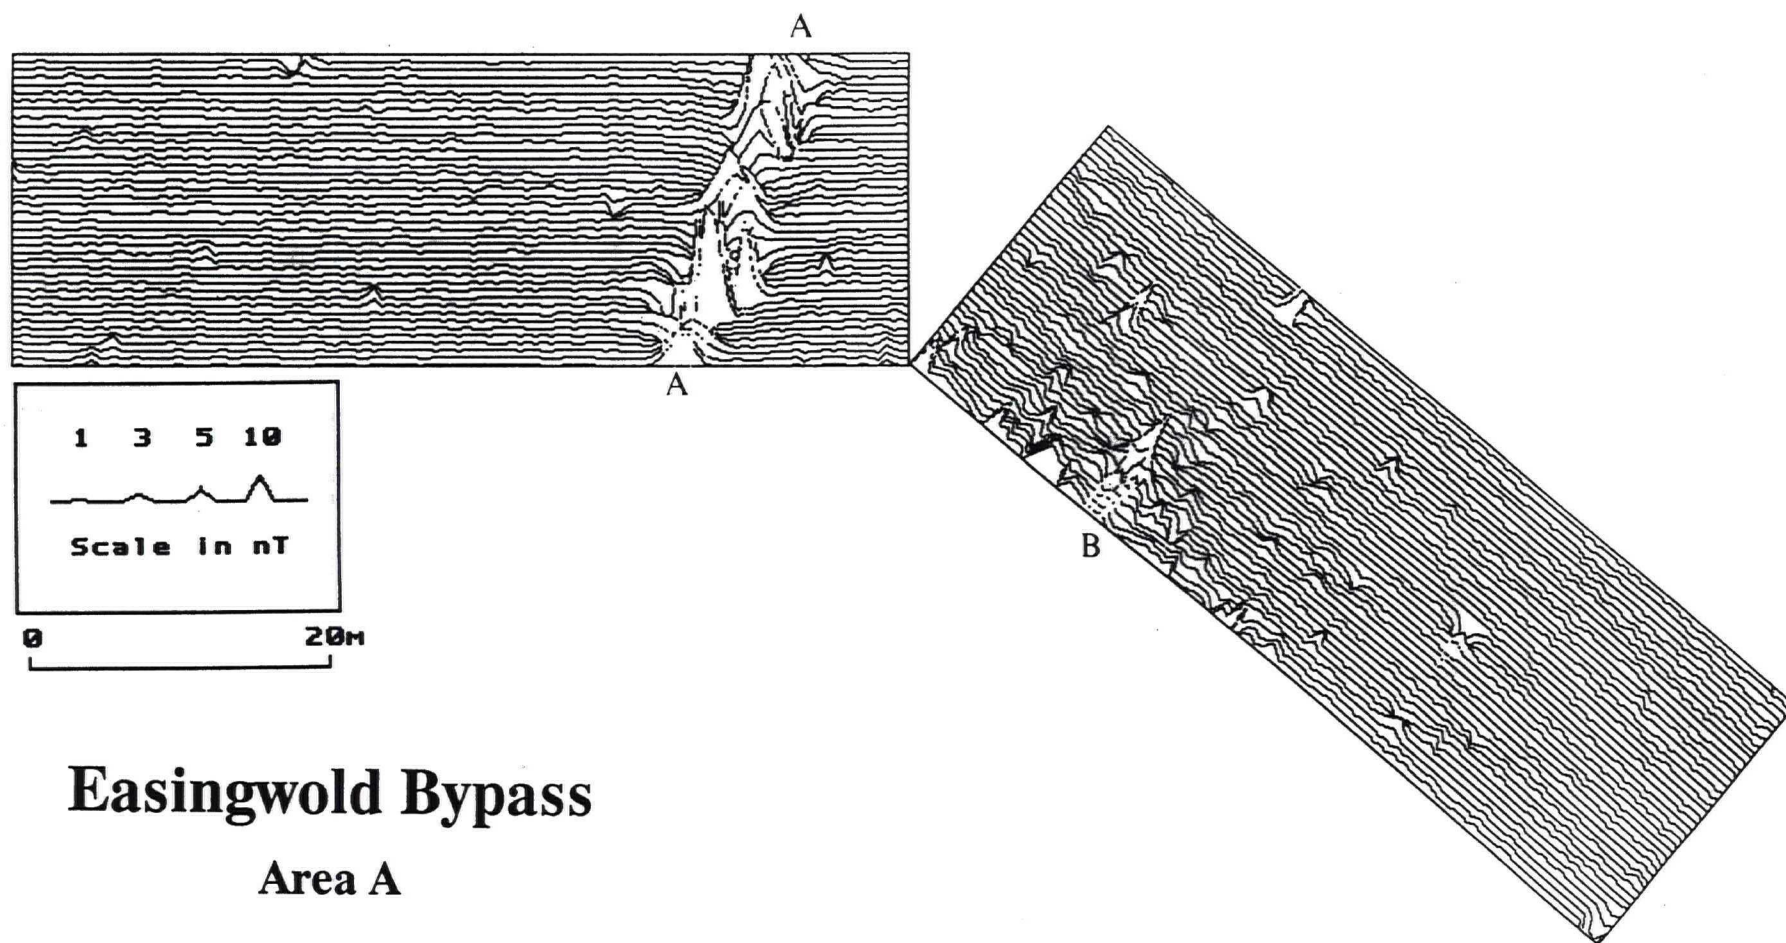
The most obvious anomaly in this area is annotated "A" in Figure A2, and is probably due to a metal pipe. Also to be noted is the area of magnetic disturbance (B), which can be seen from visual observation of the ground surface to be due to modern dumping.

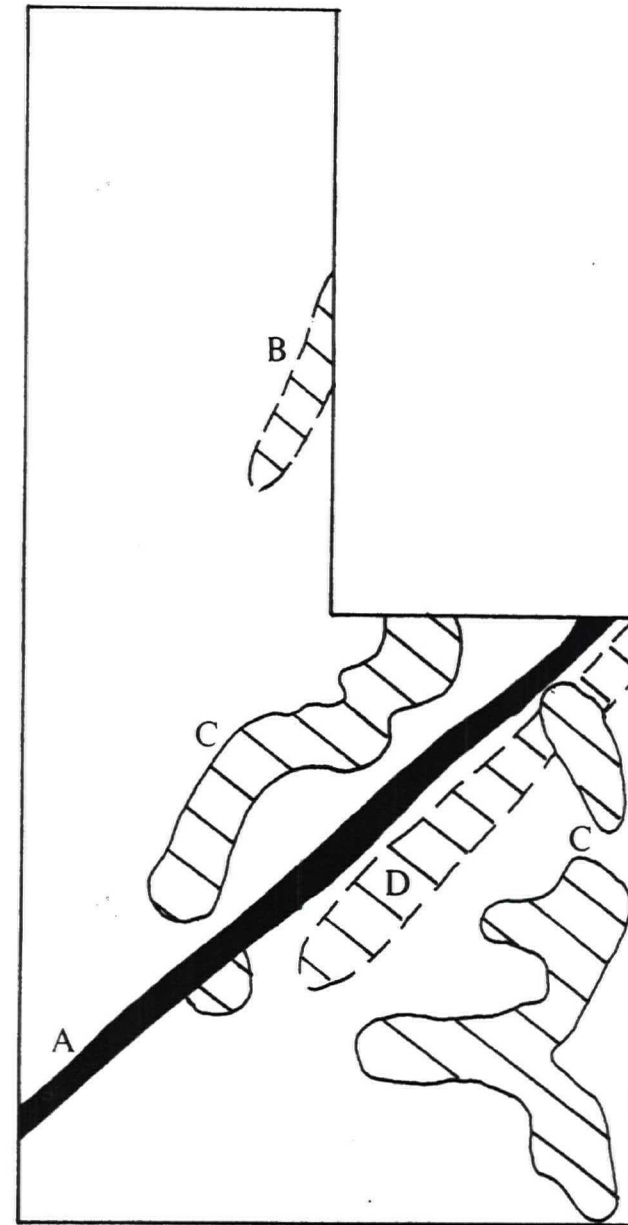
Figure B2

Interpretation Diagram

4.7.1 - The absence in Area 27 of any features corresponding with the geophysical anomaly (Fig.10 : Appendix 2 B2) requires explanation. Three possibilities present themselves. Firstly, it is possible that the plotted positions of the cropmarks are inaccurate (see 3.1.1) to the extent that the geophysical survey, the grid for which was laid out across them, actually missed the features on the ground altogether. Secondly, it may be argued that the cropmarks themselves represent not systems of ditches but variations in the natural subsoil similar to that in Area 27. This can on the whole be discounted, the apparent regularity of the cropmark, as well as the lack of congruence between any part of it with the geophysical anomaly, suggesting that the two are separate phenomena. The favoured explanation is that, as in field 0027 (4.5.3), the subsoil was largely unresponsive to the technique.
