13.3 THE DEVELOPMENT OF THE BUILDING

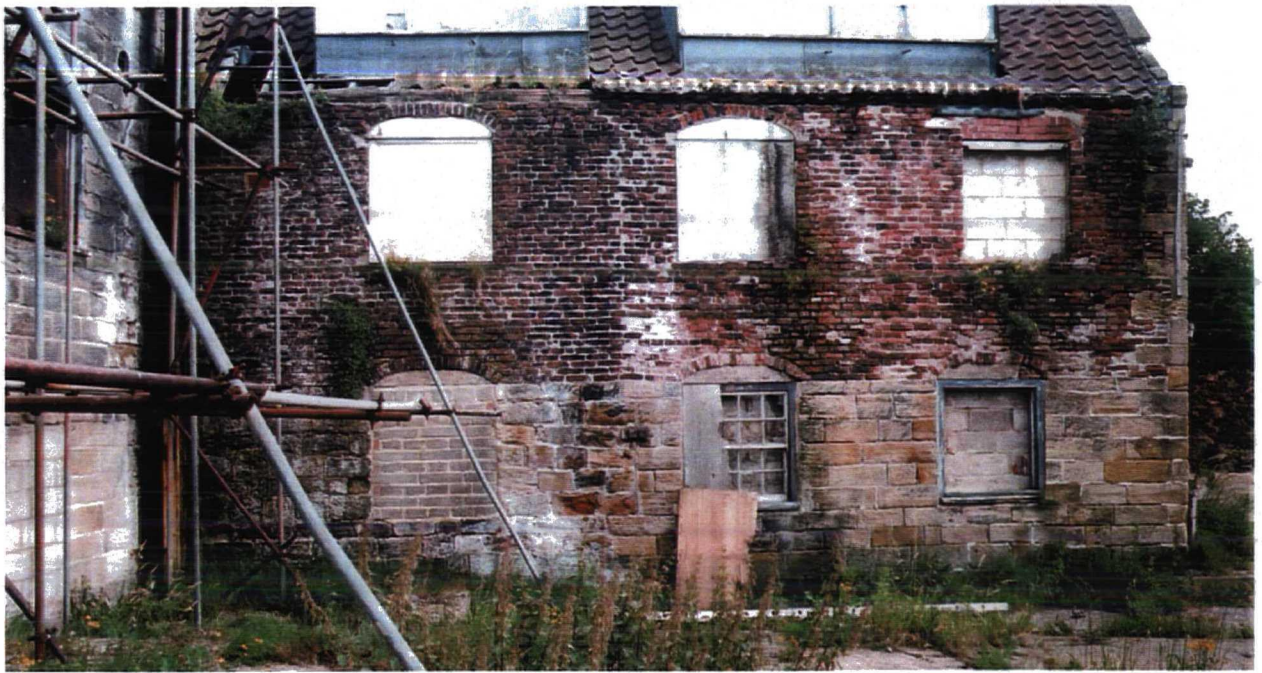
Plate 11. Old Sail Loft – north elevation of west end of long range

The evidence for this phase consists of two rather different areas of masonry. The first lies in the north elevation of the long range where it comprises a panel of coursed squared rubble at ground floor level in the re-entrant angle with the later sail loft range (Plate 11 & Figure 26); the second is an area of coursed rubble, also at ground floor level, in the internal elevation of the south wall.

The date of the former is suggested by the fact that the blocks entirely lack the herringbone tooling which is such a distinctive and universal feature of Whitby masonry construction from the 17th century on. It is also clearly earlier in date than the masonry of Phase II: which *is* tooled in this way, which is toothed into it, and which is itself probably contemporary with a first floor constructed entirely in 2" brick. These Phase I blocks are small and well cut – though not of the quality of ashlar – and bonded in a pale lime mortar.

In Phase II the ground floor of the long range was either extended or remodelled in stone and the whole building apparently given a new first floor in brick (Plate 11 & Figure 26). The date is suggested by the form of the windows, by the size of the bricks, and by the coarse herringbone tooling of the masonry. The evidence for this Phase is preserved chiefly in the north elevation of the range where a straight joint indicates the point at which Phase II masonry was toothed into Phase I masonry without much regard for course heights. Over both passes the brickwork of the

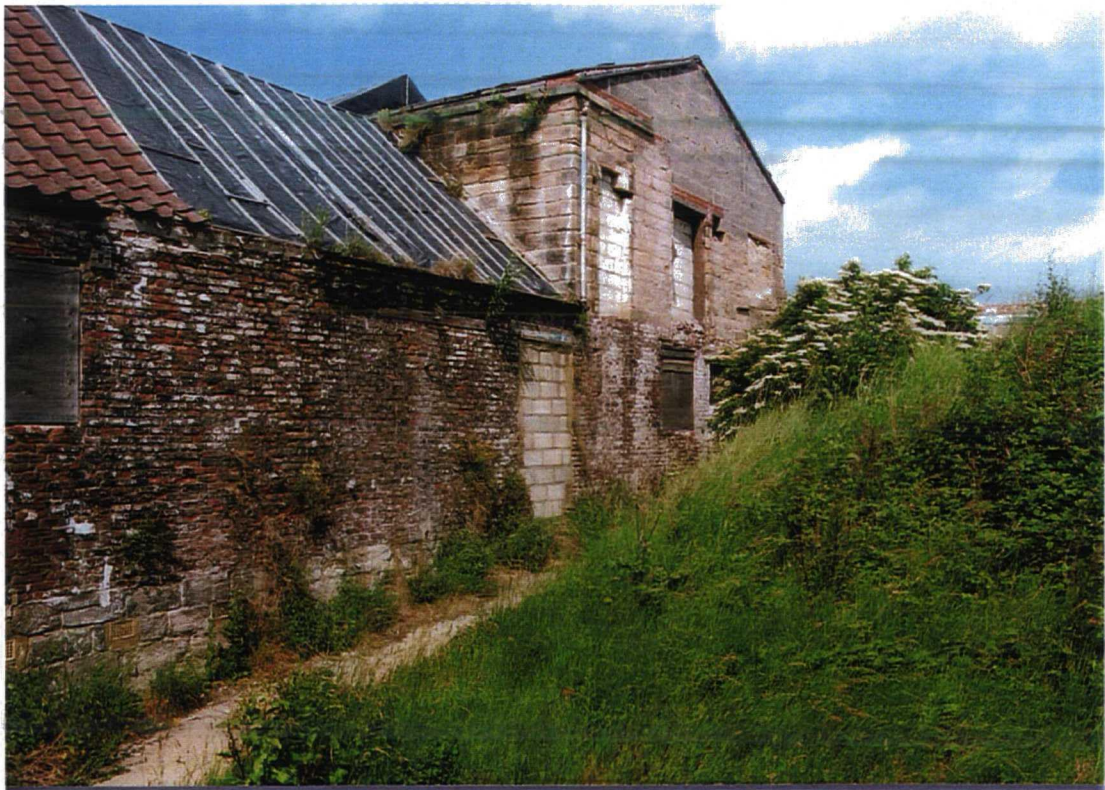
Plate 12. Old Sail Loft – south elevation of east end of long range

Although the first floor brickwork is not certainly of the same date as the ground floor masonry it seems very probable that the work is in fact all of one build. This type of brick-over-stone construction is common in Whitby; for fairly obvious reasons it is usually found close to the water's edge but it may well be a survival from an older tradition of timber-framed building. There is certainly no discrepancy or contradiction in the use of the two materials. Some of the brickwork in the central area of the *south* wall of the long range may also be of Phase II date since it is similar in character and it is oversailed by the masonry of the second floor of the Phase III sail loft range, described below (Plate 12).

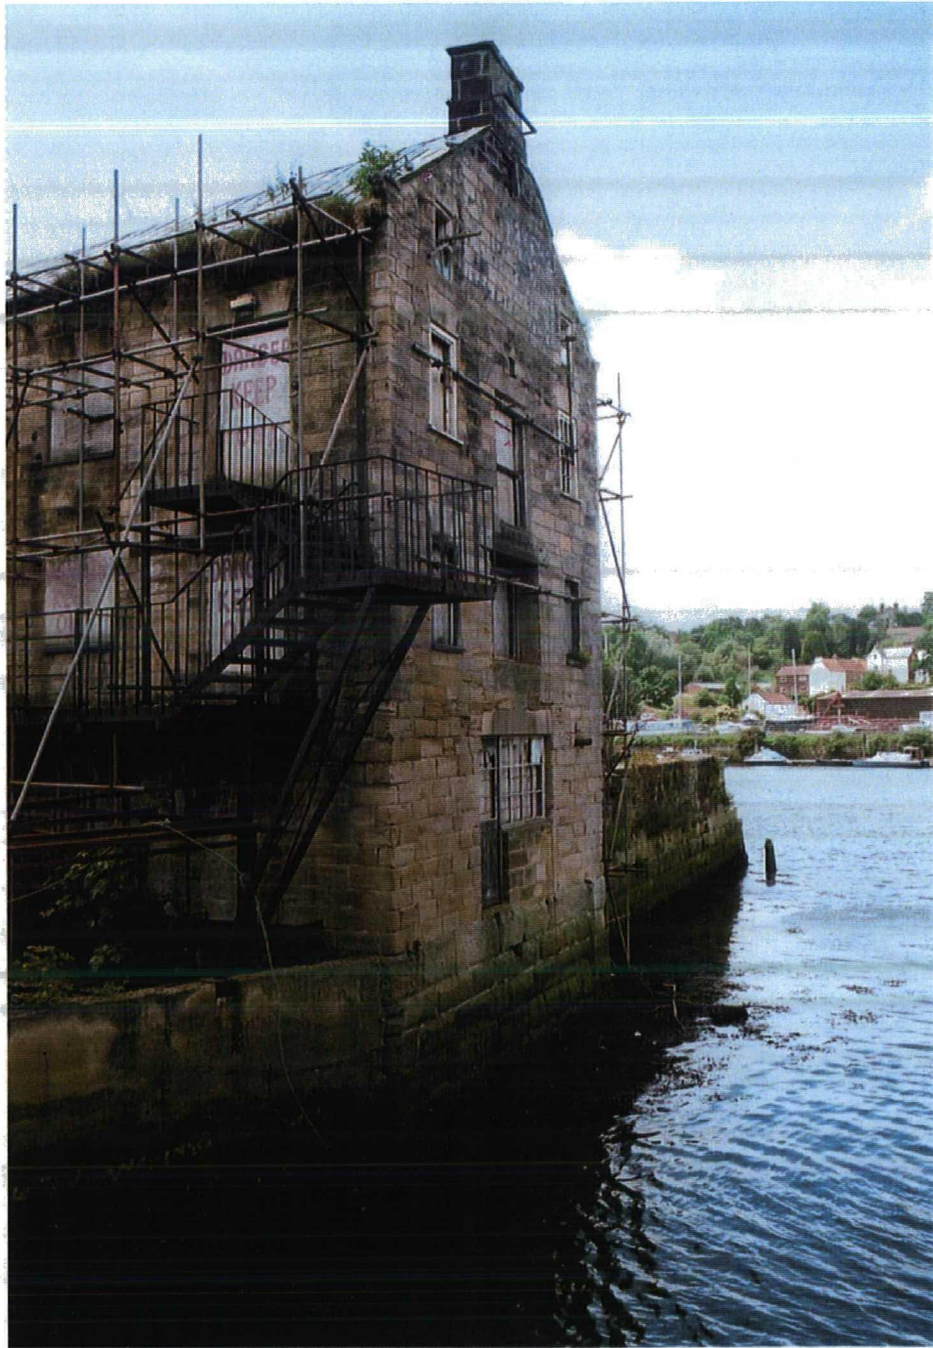
Plate 14. Old Sail Loft – Sail Loft range from north-east

The base of the range consists of several courses of well-cut rock-faced and margined masonry; let into this masonry are a number of mooring rings on iron pins (Plate 14). Above this level the fabric consists of coursed squared rubble with good herringbone tooling; in some areas the blocks are also delicately margined (Plate 15). Part of the west wall of the sail loft range was concealed behind the older roof of the long range; here the wall is roughly built of brick. The original roofing material, since lost, was probably slate. The building is four bays long and has three storeys and an attic. There is a square eaves cornice.

Much of the joinery was destroyed in the fire and many of the openings are now blocked or sealed. There seems originally to have been a tier of three taking-in doors to the centre of the north gable all of which have since been altered: these were probably used to serve ships' boats which would be able to use the Spital Beck around high water (Plate 14).
