**THE OLD SAIL LOFT,
FORMER WHITEHALL SHIPYARD,
WHITBY,
NORTH YORKSHIRE**

**REPORT ON AN
ARCHAEOLOGICAL
BUILDING SURVEY**

**2002 FIELD REPORT
NUMBER 61**

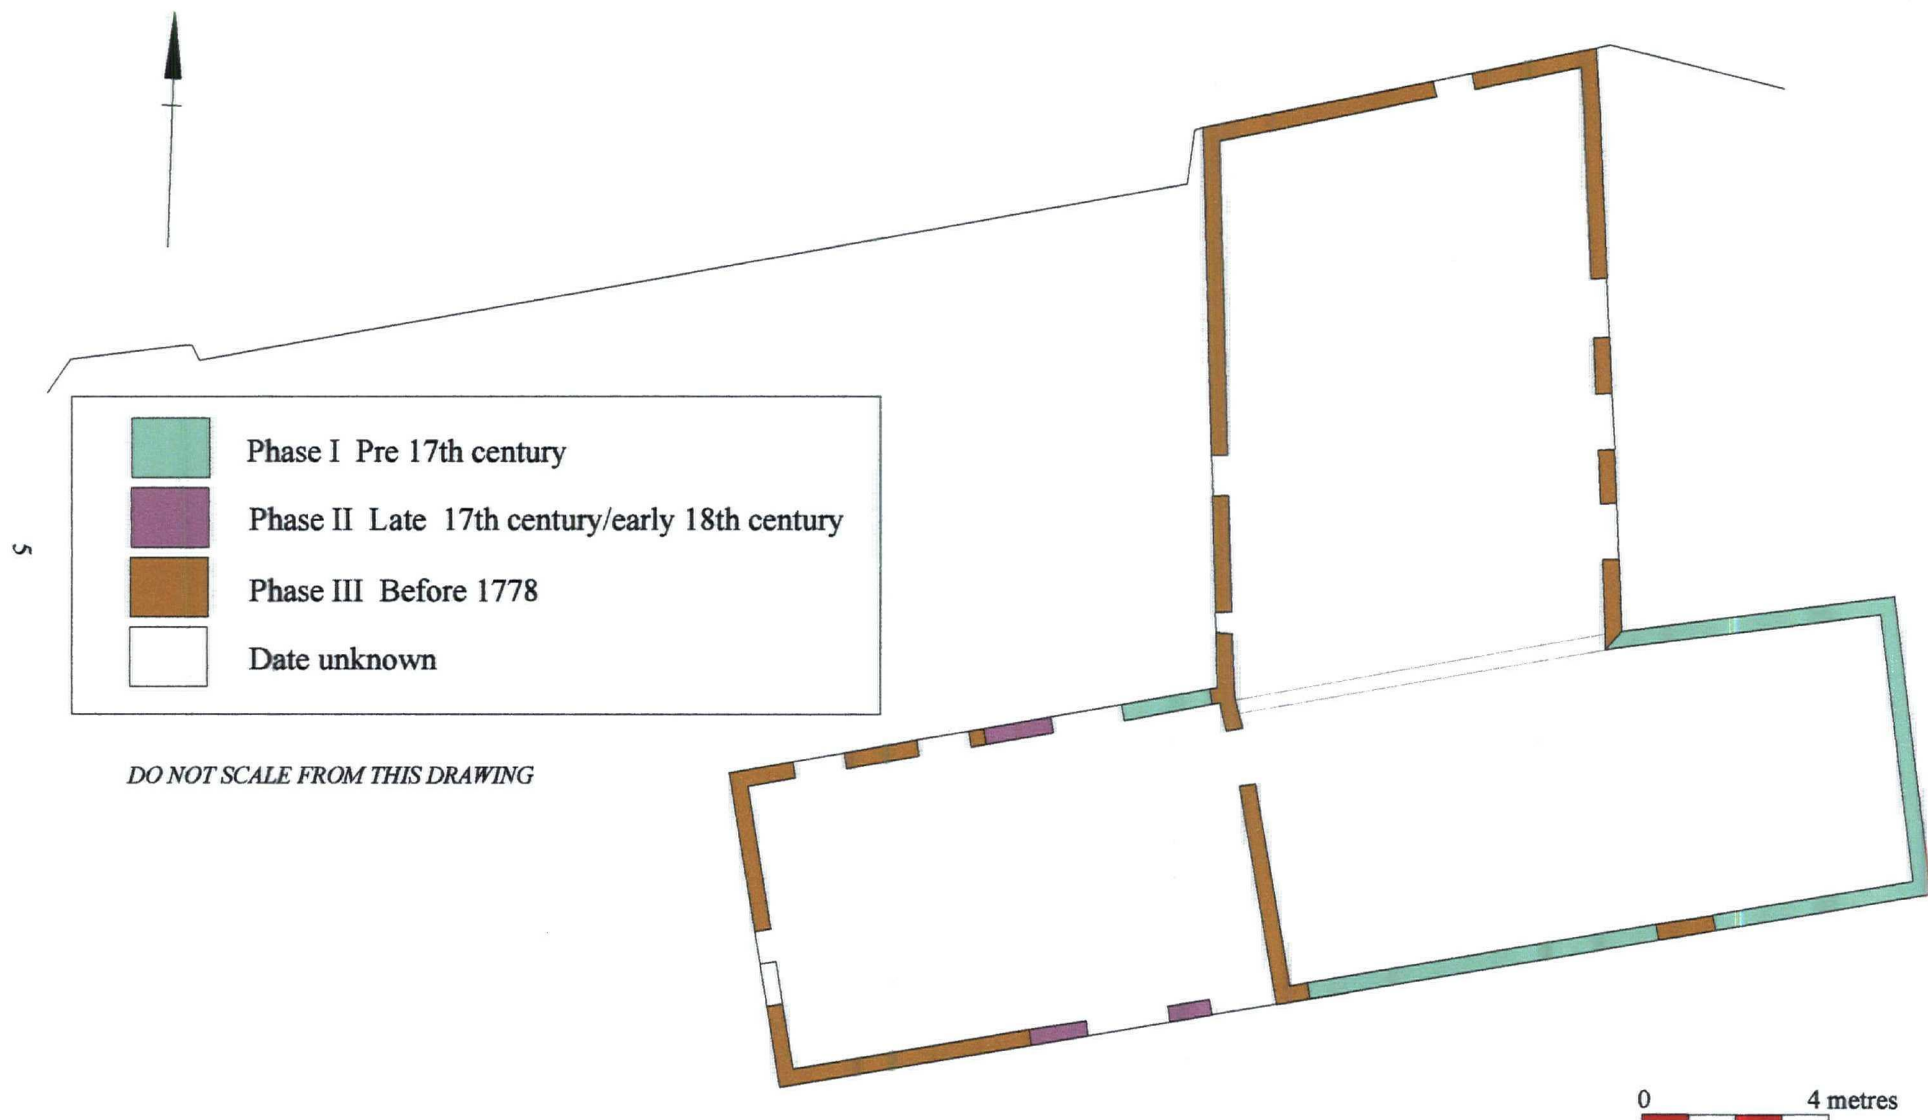
Figure 2 Sketch plan showing phasing of ground plan of Old Sail Loft

It appeared from the previous assessment that a substantial amount of fabric of probable pre-17th century date survived in the lower levels of the long east-west range. This range, which is demonstrably earlier than the mid-late 18th century sail loft which forms its northern arm, is lit by windows of c.1700-1750 which, as described in the assessment, are themselves insertions into masonry walls; and the masonry of these walls entirely lacks the herringbone tooling of the later work. The early masonry is confined to the eastern half of the east-west range, much of which was barely accessible in 2001; with clearance of the building in the summer of 2002 further investigation became possible. This consisted of the removal of as much of the internal finish as possible combined with a rectified photography survey of the revealed internal elevations. The original phase plan was then amended (Figure 2).

Phase I	<i>Late medieval ?</i>	<i>Construction of the ground floor of the east end of the long east-west range; and perhaps of a short south wing shown in the Wooler survey of 1740</i>
Phase II	<i>Late 17th - mid 18th century</i>	<i>Construction of Spital Bridge; raising, or replacement, in brick, of upper storey of range</i>
Phase III	<i>before 1778</i>	<i>Construction of the sail loft to form a north range to the earlier building; demolition of south wing, blocking of Phase I south doorway, and sealing of blocked doorway by extension to bridge ramp; construction of hearth and flue against blocking of doorway; revetting of south bank of Spital Beck to make a butt joint against Spital Bridge</i>

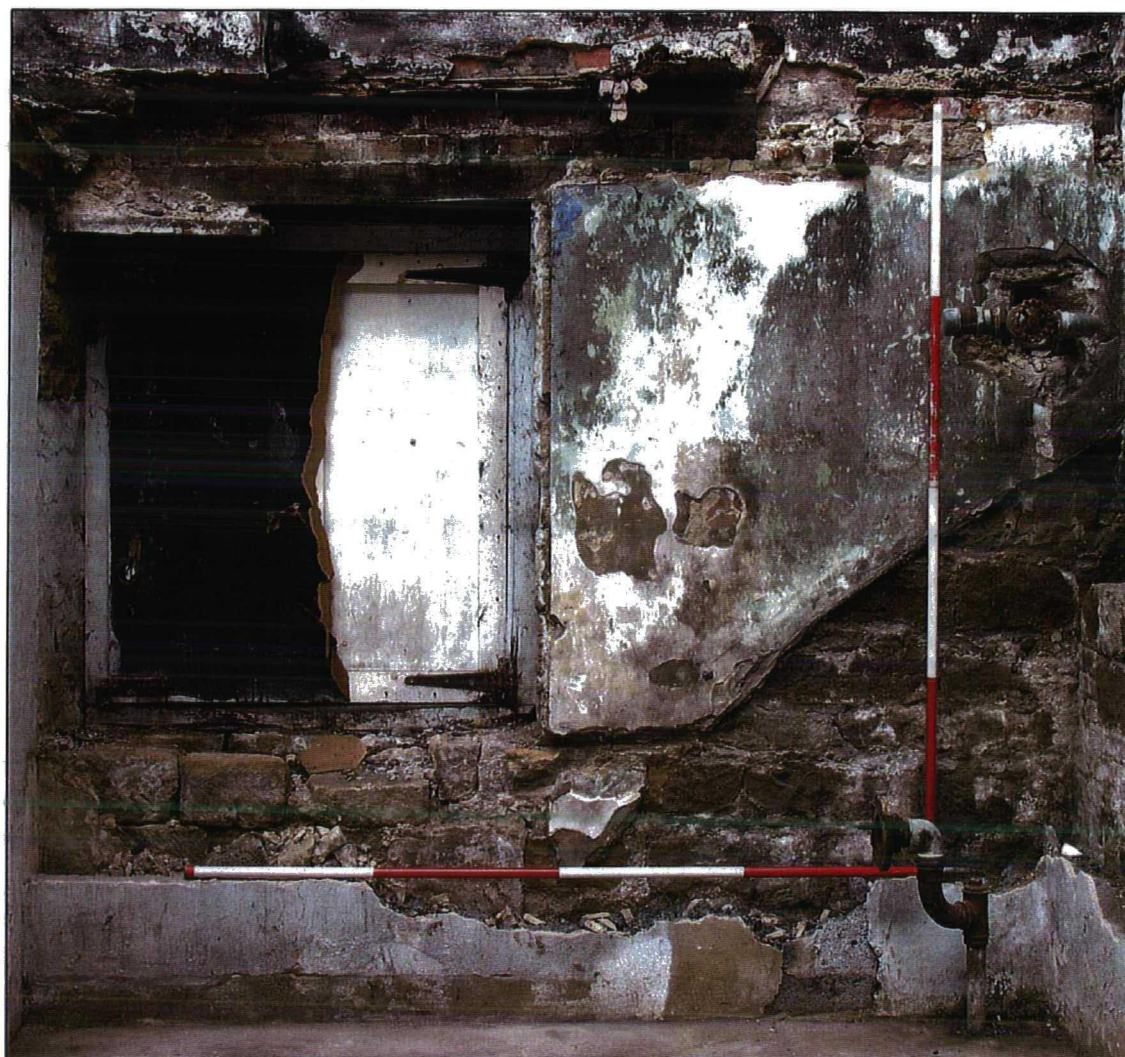
Plate 1. **North wall, eastern end, interior, 1:20**

The internal faces of the lower levels of the north, east, and south walls at the east end of the long range were found to be concealed behind modern concrete block work: this was entirely removed except for a narrow band at floor level; the flooring material in this area is modern concrete. Examination of the topmost plaster finishes revealed that they had been carried up to an inserted, but lost, timber stair: this stair, for which a deep cut had been made into the fabric of the east wall, led to an upper door of 19th century date. The very hard, brown, plaster – not particularly amenable to removal with hand tools – was stripped off in a broad band around the full length of the walls. Beneath it there was a thin skim of cream limewash which apparently had only survived in small areas. As far as possible this material was left undisturbed.

The revealed masonry turned out to be rather varied in character: some of this variation may have been due to repair work. In general it consisted of coursed sandstone rubble although in some areas courses of squared rubble were visible. The bonding material was a coarse, creamy, lime mortar; no brick or tile was seen in a primary position although tile fragments, embedded in a later mortar of a different consistency, had been pushed into it as a key for the 19th century

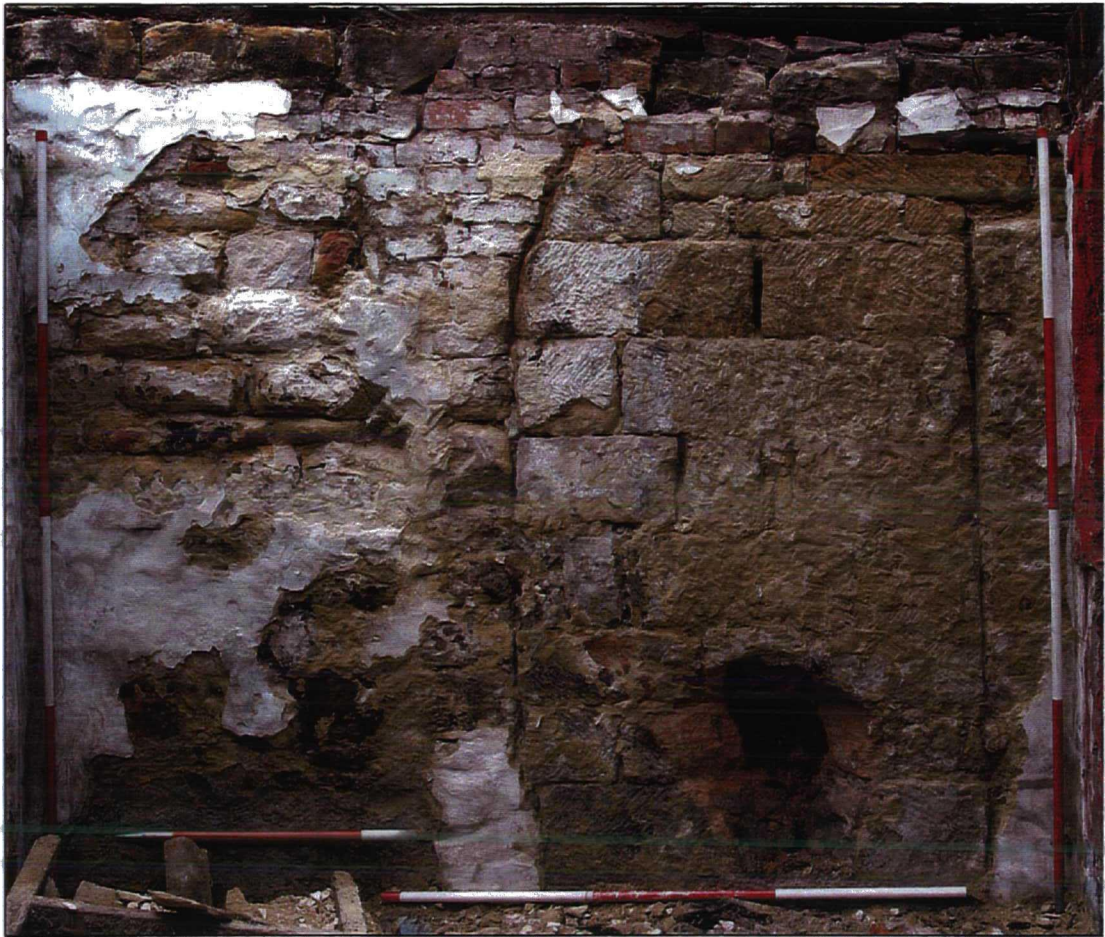
Plate 4. **South wall, bay 2, interior, 1:20**

In the south wall a blocked door was revealed. The door opening is 1.25m wide and its centre line lies 4.90m west of the south-east corner of the building. The inner face of the west jamb of the door was further exposed by removal of some of the blocking material; it turned out to be of ashlar finished with fine diagonal tooling made with a bolster chisel. The door passed directly through the wall – that is, there was no splay – but unfortunately could not be opened up as far as the outer opening without risking collapse. In 1740, the date of a survey by Wooler (Figure 1), a short south wing existed beyond the door which might have been entered from this room. The doorway is now below the external ground level; an external ground level which is itself controlled by the level of the bridge ramp to the east, to which it rises. No other Phase I openings, blocked or otherwise, were seen.

The blocking material is of massive squared rubble finished with deeply incised herringbone tooling. The head of the door was removed and an internal timber lintel and an external segmental brick arch constructed when the upper storey of the range was replaced in brick: probably in the late 17th or early 18th century. The blocking itself presumably post-dates the demolition of the south wing shown on the 1740 survey. Subsequently a hearth and a flue had been made against the base of the blocked door: a few surviving courses of the flue are suspended, rather perilously, at eaves level but all other traces have been removed. The fire was evidently an intense one as the sandstone blocks have been severely reddened and eroded. It may have been an industrial furnace; perhaps for metalworking. The flue and the uppermost three courses of the south wall are of herring-bone tooled masonry very similar in character to that of the mid-18th century north range of the sail loft.
