Crayke Castle Crake North Yorkshire SE 55724 70409

Archaeological Watching Brief

Crayke Castle Crake North Yorkshire SE 55724 70409 Archaeological Watching Brief

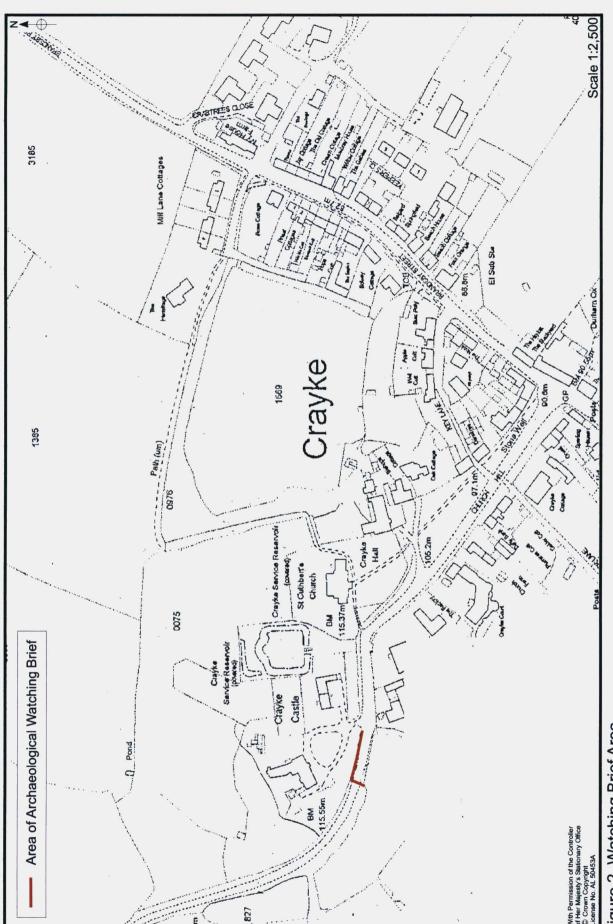
Figure 2. Watching Brief Area

The area of proposed work is approximately 100m along the northem verge of Crayke Lane, on the southern boundary of Crayke Castle (National Monument No. 12602: Grid Reference SE 55724 70409: Fig. 2).

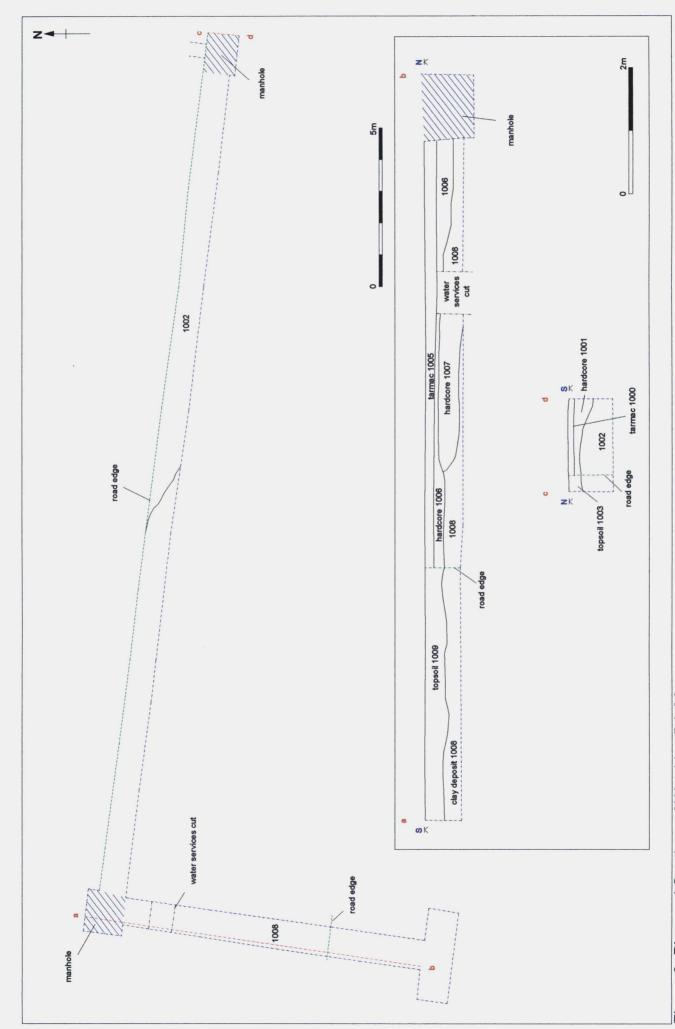
Figure 3. Plan and Sections of Watching Brief Area

Excavation revealed an uncomplicated sequence of deposits (Fig. 3). At the base of the trench was a yellowish brown clay loam with cobble inclusions (Deposits 1002/1008), measuring up to 0.42m in depth. Recent service trenches including water and BT had heavily truncated this deposit, which was interpreted as natural.

Above Deposits 1002/1008 was a relatively thick deposit of yellow sand with small limestone fragments (Deposits 1001/1006), which represented modem hardcore. The hardcore was sealed by a thin layer of tarmac (Deposits 1000/1005).

A 0.20m thick deposit of greyish brown silty loam topsoil (Contexts 1003/1009) was recorded along the northern edge of the excavated trench. This deposit was directly above natural deposits

Excavation confirmed that the new drainage trench had been excavated within an area which had been previously disturbed by other services and that no archaeological deposits/features or finds were observed.
