3.2 Observations of the new drainage channel around the chancel and grading down of the cemetery soils to the north and east of the chancel

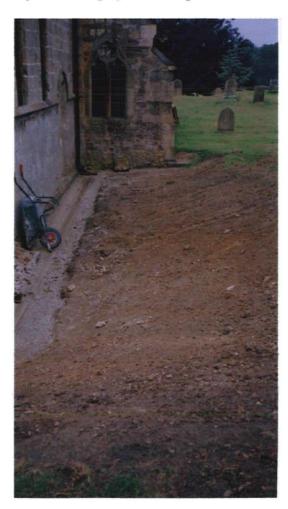
Plate 7 Grading down of cemetery soils to north of chancel

3.2.2 The drainage channel and grading down of the cemetery on the northern and eastern sides of the chancel (Figure 3 Section 4).

The earliest deposit was orange-brown slightly silty sandy-clay, in excess of 0.25m thick, with occasional angular limestone fragments up to $0.04 \times 0.04 \times 0.015m$ in size, occasional rounded pebbles up to $0.06 \times 0.04 \times 0.03m$, and frequent flecks of degraded limestone (context 1010). Above this was a 0.08m thick deposit of mid brown silty-sand with frequent limestone fragments, mortar flecks and tile fragments (context 1009), which seems to equate to context 1007 to the south of the chancel. Human bones were recovered from both contexts 1010 and 1009, but no grave cuts were observed, probably due to constant re-cutting. The only human bone recovered from the northern side of the church was the proximal end of an adult ulna. The workmen recovered a number of human bones from the eastern side of the chancel, which were from at least three adults, an infant and a child. The human bones were placed in two plastic bags which measured $0.25 \times 0.25 \times 0.20m$ in size. The bones recovered were:-

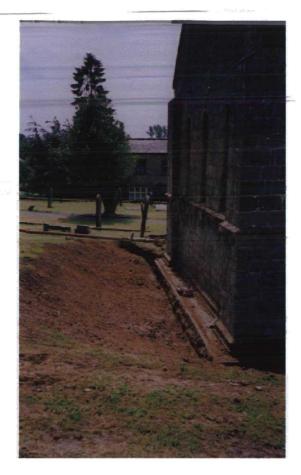
Plate 8 Grading down of cemetery soils to east of chancel

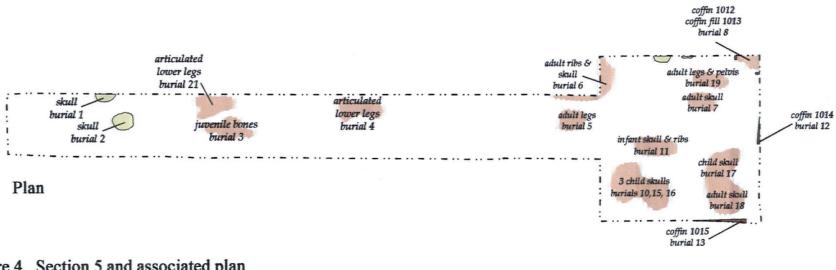
Figure 4 Section 5 and associated plan

A trench aligned roughly south-east, c.6.5m in length and between 0.30m and 1.00m in depth, was excavated from the south-eastern corner of the chancel. The trench was excavated to full depth by machine from the north-western end, for a distance of about 0.70m, at which point the mini-digger was moved to the south-east and the process was repeated. This drainage channel fed into a soakaway pit 1.75m x 1.75m in size and 1.85m deep. The uppermost 0.80m of this pit were excavated on one day, and it was deepened to 1.85m on the following day.

The earliest deposit was a degraded block of limestone in the north-eastern corner of the soakaway (context 1017). This was sealed by pale-brown to yellow sandy clay with occasional large irregular limestone fragments and frequent small limestone fragments (context 1016). Context 1016 was sealed in the south-eastern quarter of the soakaway by a deposit of very clean mid brown medium grained sand (context 1018). No human remains were recovered from these deposits, and they probably pre-date the foundation of the church. The upper surfaces of these deposits were at c.1.50m below present ground level.
