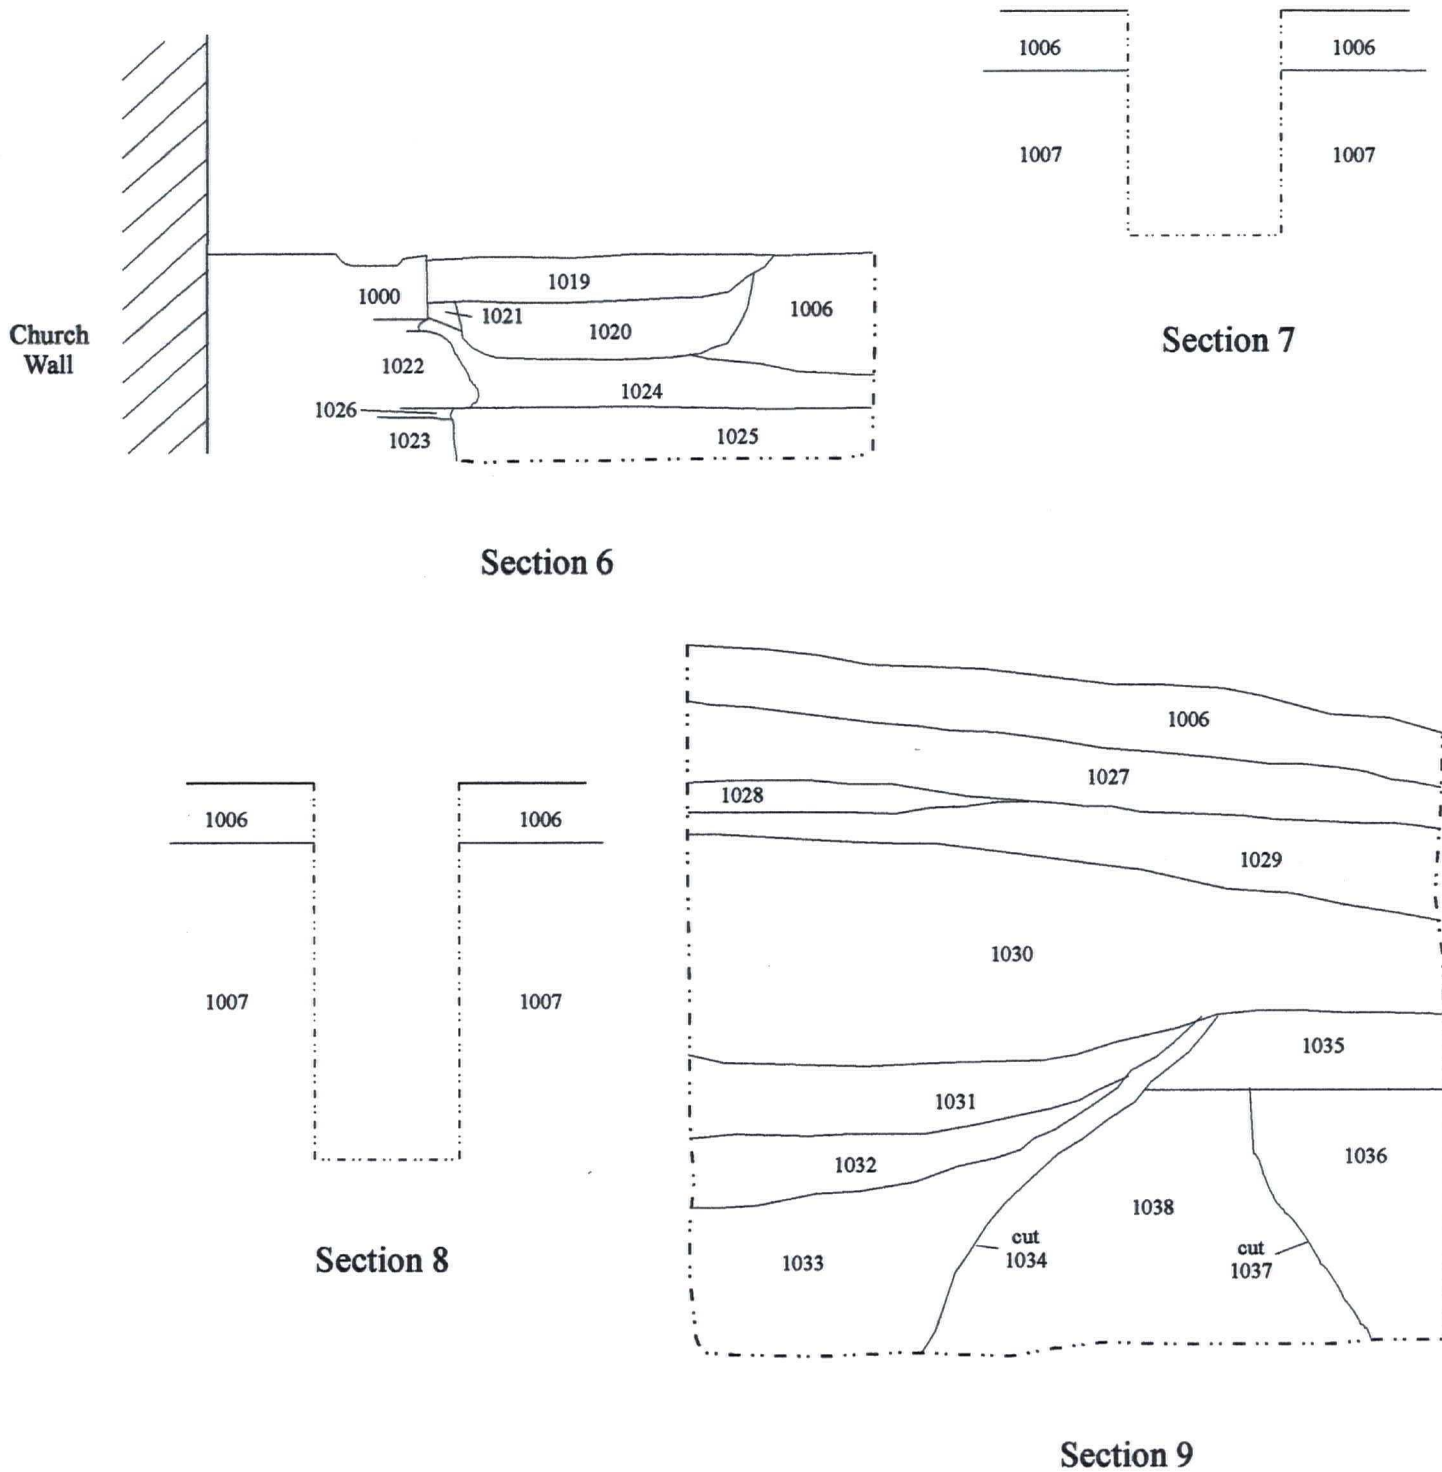
Figure 5 Recorded sections 6 to 9

Contexts 1016-1018 were sealed by context 1010 (for description see 3.2.2 above), which was up to 1.40m thick. Context 1010 was clearly a cemetery soil that had been constantly re-cut and reworked. Although it was not possible to clearly distinguish any grave cuts in the sections of the trench, three coffins (contexts 1014, 1015 and 1012 with associated fill 1013) and the base of a grave cut lined with loosely compacted fine grey ashy-grit (context 1011) could be seen. The method of excavations (i.e. use of a mini digger) made it impossible to fully expose or record any burials. Small portions of individual burials were recovered from each bucket load of earth, but by carefully observing which types of bones were recovered it was possible to calculate that a minimum of 21 burials were disturbed by the excavations. Most of the burials were identified from the presence of a skull, substantial parts of the legs, or were visible in the trench sections. The burials were aligned east-west with their heads at the western end, they were therefore truncated diagonally by the drainage trench and soakaway. Most of the burials were only partially disturbed. The bones were placed in 15 plastic bags 0.25 x 0.25 x 0.20m in size. Bags 1-4 were recovered from the drainage trench and bags 5-15 from the soakaway pit. The burials are listed below and their locations are shown on Figure 5.

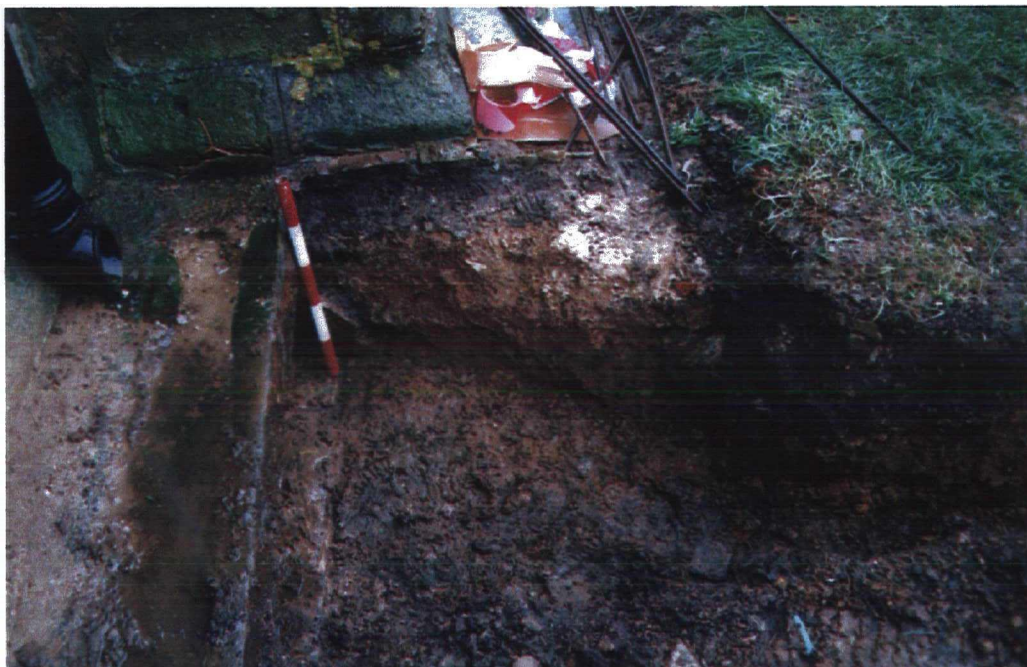
Plate 9 Stone work beneath stone eaves drip gully, north aisle

The only area in which the new drainage trench was dug adjacent to the church in was close to the north-west corner of the north aisle. Here the earliest deposit was thought to be of natural origin consisting of orangey brown silty sand with occasional limestone fragments (1025). This may have been truncated, though this was not clear, by a construction cut for a wall or footing of limestone blocks (1023) that was aligned east-west, but slightly differently from the north aisle (plate 9). It was unclear what function or date this footing took, and its relationship to the north-aisle or its buttress was not ascertained.

Sealing wall footing (1023) was a thin layer of material very similar to (1025) which may have been laid as a bedding layer prior to the laying of a further limestone block (1022). Again it could not be ascertained how this new footing related to the church or to the earlier footing (1023) due to the presence of the eaves drip (1000).

A layer of orangey brown silty sand (1024/1007) which contained occasional brick and tile fragments sealed footing (1022). This was interpreted as a subsoil or graveyard soil. This was truncated by the insertion of a ceramic pipe for the original toilet inside the western end of the north aisle. This was sealed by topsoil (1006 and 1021). The latter was truncated by the insertion of the stone eaves drip (1000) which was sealed by two modern deposits. These consisted of mixed lime based mortar and red to orange brown silty sand (1020) and a dark brown sandy silt (1019) with occasional to moderate mortar and sandstone fragments. Both may relate to recent building work or repointing on the north aisle.

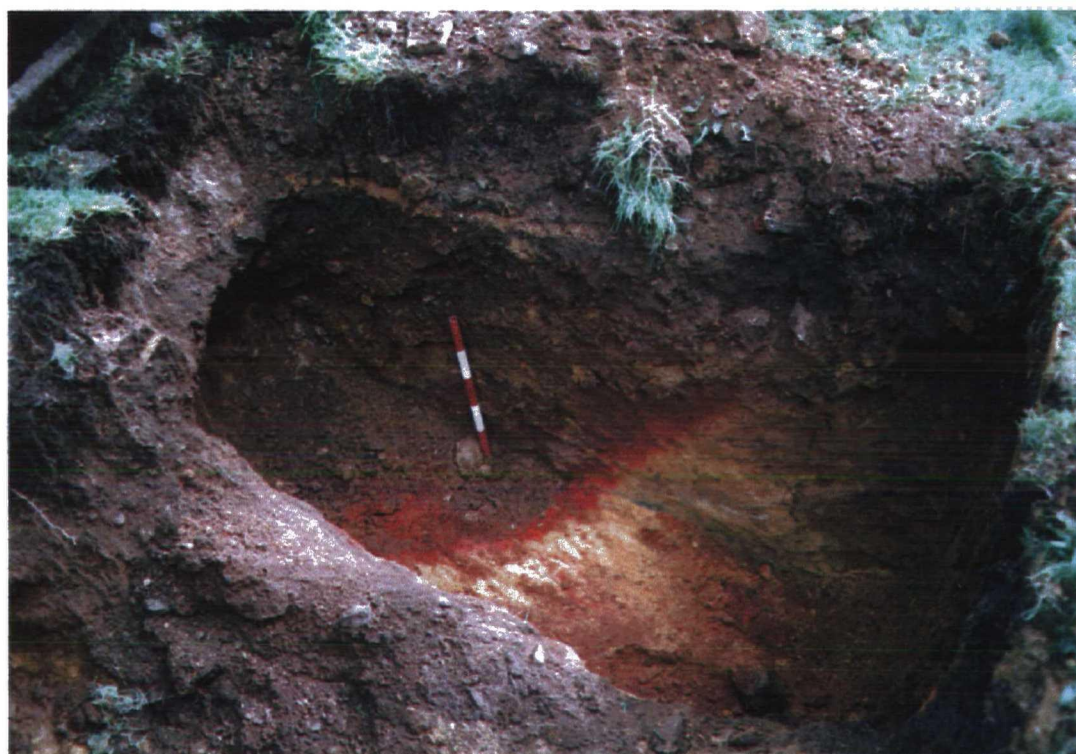
Plate 10 Lime Slaking Pit in soakaway hole, New Cemetery

On the eastern side of the trench a new feature (1034) then truncated levelling layer (1035). This had steep sides and was interpreted as a large liming pit for the slaking of lime for the manufacture of lime based mortar. Its primary fill was a layer of bright red sand (1033) clearly showing that there was substantial heat given off by the process. This was then sealed by a layer of ashy lime (1032) presumably from the last slaking process. The pit then appears to have become disused and was backfilled with a mid orange brown clay loam (1031) prior to the whole pit and the area being sealed by a similar deposit (1030) which contained frequent tip lenses of orangey yellow sand, gravel and limestone fragments. A former top-soil of mid orangey brown clay loam (1029) may then have formed. A layer of sand (1028) and hard-core (1027) perhaps as a path into the new graveyard area was then laid down prior to being turfed over with a layer of topsoil (1006).

To the west of the old cemetery in the soakaway pit within the new cemetery several features were uncovered. Of most interest was a feature interpreted as a lime slaking pit. This may have been used during the construction of the cemetery wall between the old and new cemeteries. The date of both the wall and the lime slaking pit is unknown.
