*An
Archaeological Excavation
at
Springfield,
Scarborough*

Trevor Pearson

Scarborough Archaeological and Historical Society

Interim Report 30: 1998

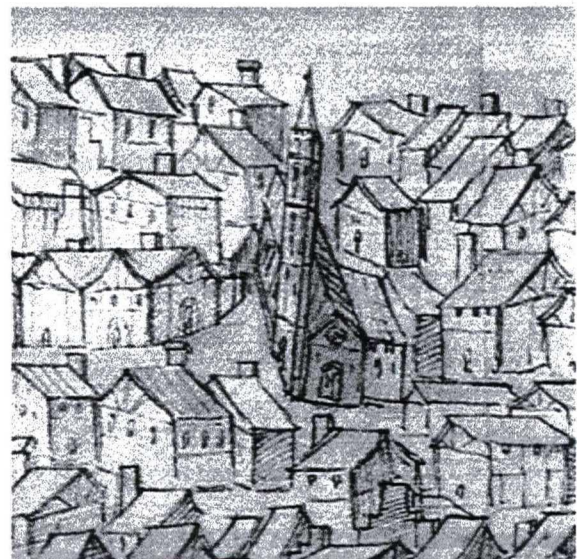
Fig. 5 Part of the 1530s view of Scarborough showing what may be St Sepulchre Church

circular nave as in the early-twelfth-century St Sepulchre Churches in Northampton (R.C.H.M.E. 1985, 59-61) and Cambridge (R.C.H.M.E. 1959, 255-57) which were intended to imitate the rotunda constructed over the Holy Sepulchre in Jerusalem in the 4th century AD. The earliest view of Scarborough, dating from the 1530s, (Binns 1983) shows a church with a rectangular nave and five-storied tower at its west end (Fig. 5) in this part of the town which may be proof that St Sepulchre Church was not circular in plan. However this evidence is not conclusive as the building depicted could be the church of the Franciscan Friary.

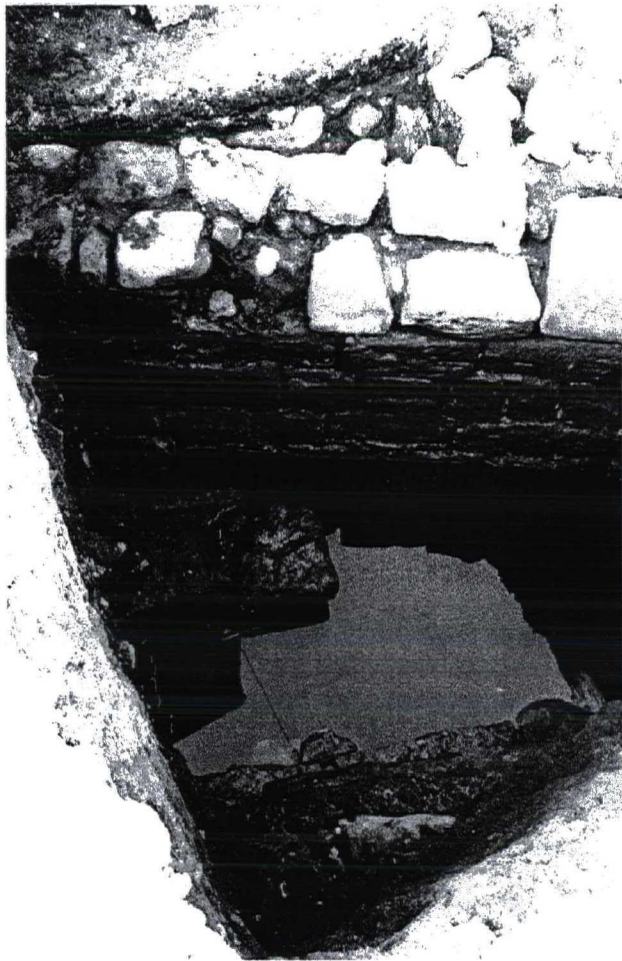
Fig. 19 Trench Nine looking north showing the culvert

A well-preserved stone culvert was found in Trench Nine, built into the Damyot and running east-west in the same direction as the stream (Figs. 18 and 19). The sides of the culvert were built of stone, that on the north of well-coursed masonry (F905 and F919) whilst the south side was more crudely constructed of roughly squared stones built on a slight batter (F912). The two sides were not parallel but converged by up to 0.4m towards the east. The bottom of the culvert was not reached because of problems

The building of the culvert clearly indicates that, at least at this point in its passage, the Damyot was a managed watercourse though to what purpose is not clear. The features revealed in the culvert did little to clarify the question. Two wooden posts (F925) were found either side of the drain opening in the north face of the culvert where they could have supported some form of wooden shuttering to impede the interchange of water between the drain and the culvert. Several small stones placed on edge against the north face of the culvert (F913) could have been to direct the flow and adjacent to them were two massive

stones placed one on top of another which may have supported an upright timber post (F909). A square socket 0.1m across had been chiselled out of the top stone and packed with clay and similarly several shallow notches in the north wall of the culvert may
