Ripon Flood Alleviation Scheme, North Yorkshire

York Archaeological Trust 2002, Field Report Number 60

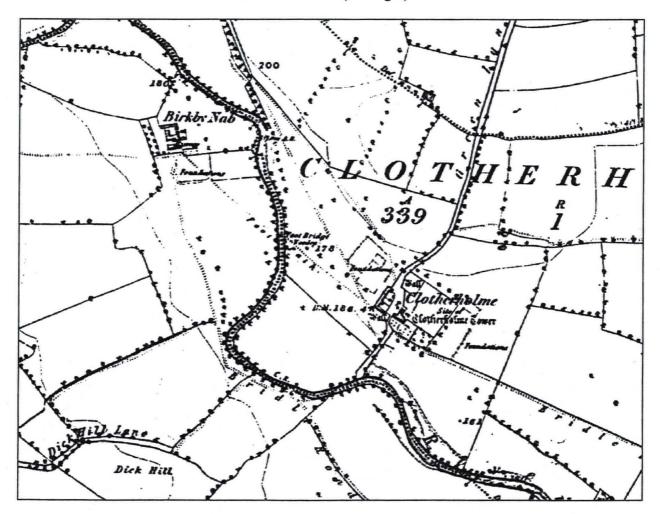
Fig 5, Extract from the Ordnance Survey map, 6" to the mile, 1856 edition (sheet 119), Clotherholme

Secondly, a settlement at **Clotherholme** (SE 2856 7225) (NMR UI **52133**, NYM 15288) was recorded as separately taxed in the 1297 Subsidy, but the village was reportedly destroyed by the Scots in 1322. The 1<sup>st</sup> edition OS map shows the existence of "foundations" in both the field to the west and to the east of the Clotherholme farm (see Fig 5).

Beresford also notes the 1<sup>st</sup> edition OS map as showing "old foundation" at this location (Beresford 1953, 234) and suggests that these may have been of a manor house at Clotherholme said to have been demolished in the 17<sup>th</sup> century (Beresford 1953, 61). In 1312 Roger de Clotherholme had licence to found a chantry chapel. This settlement included Clotherholme tower (SE 2862 7220) (NMR UI **52139**) (also shown as "the site of " by the 1<sup>st</sup> edition OS map) and the site now occupied by the modern farm. Antiquarian references to fragments of walling and Tudor masonry still visible at the end of the 19<sup>th</sup> century but NMR reports field workers note no above ground remains visible in 1963. The farm buildings are constructed from stone and cobbles and in parts could be remade from earlier buildings on the site.

The NMR reports that field investigation in 1962 noted that earthworks may represent a deserted medieval village (DMV) but they also suggest that they were caused by the remains of military buildings and practice trenches dug during the 1914-18 war. The grid references for the site given by the NMR and the SMR differ. The NMR grid reference lies to the west of Clotherholme farm and the North Yorkshire SMR lies on the east side of the farm (see Fig 8, and Appendix 1, 42, 43, 44). Currently the land, on a river terrace, partly occupied by the modern farm is under pasture. The topography of the field lying to the west of the farm certainly warrants further examination and a fuller survey of the area to both east and west of the farm is recommended. Some of the "earthworks" may represent old natural watercourses, but there is a strong likelihood that the remains of medieval settlement may be preserved here.

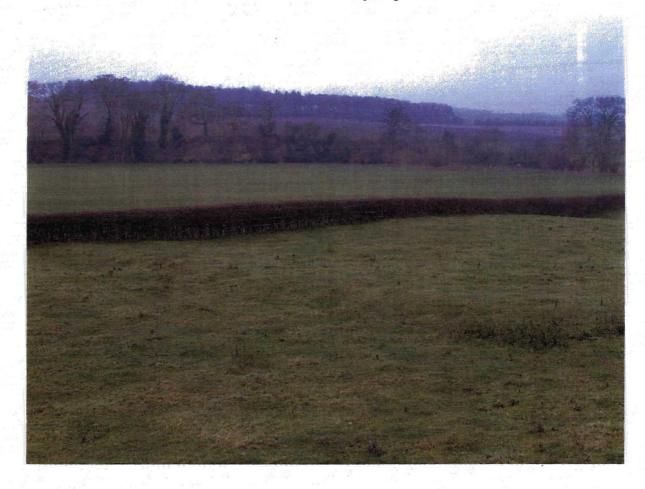
Plate 7. Earthworks in field on a river terrace above the river Laver at Clotherholme farm, facing west

The fields adjacent to the proposed site are thought to be the site of a deserted medieval village of Clotherholme where now only one modern farm occupies this area. There are earthworks in these fields some of which may be the remains of a medieval village, although natural drainage features and alluvial accumulation may account for some of the earthworks. Below the farm, close to the river there is a clear right angled bank, although this is too large a structure to represent a building. An archaeological topographic survey could help to ascertain the presence and extent of a DMV (deserted medieval village) here. The construction compound and roadway likely to be associated with the construction of the attenuation structure might be sited to avoid the remains. A scheme of archaeological excavation and monitoring would be required if below ground deposits where to be disturbed here or on the lower river terrace where an attenuation structure may be constructed.

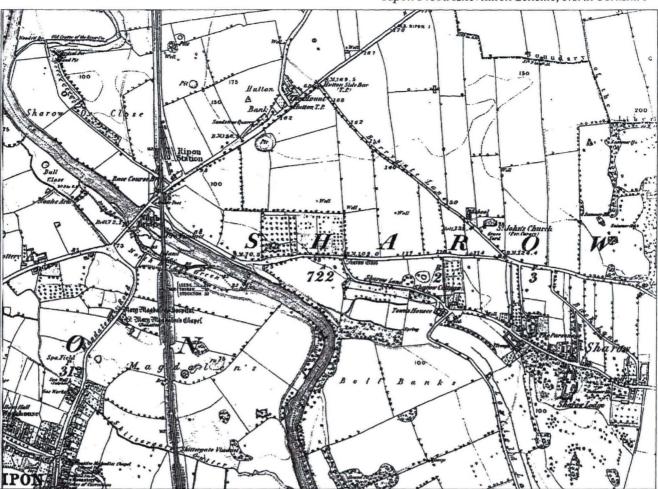
Figure 6, Extract from the Ordnance Survey map, 6" to the mile, 1856 edition (sheet 119)

The first edition OS map, 1856 shows a possible spring line evidenced by six wells located in the area between the rivers Ure and Sharrow (see Fig 6). Some of these wells may have been in use earlier than the post medieval period.

The Skittergate Gutter appears to run from Magdalene Road, under the railway and on into the River Ure. This feature is shown on the first edition OS map, 1856 (see Fig 6).

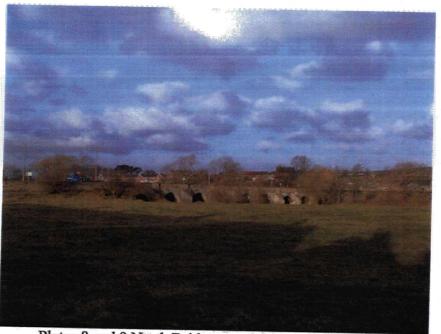
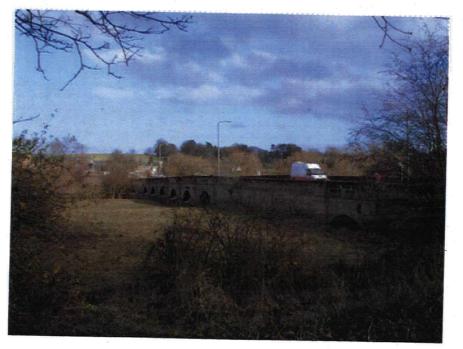
North Bridge, North Road much rebuilt from the medieval period and twice widened on the upstream side. It was widened considerably in 1880-81 due to an increase in traffic to the railway station.

Plates 8 and 9 North Bridge, north and south sides

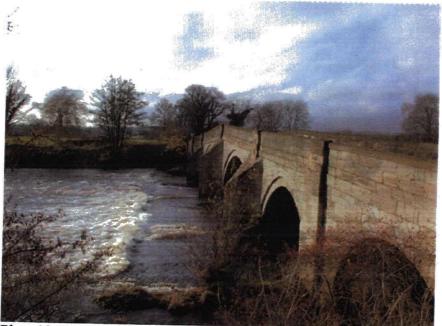
Plate 10. Hewick Bridge

Hewick Bridge, Boroughbridge Road, dates from the late 18<sup>th</sup> century, with six segmental arches, the bridge has been widened on the upstream side.

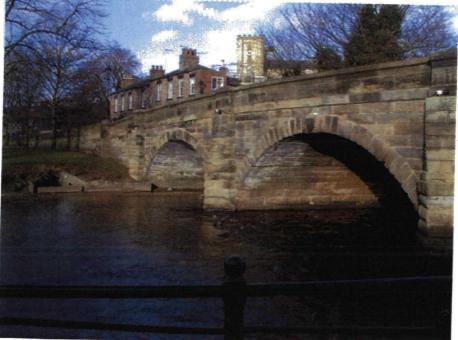
Plate 11. New Bridge

The New Bridge at Bondgate Green was constructed in 1811 replacing the former Archer Bridge, a chain bridge which spanned the Skell from a point between Thorpe Prebend House and St Ann's Hospital in High St Agnesgate, the latter was only a footbridge, and thus the principal vehicle access from the south prior to the construction of the New Bridge must have either been over Bondgate Bridge or by the ford further down stream.

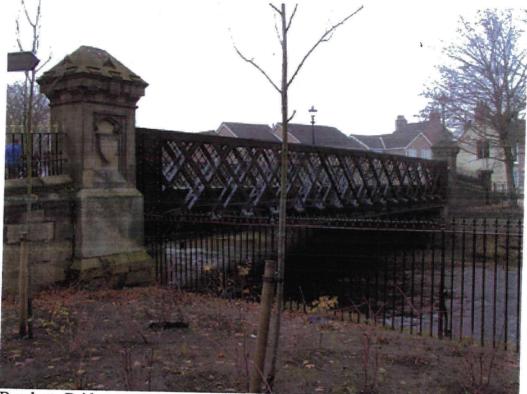
Plate 12. Bondgate Bridge

**Bondgate Bridge** constructed in 1892, has a single iron lattice girder span on four ashlar piers with pyramidal and crenellated tops and tracery panel sides with the Ripon coat of arms. A ford is shown on the 1856 OS map leading from Low Bondgate across the Skell.

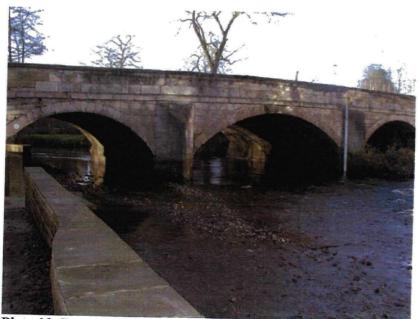
**Borrage Bridge**, dates from the 18<sup>th</sup> or early 19<sup>th</sup> century, and was widened westwards in the late 19<sup>th</sup> century. The bridge has three segmental arches; the east side is limestone ashlar; the west side rock-faced millstone grit.

Plate 13. Borrage Bridge, east side

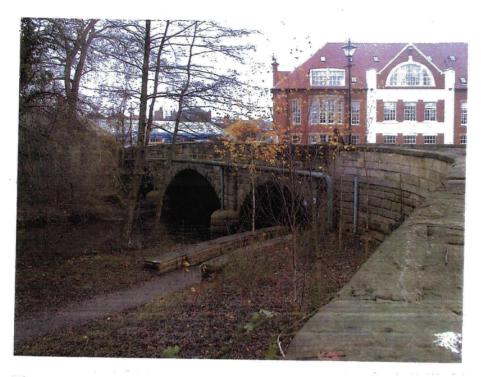
# Plate 14. Borrage Bridge, west side

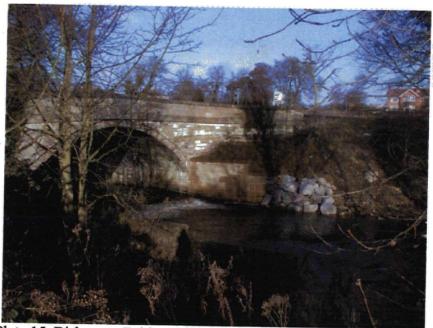
**Bishopton Bridge**, Studley Road dates from the late 18<sup>th</sup> or early 19<sup>th</sup> century. Constructed as a single segmental span not long after the turnpiking of the Patchley Bridge Road in 1756, it was widened in 1885.

Plate 15. Bishopton Bridge, across the river Laver, downstream side

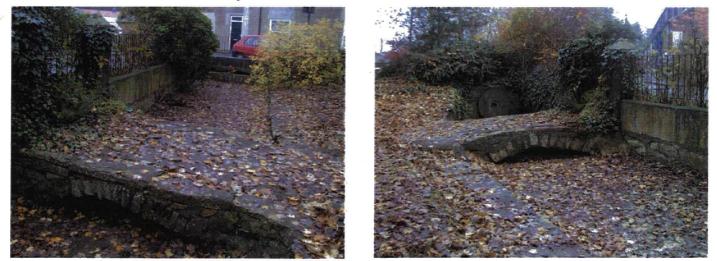
The mill race and the site of the mill on Skellgarths are features which continue into the post medieval period (see Medieval period, above). In 1776 an engine was installed at Bye Mill, Duck Hill Mill to pump water to stand pipes in the city. (This "water works" is wrongly identified on Jeffrey's map as at Union Mill) (Taylor 1998, 15). The mill race is shown clearly on Jeffrey's 1772 map and Langdale's 1818 map running along the line of Skellgarths. High Cleugh dam burst in 1892 after which and the owner of High Mill, who bore most of the cost of repair, could no longer afford to compete with the steam mills and High Mill and Union mill closed. A corn stream mill is shown on the 1856 Ordnance Survey map on Bondgate Green Lane. Later in the 19<sup>th</sup> century saw mills are established close to the canal.

Plates 16 and 17. Visible surviving remains of Low Mill millrace near Low Mill Road
