ARCHAEOLOGICAL WATCHING BRIEF

SAINT OSWALD'S CHURCH

LEATHLEY

JULY 1999

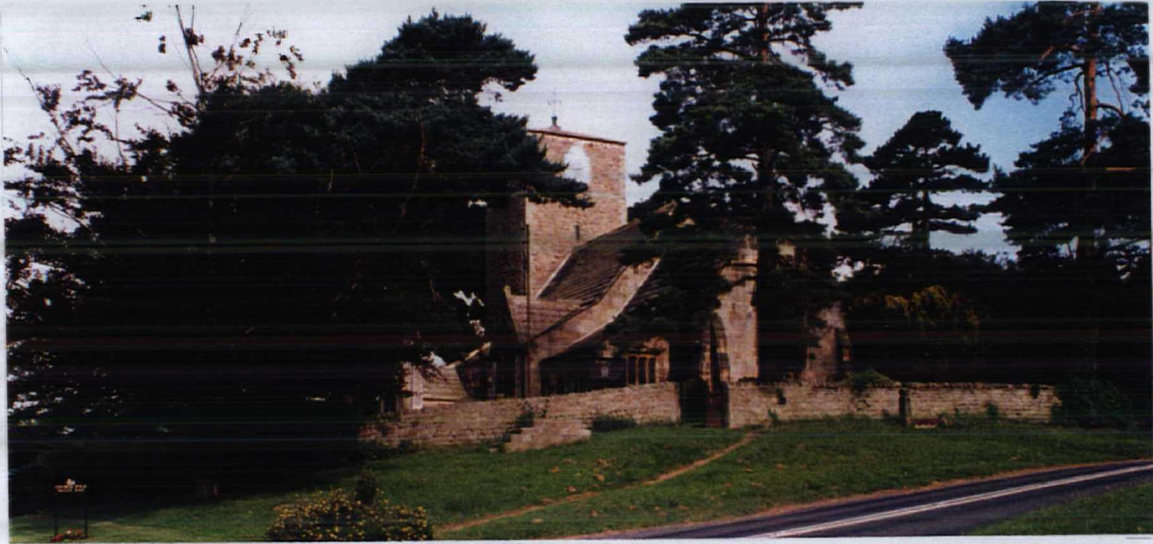
PLATES 1, 2 AND 3

St. Oswald's Church, facing north west.

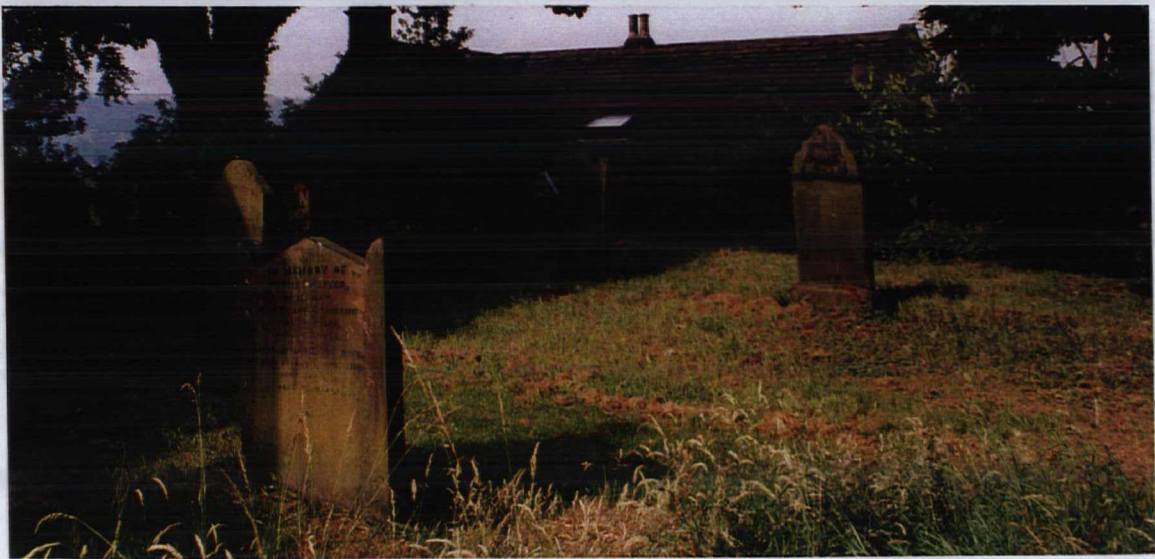
Site location, facing south west.

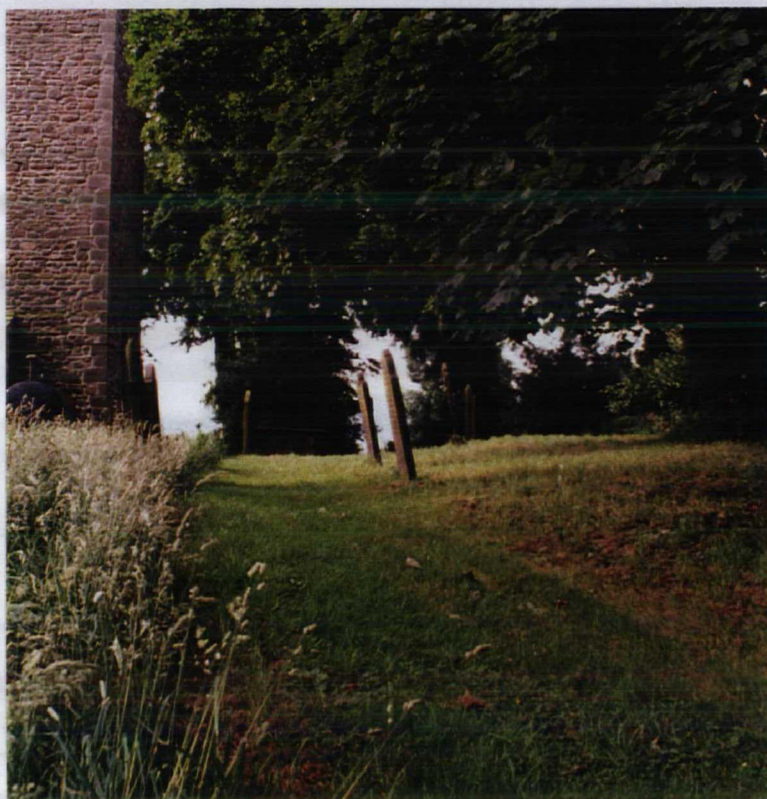
Site location, facing south.

The site is situated within the western extent of the graveyard, in area with shallow undulations. The existing ground level falls away from the base of the tower very gently to the west, on an even gradient, before rising, unevenly toward the dry stone boundary wall. The ground level to the west of same is approximately 0.60m below that of the graveyard.

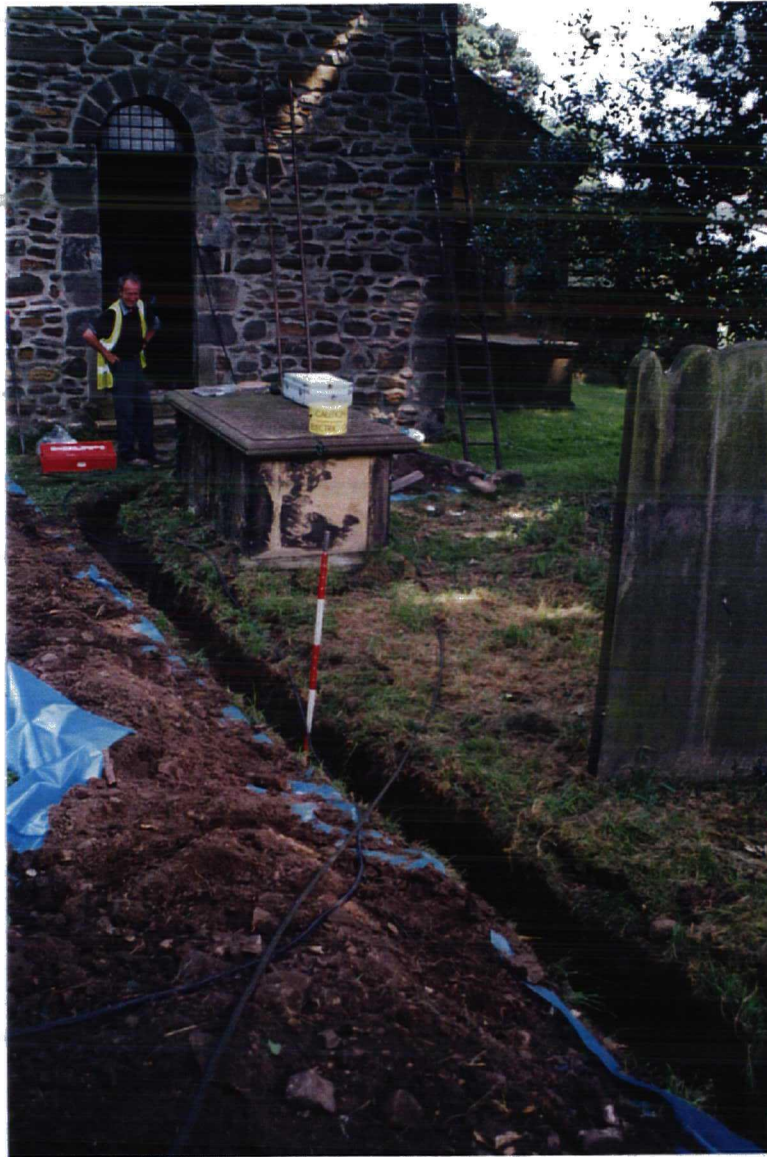
PLATES 5 AND 6

These works consisted of the hand excavation of a curvilinear service trench, towards its western extent the trench was broadened and deepened in order to pass beneath the dry stone boundary wall. The following stratigraphy was identified within the trench;

The earliest anthropogenic deposit was a layer of disturbed ground / former grave fill that was identified along the entire track. This layer of medium brown (10YR4/2) sandy loam was dry and well compacted. The layer contained a moderate quantity of

Trench as excavated, facing east south east.

inclusions, dominated by water worn pebble, root and ash / cinder. The layer also contained the occasional large water worn cobble that measured up to 0.30m in size, these stones were recovered intermittently long the eastern and central area of the trench. The layer exceeded 0.35m in depth being identified within the base of the excavation. The layer contained a small assemblage of 19th century pottery and bottle glass together with de-articulated fragments of human bone. The human remains were representative of most of the more robust areas of the skeleton including fragments of cranium, mandible, dentition, clavicle, vertebrae, radius and femur. These small broken fragments were found to be in poor condition, the breakage's and fractures were not the result of trauma but were attributable to post mortum damage. It is likely that the excavation of the 19th century graves within the immediate area was responsible for disturbing earlier, unmarked, graves. These fragmentary human remains were encountered within the central and eastern extent of the trench and were almost certainly representative of a more than one burial.

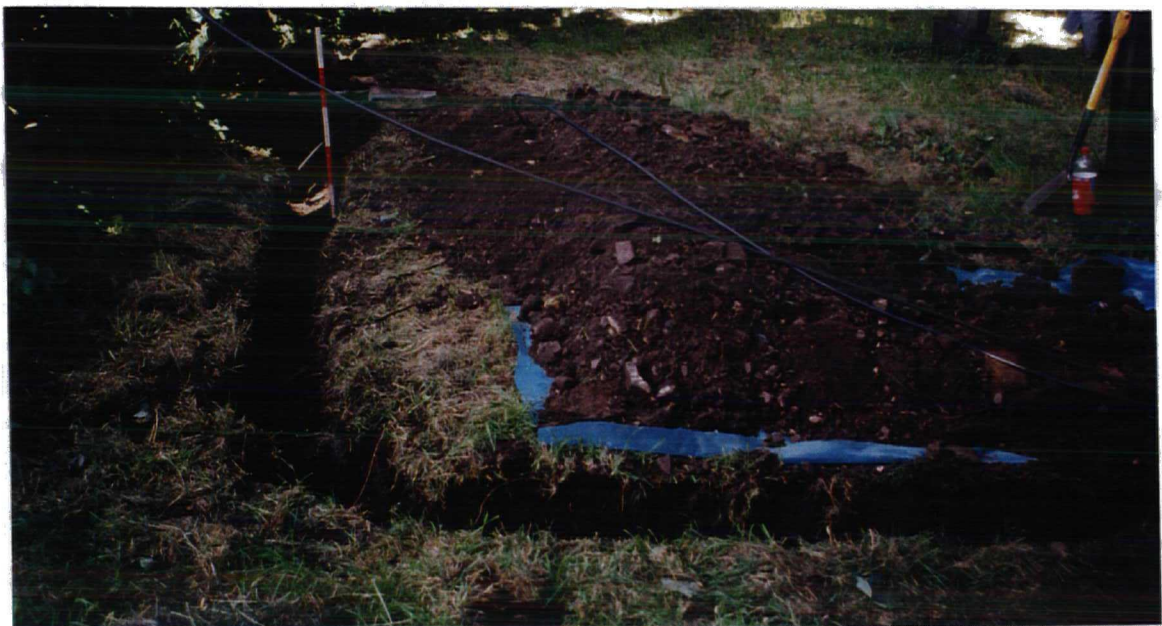
Trench as excavated, facing north.

Within the western extent of the trench this layer was sealed by a recently deposited layer of made up ground that measured up to 0.25m in depth. This deposit of medium brown (10YR4/3) loamy sand was dry and friable and contained a high quantity of inclusions. These were dominated by water worn cobbles, angular sandstone fragments measuring less than 0.18m in size, together with cinder, clinker and brick fragments. The layer also contained 19th /20th century pottery, glass and metalwork. The finds and inclusions within this layer were consistent with that of spoil resulting from building works/demolition and boiler waste. The layer was confined to that area of undulating ground within the western extent of the study area, suggesting this dumped material accounts for the make up of these shallow undulations.

Within the eastern extent of the trench in the immediate vicinity of the flight of two steps that ascend to the door in the western elevation of the tower, the fragmentary remains of a buried pathway was identified. The cinder and clinker surface was identified immediately below the turf and measured up to 0.12m in depth. The cinder and clinker was suspended within a matrix of blue black (7.5YR3/2) loamy sand that was dry and well compacted. The layer contained a number of other inclusions; namely root, pebble together with shallow lenses of coarse gritty sand. The layer contained a small quantity of 19th century pottery. This former surface butted to the steps and the western elevation of the tower, extending up to 1.50m to the west of same. The surface sealed the layer of disturbed ground and was sealed by the turf.

A dark brown (10YR4/3) loam topsoil was identified along the majority of the trench with the exception of the eastern extent where it was replaced by the former footway. The topsoil was dry and friable with low quantity of inclusions dominated by root.
