Hellifield Peel And Homestead
Hellifield
North Yorkshire

5. Archaeological Trial Trenching

Summary

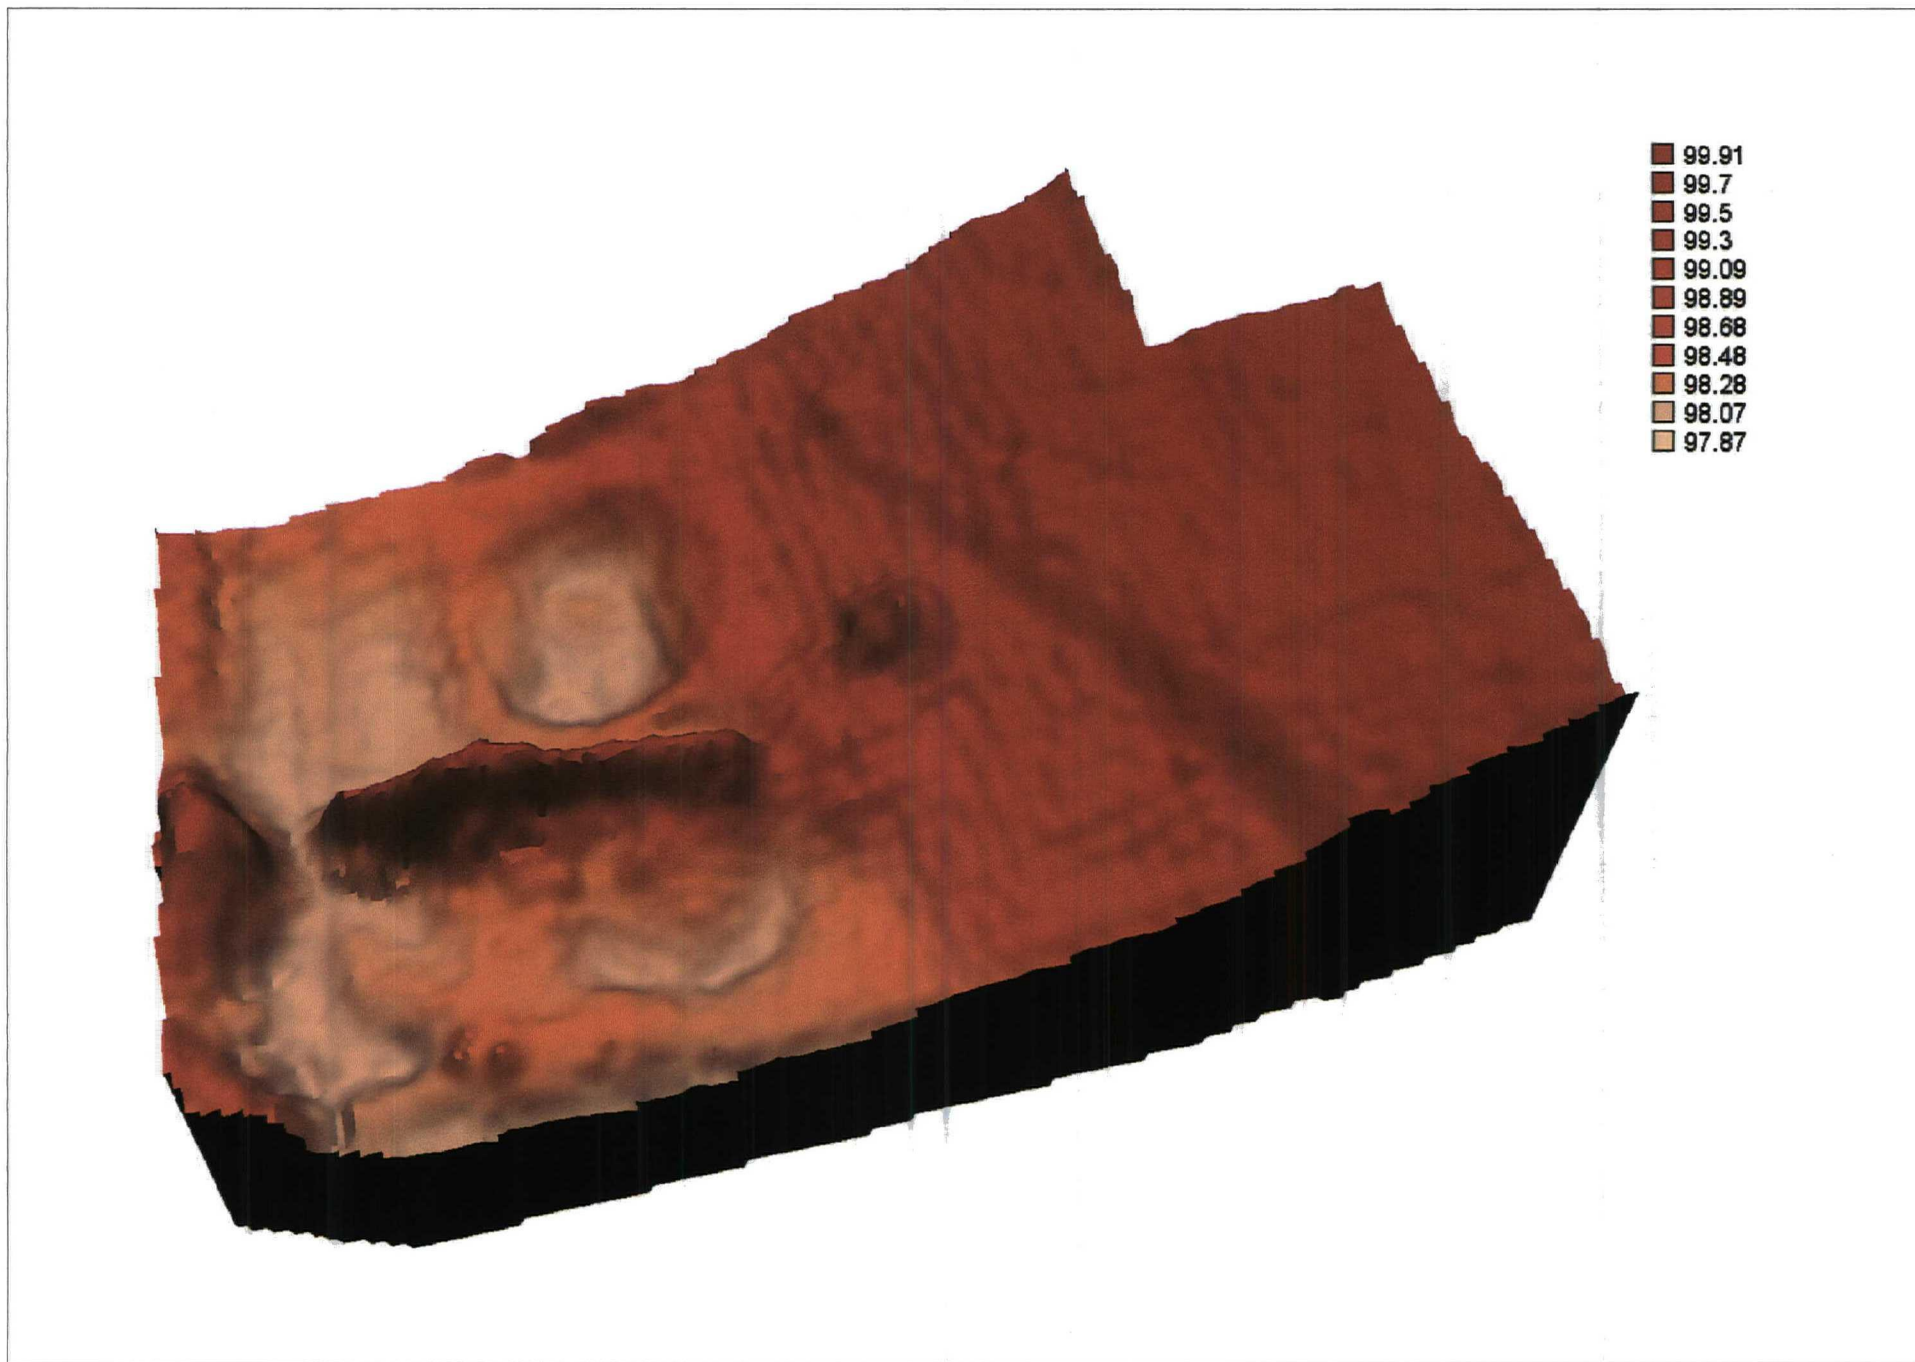
Fig. 2. Three-dimensional representation of earthwork survey results

- 6.3. Results of the earthwork survey have mapped those features visible within the south-west of the enclosure as well as identifying further sunken elements that may relate to the Victorian and/or Edwardian ornamental garden. Complete recording and interpretation of the layout and workings of this area of the site would require intrusive excavation, which should be considered at any point in the future if this area is to be developed or disturbed.

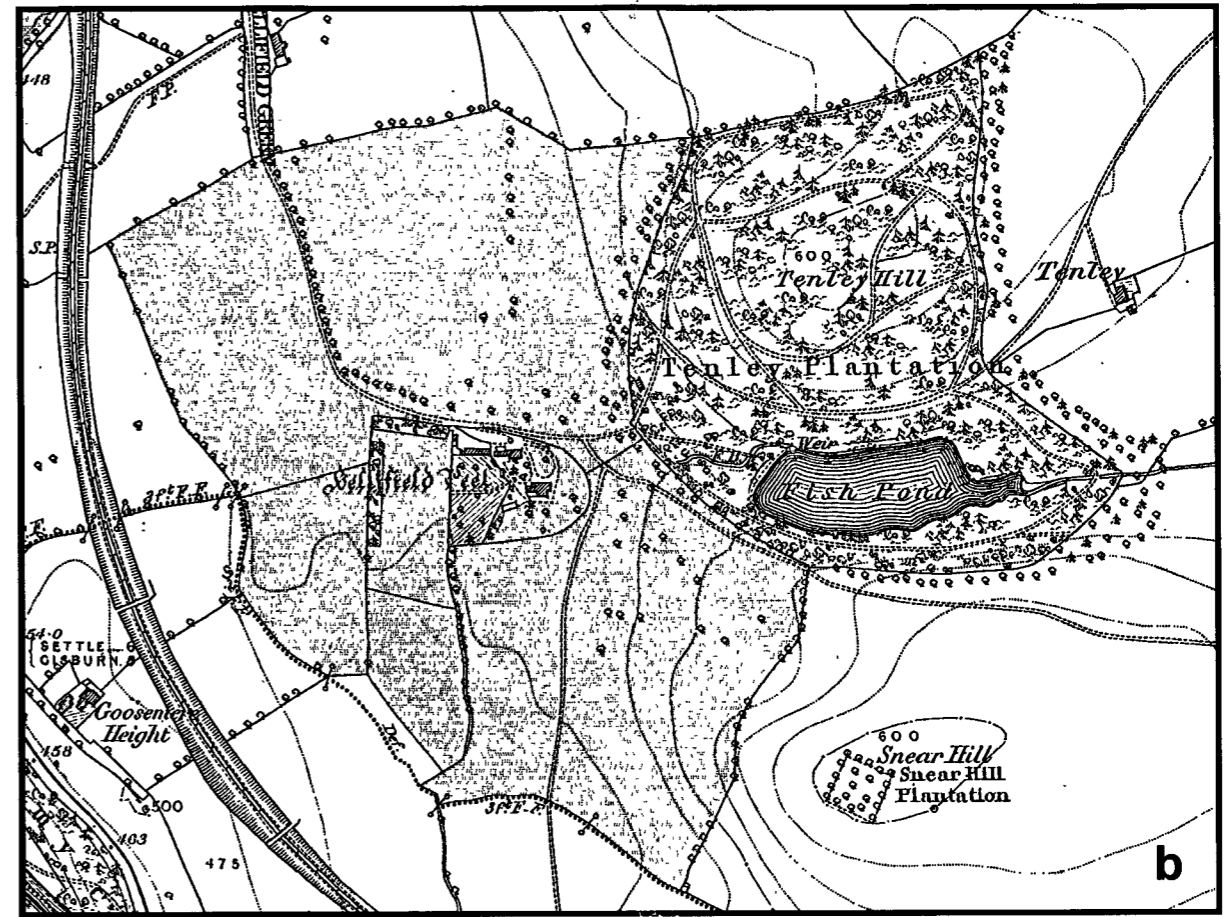
Fig. 8. Hellifield Peel and parkland map regression: a 1852, b 1894, c 1910 and d 1955 OS, Scale approx. 1:7500
