## APPENDIX 1

### Context Listing

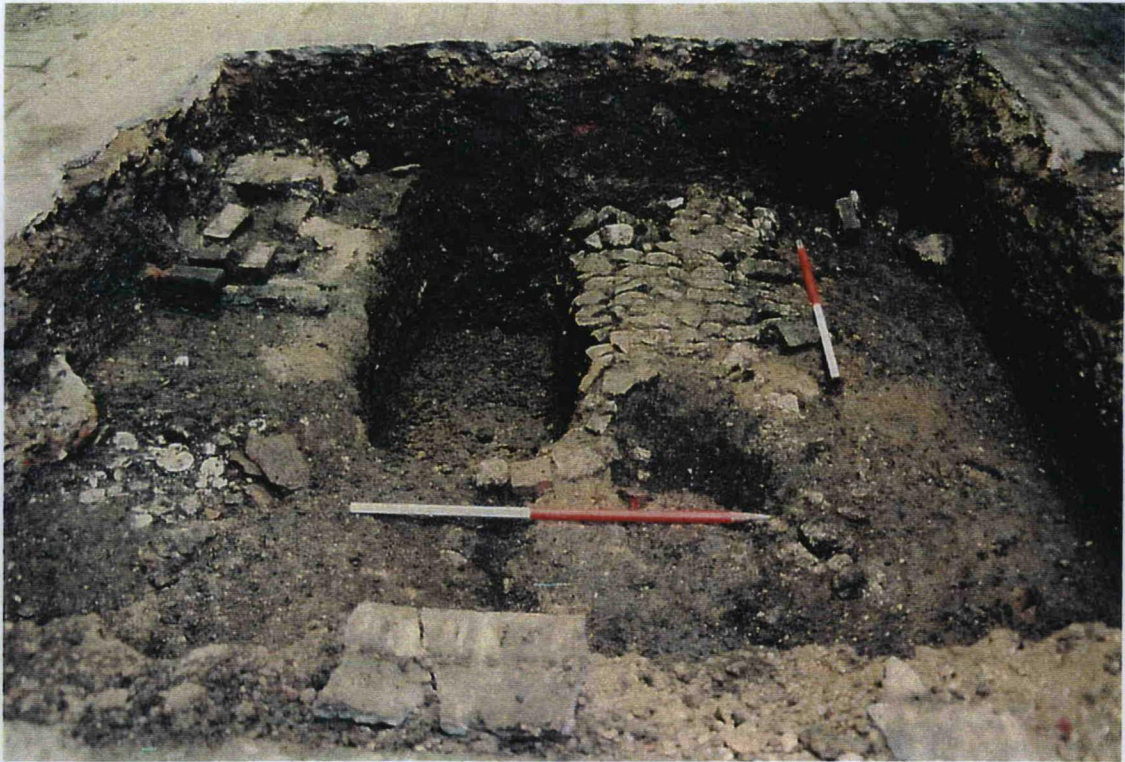
Plate 1. Trench 1. Stone surface 1003. Facing south west.

| <i>Context</i> | <i>Type</i> | <i>Munsel</i> | <i>Description</i> |
|---|---|---|--|
| 1003 | Surface | N/A | Surface of pitched limestone |

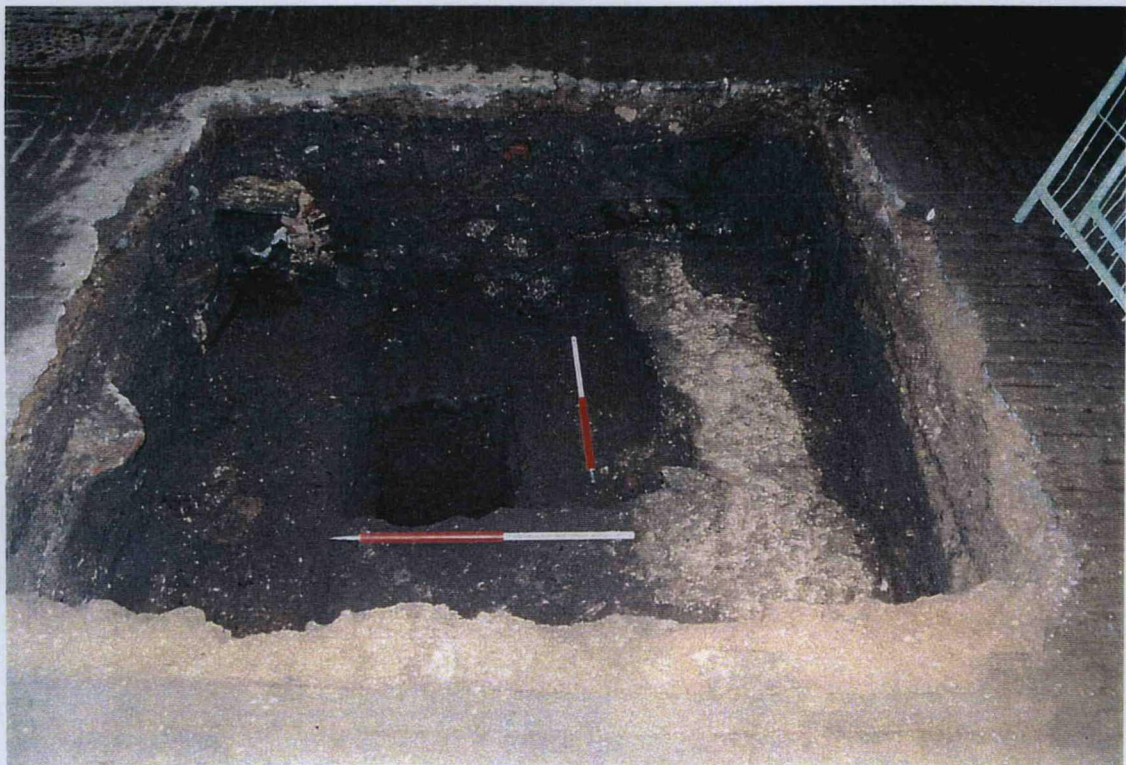
Plate 2. Trench 1. Wall 1016 and deposit 1006. Facing south west.

| <i>Context</i> | <i>Type</i> | <i>Munsel</i> | <i>Description</i> |
|---|---|---|--|
| 1006 | Deposit | 10YR 5/1 | Ashy Material |
| 1016 | Structure | N/A | Degraded Limestone Mortar |

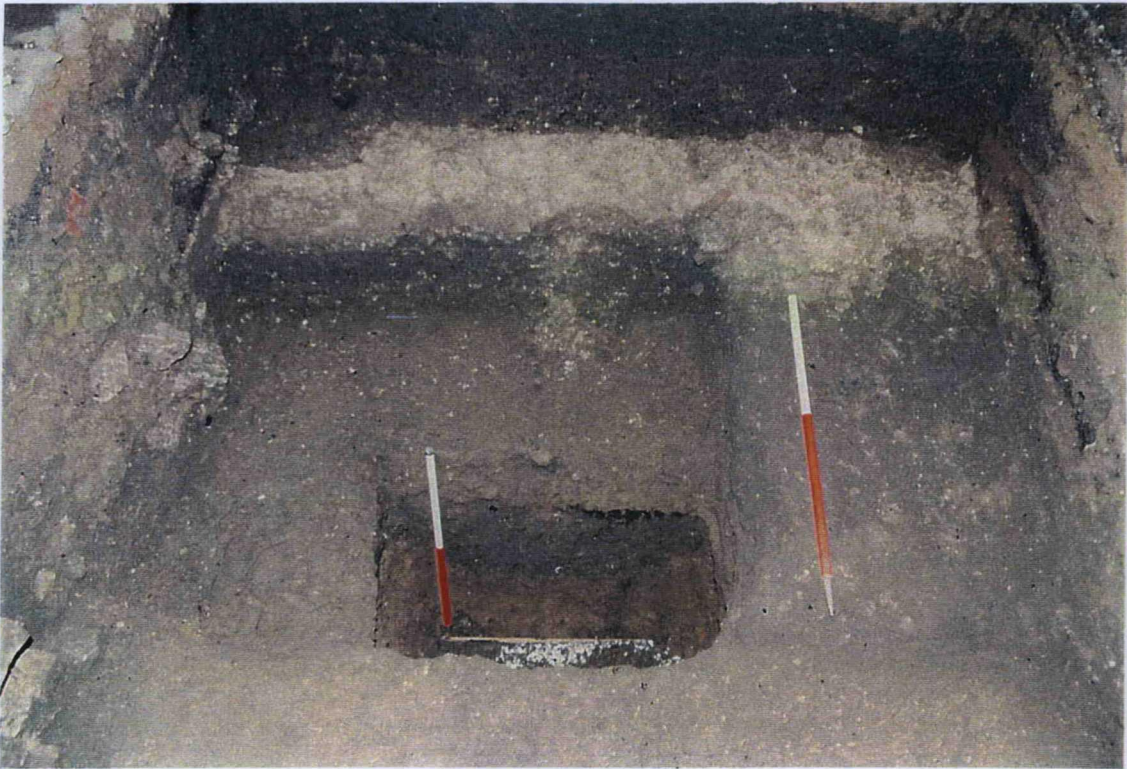
Plate 3. Trench 1. Wall 1016, deposit 1006 and test pit 6. Facing north west

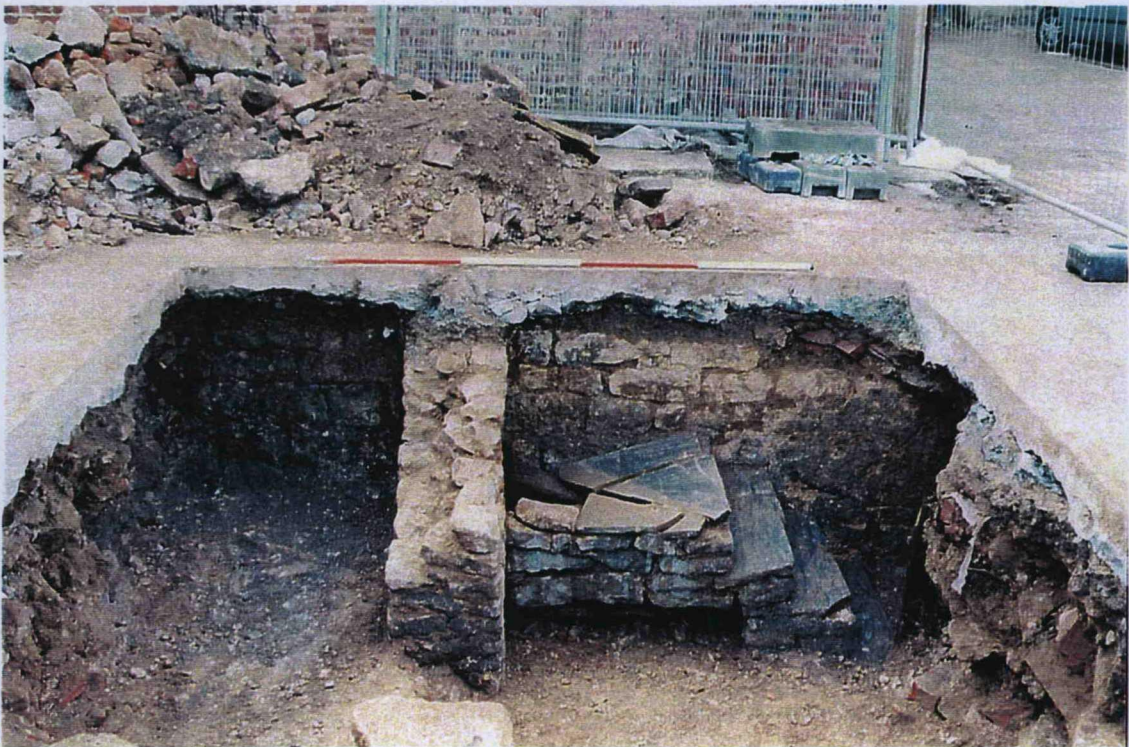
Plate 4. Trench 2. Walls 2004, 2005 and staircase 2003. Facing south west

| <i>Context</i> | <i>Type</i> | <i>Munsel</i> | <i>Description</i> |
|---|---|---|--|
| 2003 | Structure | N/A | Cellar stairs |
| 2004 | Structure | N/A | Internal cellar wall |
| 2005 | Structure | N/A | Cellar wall |

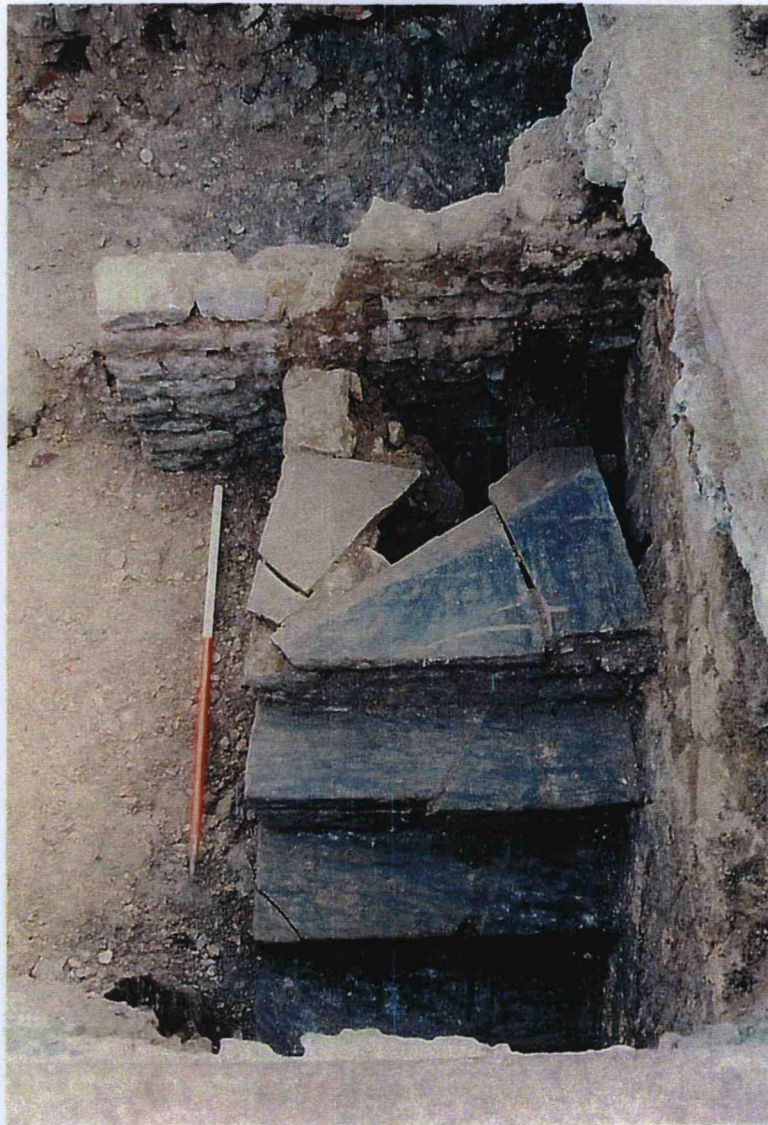
Plate 5. Trench 2. Staircase 2003. Facing south east

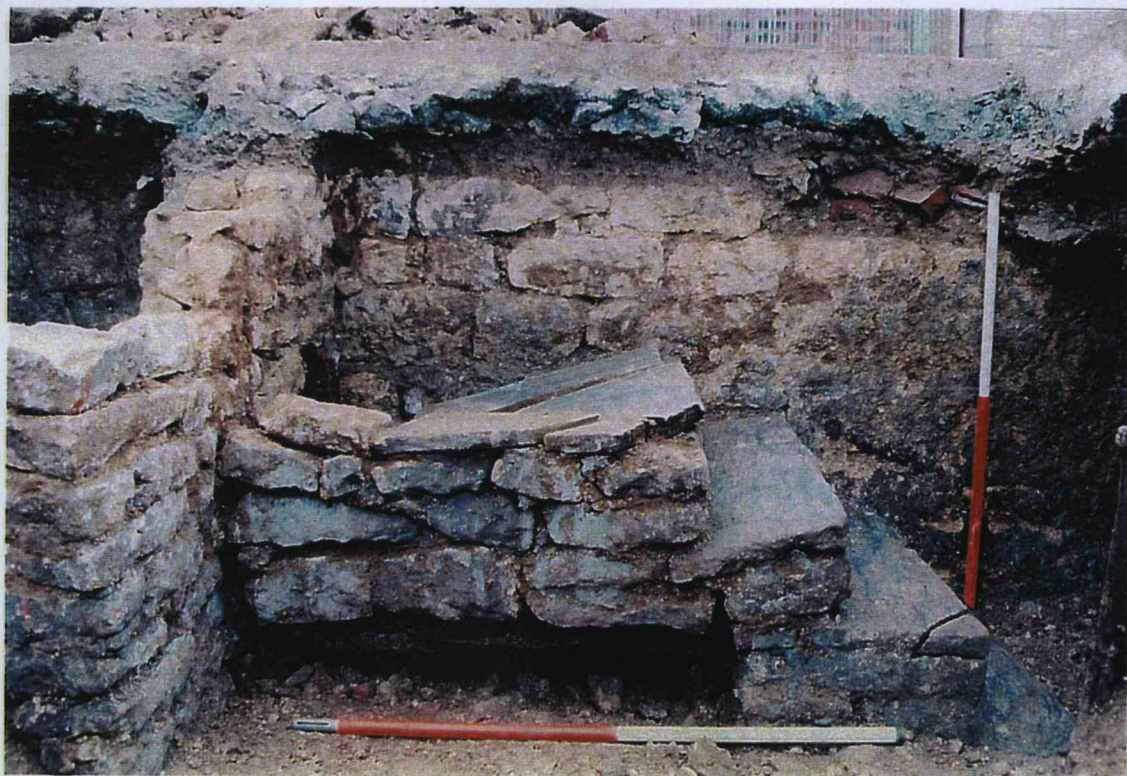
Plate 6. Trench 2. Staircase 2003 showing wooden lintel. Facing south west

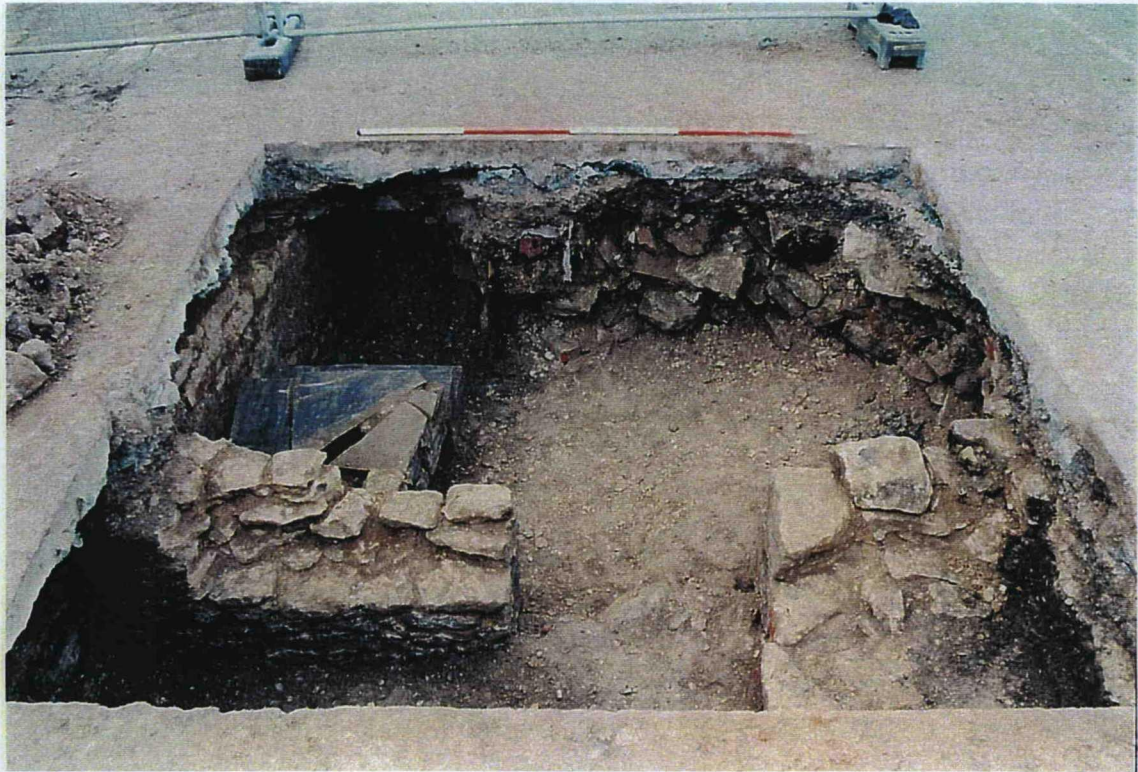
Plate 7. Trench 2. Walls 2004/2008 and rubble backfill 2009. Facing north west

| <i>Context</i> | <i>Type</i> | <i>Munsel</i> | <i>Description</i> |
|---|---|---|--|
| 2008 | Structure | N/A | Internal cellar wall |
| 2009 | Deposit | 10YR 6/6 | Demolition rubble filling cellar |

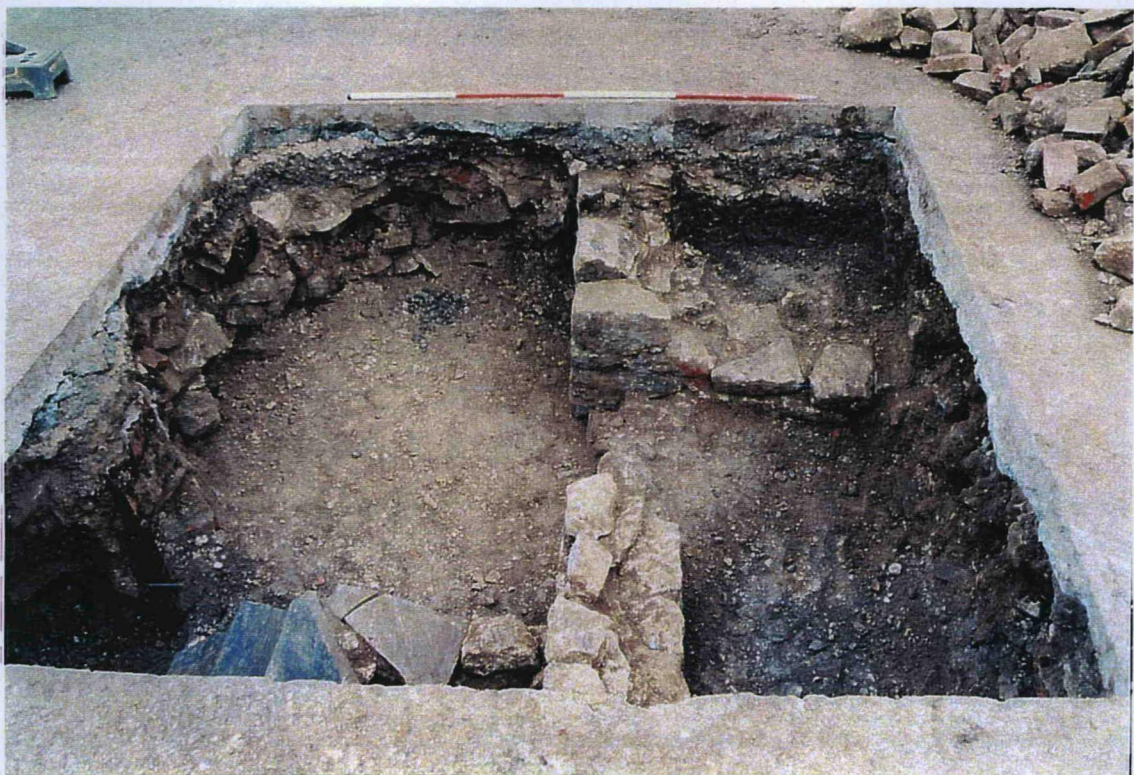
Plate 8. Trench 2. Walls 2004, 2008 and soil deposits 2006 and 2007. Facing north east

| <i>Context</i> | <i>Type</i> | <i>Munsel</i> | <i>Description</i> |
|---|---|---|--|
| 2006 | Deposit | 10YR 5/2 | Possible backfill of cellar above 2007 |
| 2007 | Deposit | 10YR 5/3 | Possible backfill of cellar above 2012 |
