**The Old Post Office  
81/83 The High Street  
Knaresborough  
North Yorkshire  
SE 349 572**

**Residential & Commercial Development  
Archaeological Excavation**

**MAP  
July 2003**

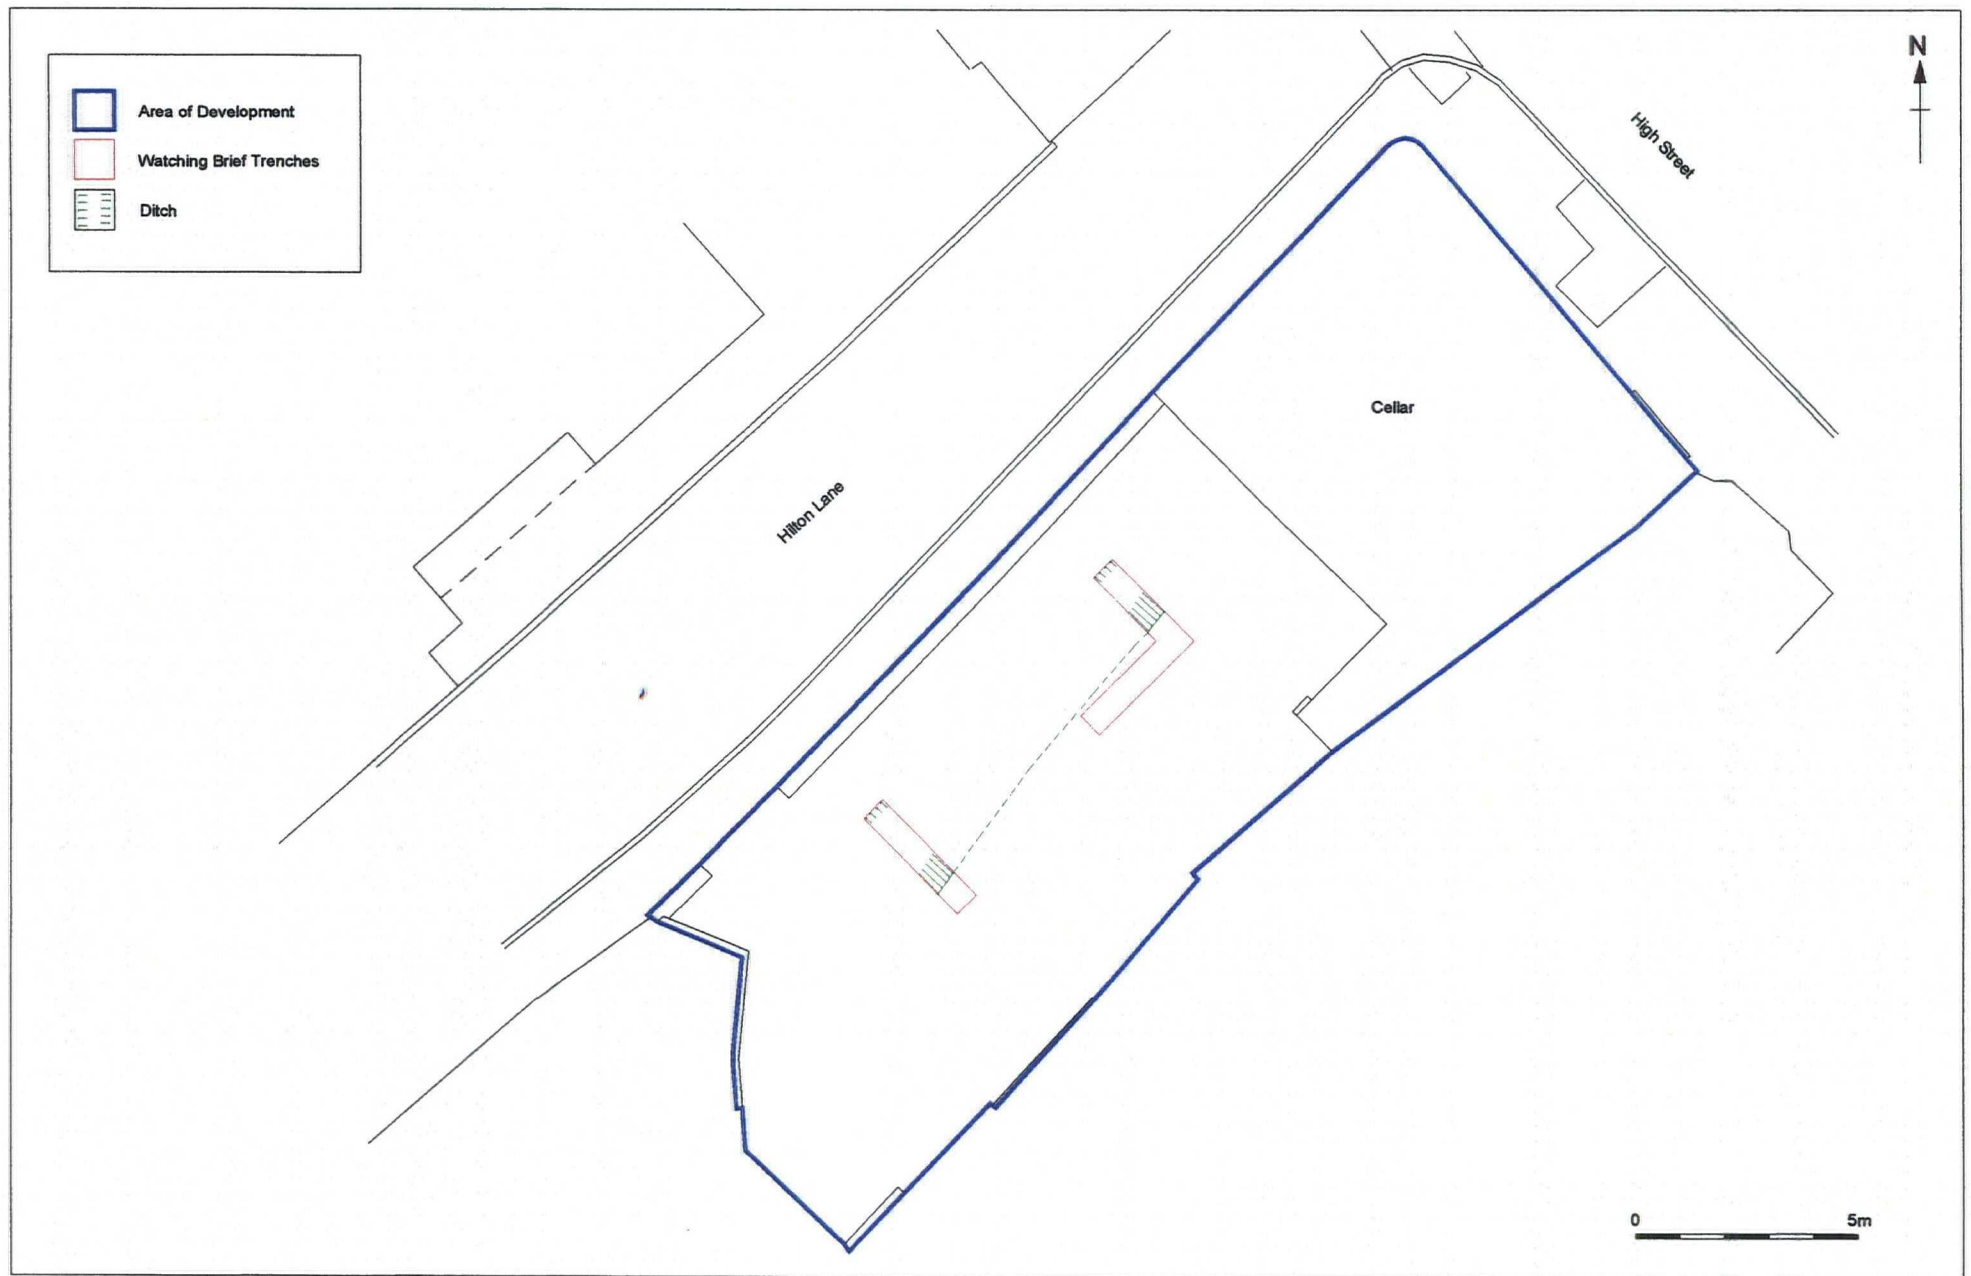
Figure 8. Watching Brief Features

- 6.1 In June 2003, an Archaeological Watching Brief was undertaken during the excavation of two geotechnical test pits (Fig. 8).

- 6.2 Each test pit measured approximately 3m in length, 0.6 in width and was excavated to a depth of approximately 2.25m from the existing ground surface. Test pit 1 was extended after the recorded stratigraphy in Test pit 2 were found to have implications for the foundation design of the redevelopment. Excavations were undertaken using a JCB with a backactor and a toothless bucket.

- 6.3 Both test pits exhibited identical stratigraphy consisting of natural limestone bedrock at a depth of 2.25m at its deepest from the existing ground level. Although in both test pits it was observed that the bedrock rose sharply towards the southern boundary of the site being 0.4m below the existing ground level close to the boundary with 79 High Street (Fig 8: Pls. 3-8). The bedrock was also observed to rise steeply to the north thus giving the impression that the site was bisected by a steep sided 'V' shaped ditch.

- 6.4 Above the bedrock was up to 0.45m deposit of medium sand (10YR 4/4). This deposit was sealed by two substantial deposits of silt clay (10YR 4/6), and limestone rubble, both measuring approx 1m in depth. The uppermost deposit was sealed by a layer of demolition rubble associated with the demolition of the Old Post Office building. No finds were observed from any of the deposits described above. In fact the sand deposit above the bedrock was compacted and had the appearance of laminations possibly from water borne deposition. The exceptionally loose nature of the majority of deposits above the sand suggested deliberate backfilling, however, although the form of the 'V' - profiled linear feature suggests an early date, the lack of finds and the fact it was impossible to enter the trench for health & safety reasons. Coupled with the lack of cartographic information makes it impossible to interpret this feature further.

- 7.2 Little archaeological work has been undertaken in the immediate vicinity of the site. The Archaeological Watching Brief on the geotechnical test pits showed that a single 'V' shaped linear bisected the site. Unfortunately the unstable nature of the features fill and complete lack of dating material makes an absolute interpretation problematic. The form of the ditch did not suggest that it housed any modern drainage facilities, however, the primary sand fill did suggest water deposition and therefore the ditch may have been an open sewer which was backfilled prior to the sanitation improvements in the 19<sup>th</sup> century. The topography of Hilton Lane immediately adjacent to the site indicates the natural fall of land down to the river. This taken along with the alignment of Gap Row to the east suggests an earlier street alignment, which has been removed by Hilton Lane. Unfortunately it was not possible to test this theory as no earlier maps than the 19<sup>th</sup> century were available for consultation.
