**Scarborough Castle  
Scarborough  
North Yorkshire  
NGR TA 0510 8930  
SAM No. 0557**

**Archaeological Watching Brief**

**MAP  
Archaeological Consultancy Ltd.**

**July 2003**

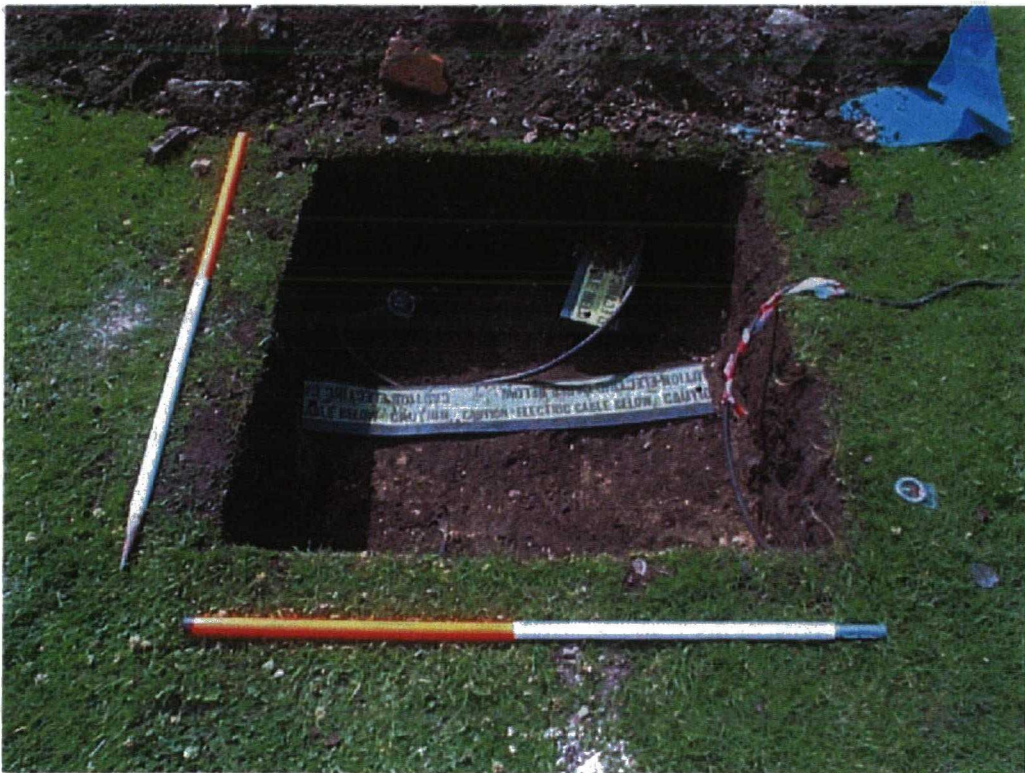
Plate 2. Trench 2. Facing South West

The deposits encountered in Trench 2 comprised a dark brown friable sandy silt with occasional moderate limestone fragments, measuring 0.23m in depth. Finds included frequent brick and mortar fragments, post-medieval glass and clay tobacco pipe. Above this deposit, which was not excavated to its' full depth, was a turf and topsoil layer of 0.15m in depth.

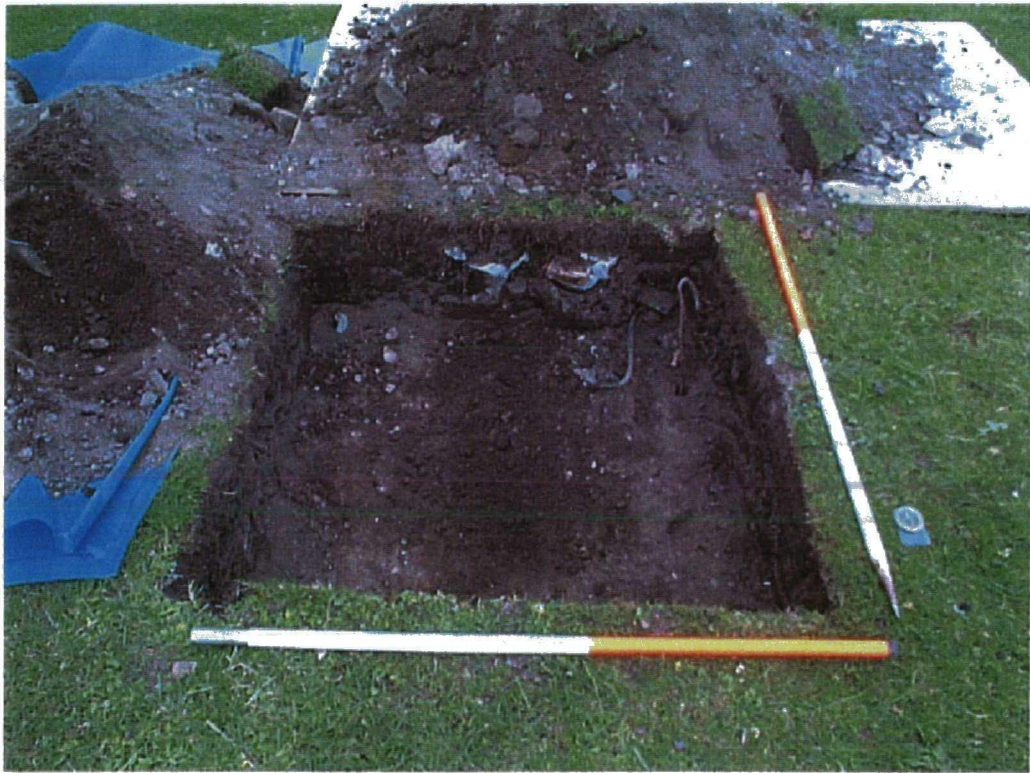
Plate 5. Trench 5. Facing South

The deposits encountered in Trench 5 comprised primarily of a dark brown friable sandy silt with frequent small sandstone inclusions and small rounded pebbles. This deposit measured 0.23m in depth, and finds recovered included frequent fragments of coal or coke, mortar, ceramic tile and brick, bone, clay pipe and post-medieval pottery. A layer of turf and topsoil 0.15m in depth lay immediately above this deposit.
