**Church Farm  
Middleton  
Pickering  
North Yorkshire**

**Archaeological Watching Brief**

**MAP  
May 2003**

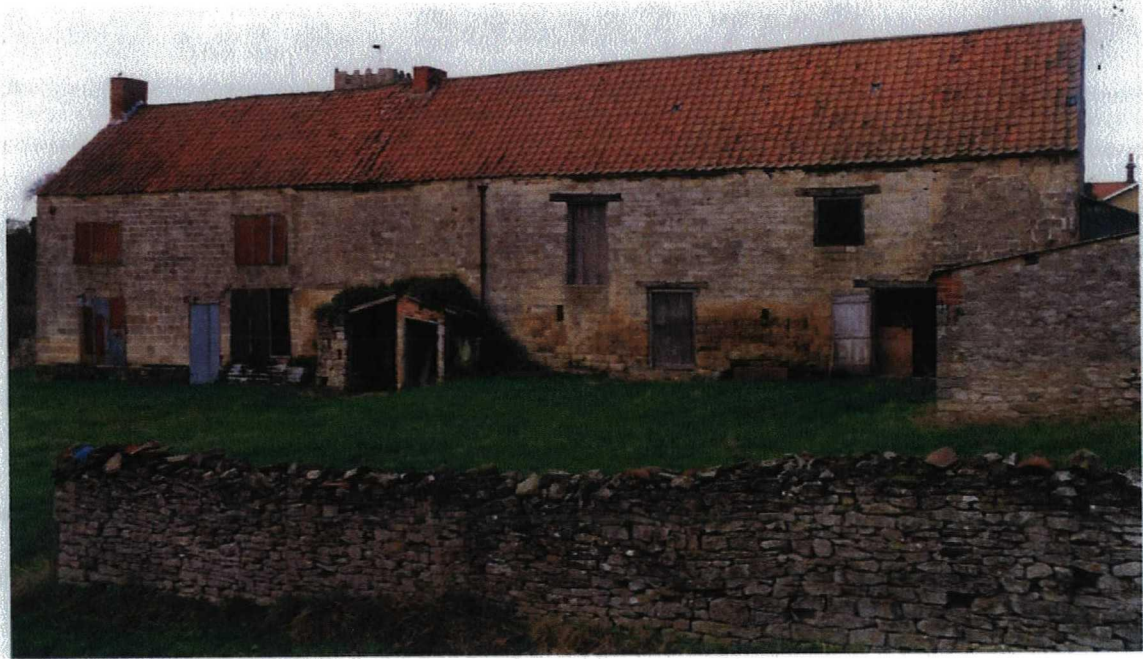
Plate 1. Exterior of Church Farm. Facing West

Church Farmhouse is a redundant agricultural building immediately adjacent to, and north-east of St. Andrew's Church (Fig. 2 & Pl. 1).

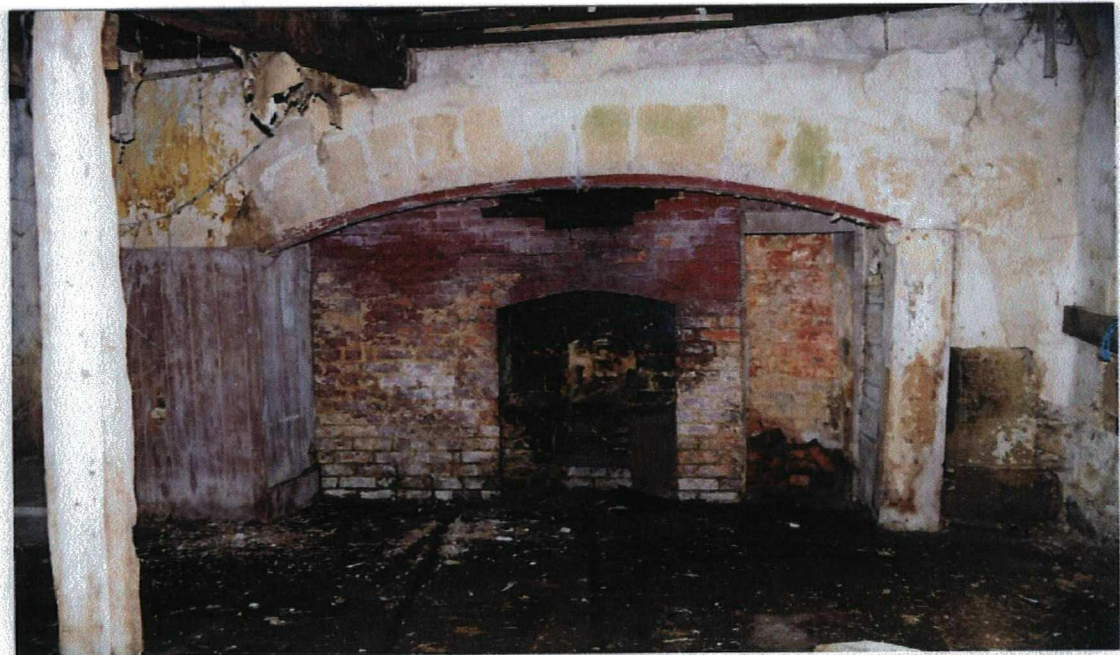
Plate 2. Stone Walk in Fire Place. Facing North

The only structural feature of note was a stone walk in fireplace originally supported by two stone columns, of which only one survived, the second had been replaced in the past by a tree trunk (Pl. 2).
