28 Church Street
Norton
North Yorkshire
(SE 7925 7140)

Archaeological Watching Brief

**28, Church Street
Norton
North Yorkshire
SE 7925 7140**

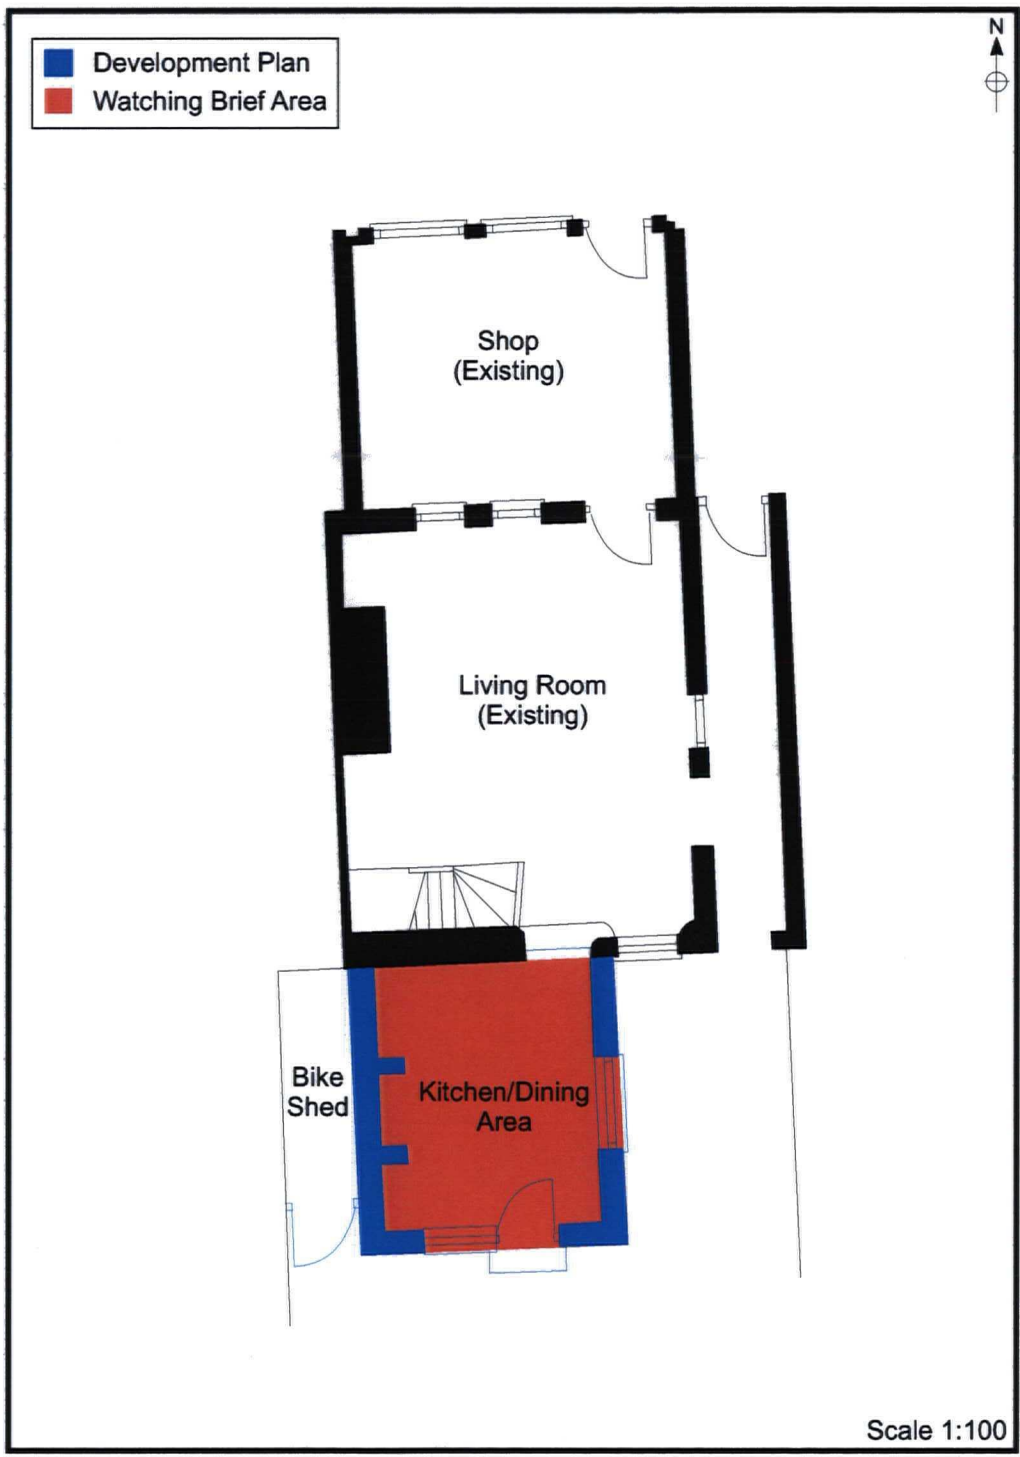
Figure 2. Watching Brief Area

- 1.1 An Archaeological Watching Brief was carried out by MAP Archaeological Consultancy Ltd at 28 Church Street, Norton, North Yorkshire (SE 7925 7140) in advance of the development of the site from a former jeweller's shop into a residential dwelling (Figs.1 and 2).
- 1.2 The work was carried out by MAP Archaeological Consultancy Ltd, from the 9th to the 12th of May 2003, and involved the observation of groundworks to the rear of the standing building (Pl. 1).
- 1.3 All work was funded by Ms. L. Carr and construction work undertaken by Transcore.
- 1.4 All maps within this report have been produced from the Ordnance Survey with the permission of Her Majesty's Stationery Office, Crown Copyright. Licence No AL 50453A.

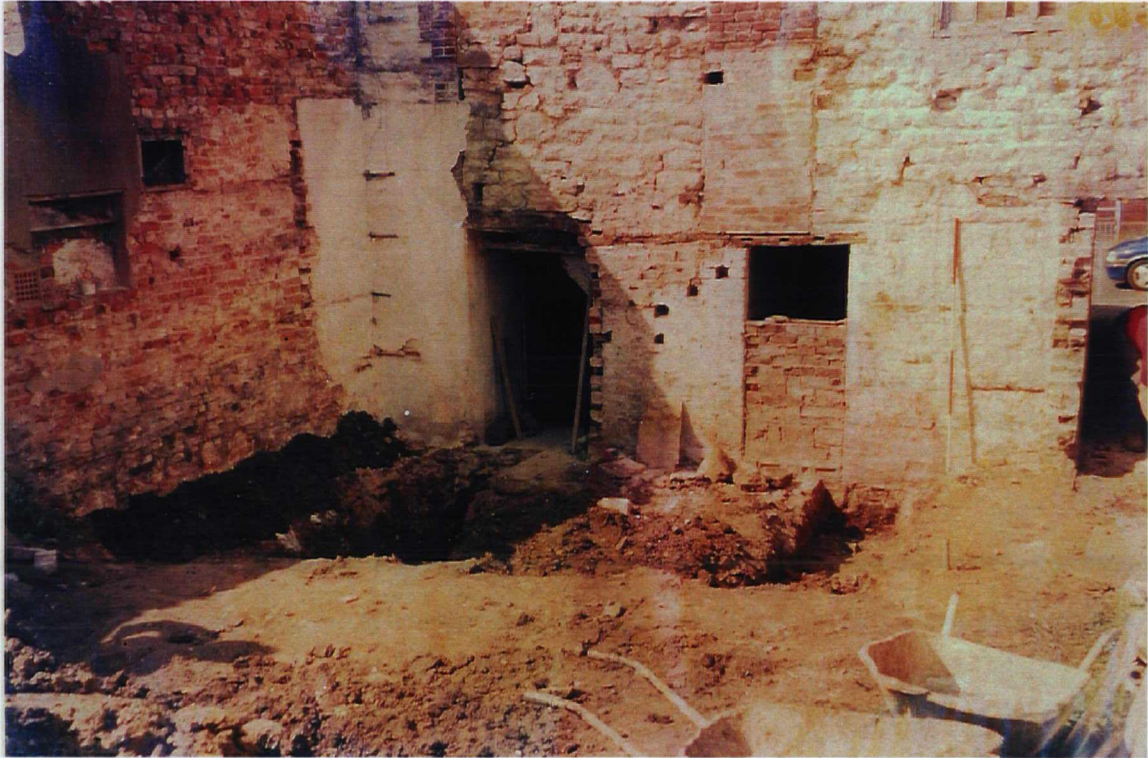
Plate 1. General shot of the site. Facing north west.

enclosed garden, which had been covered by spoil and other building material (Pl. 1).

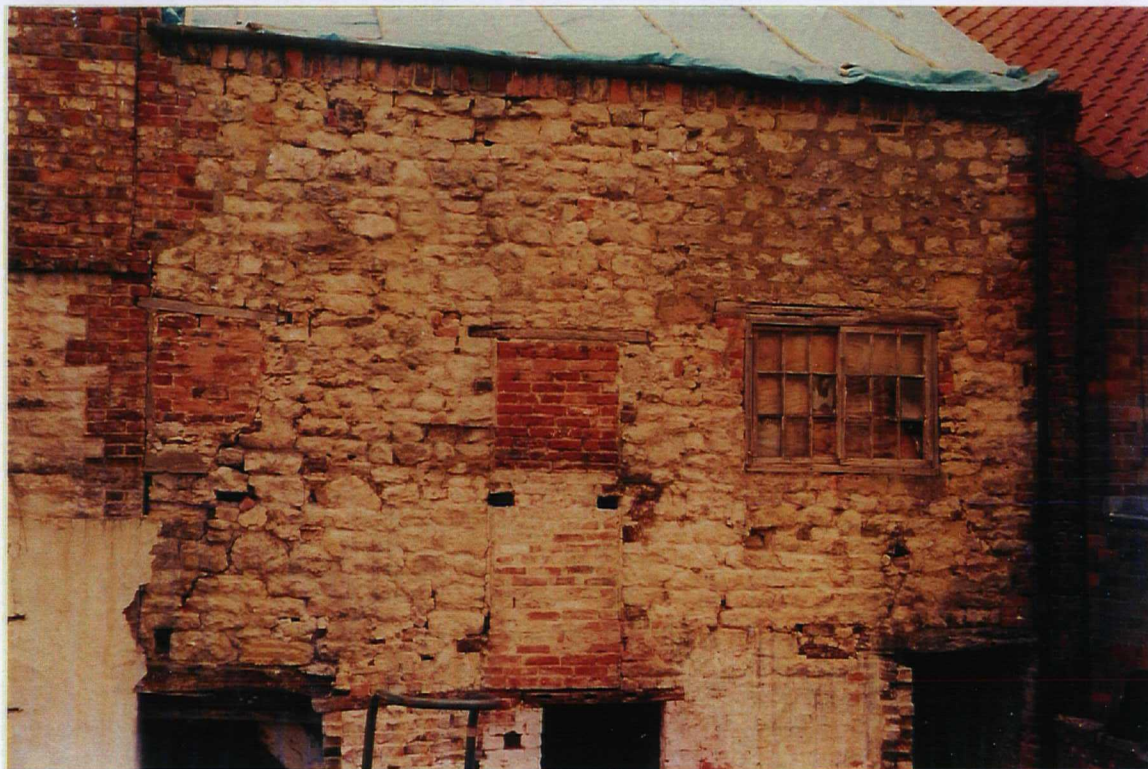
Plate 2. Detailed shot of adjacent building. Facing north.

- 2.1 The development site lies to the rear of a two storey former town house at 28 Church Street, Norton which has until recently been used as a jeweller's shop. The property is now in a dilapidated state, with the frontage facing onto Church Street, and is flanked on the west side by the Derwent Arms public house and a residential unit on the east side (Pl. 2). The rear of the site comprised of a small
