**Back Street/Castle Hill
Middleham
North Yorkshire
SE 1265 8755**

Archaeological Watching Brief

**MAP
June 2004**

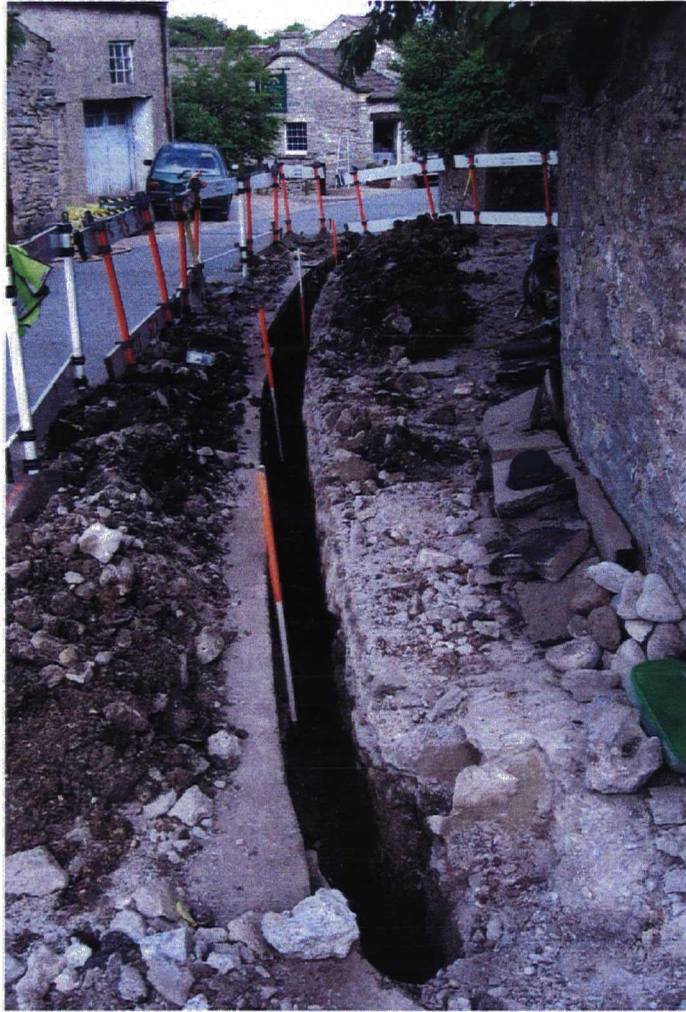
Plate 3. Excavated cable trench. Facing east.

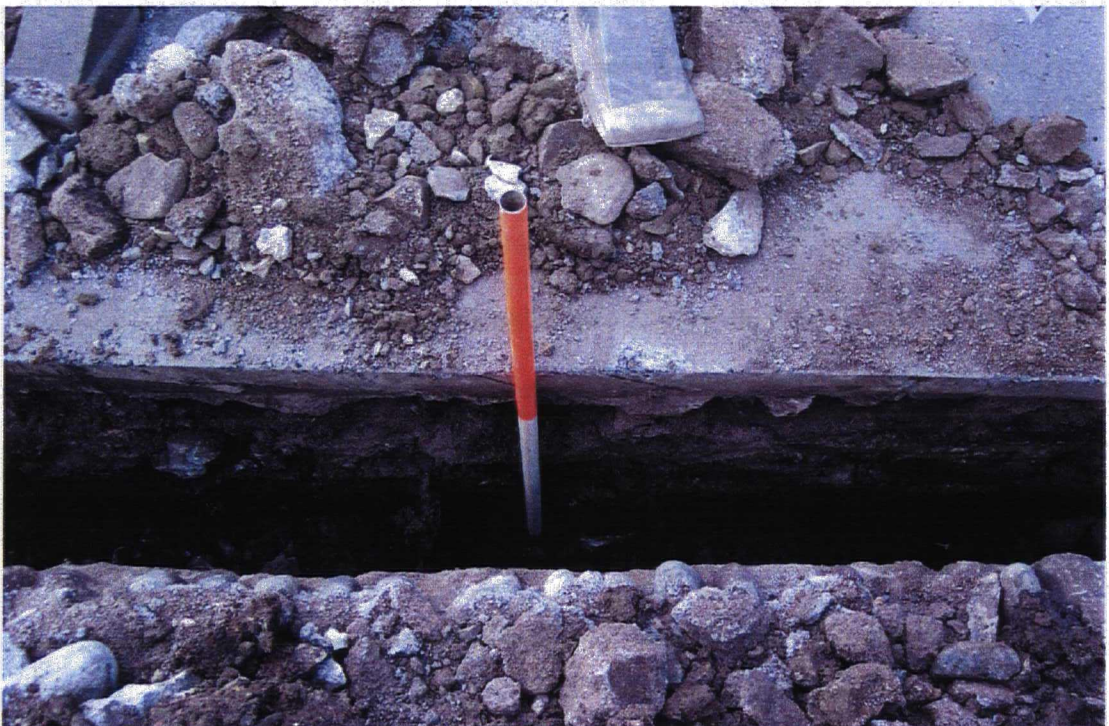
Plate 4. North facing section of excavated trench. Facing south.

The earliest deposit encountered consisted of a stiff clay with no inclusions (1008). This deposit, which probably represented a natural subsoil, was only seen in the base of the trench for a length of approximately 2.0m. Deposit 1008 was sealed by a deposit of solid clay which contained limestone fragments (context 1009). Deposit 1009 became thinner towards the east and merged into context 1011. Deposit 1011, a firm clay contained no inclusions nor associated finds.

Deposits 1009 and 1011 were sealed by a clay deposit (context 1006) to the west and a deposit of limestone hardcore to the east (context 1004). Further mixed deposits (contexts 1005 and 1007) were observed immediately above Deposit 1006.

Further evidence for an earlier road surface was confirmed by the presence of a cobble layer (context 1010), situated immediately above Deposit 1005. A silty sand with small limestone inclusions (context 1003) sealed Surface 1010. Deposit 1003 was in turn sealed by a layer of modern concrete (context 1002) and the existing tarmac road surface (context 1001).
