BANK YARD, RICHMOND
AN ARCHAEOLOGICAL EVALUATION
FOR
HOME HOUSING ASSOCIATION LTD

BANK YARD, RICHMOND – ARCHAEOLOGICAL IMPLICATIONS OF DEVELOPMENT

REPORT ON BOREHOLES AT BANK YARD RICHMOND, NORTH YORKSHIRE

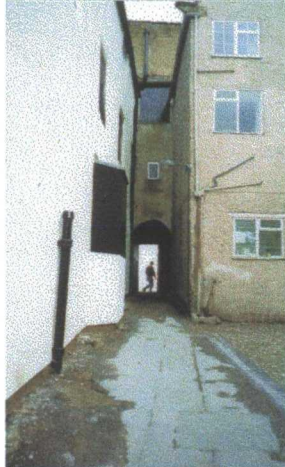
Plate 1 – Bank Yard looking east

1.1 Bank Yard, Richmond (see fig 2), is situated just off the western side of the semi-circular Market Place of the town. A passage runs back from the street, between two shops, which occupy a single nineteenth century frontage. From the rear it is apparent that this frontage has been superimposed upon two earlier buildings which extend further back on each side of the yard (Plate 1).

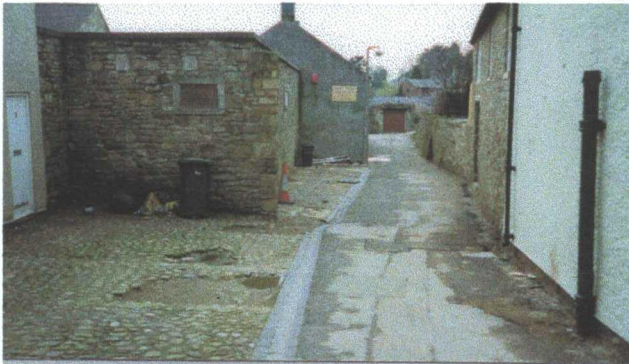
Plate 2 – Bank Yard looking west

1.2 Other buildings on the site are further west and consist of stone-built public conveniences, now closed, and a brick built former bakery (Plate 2)

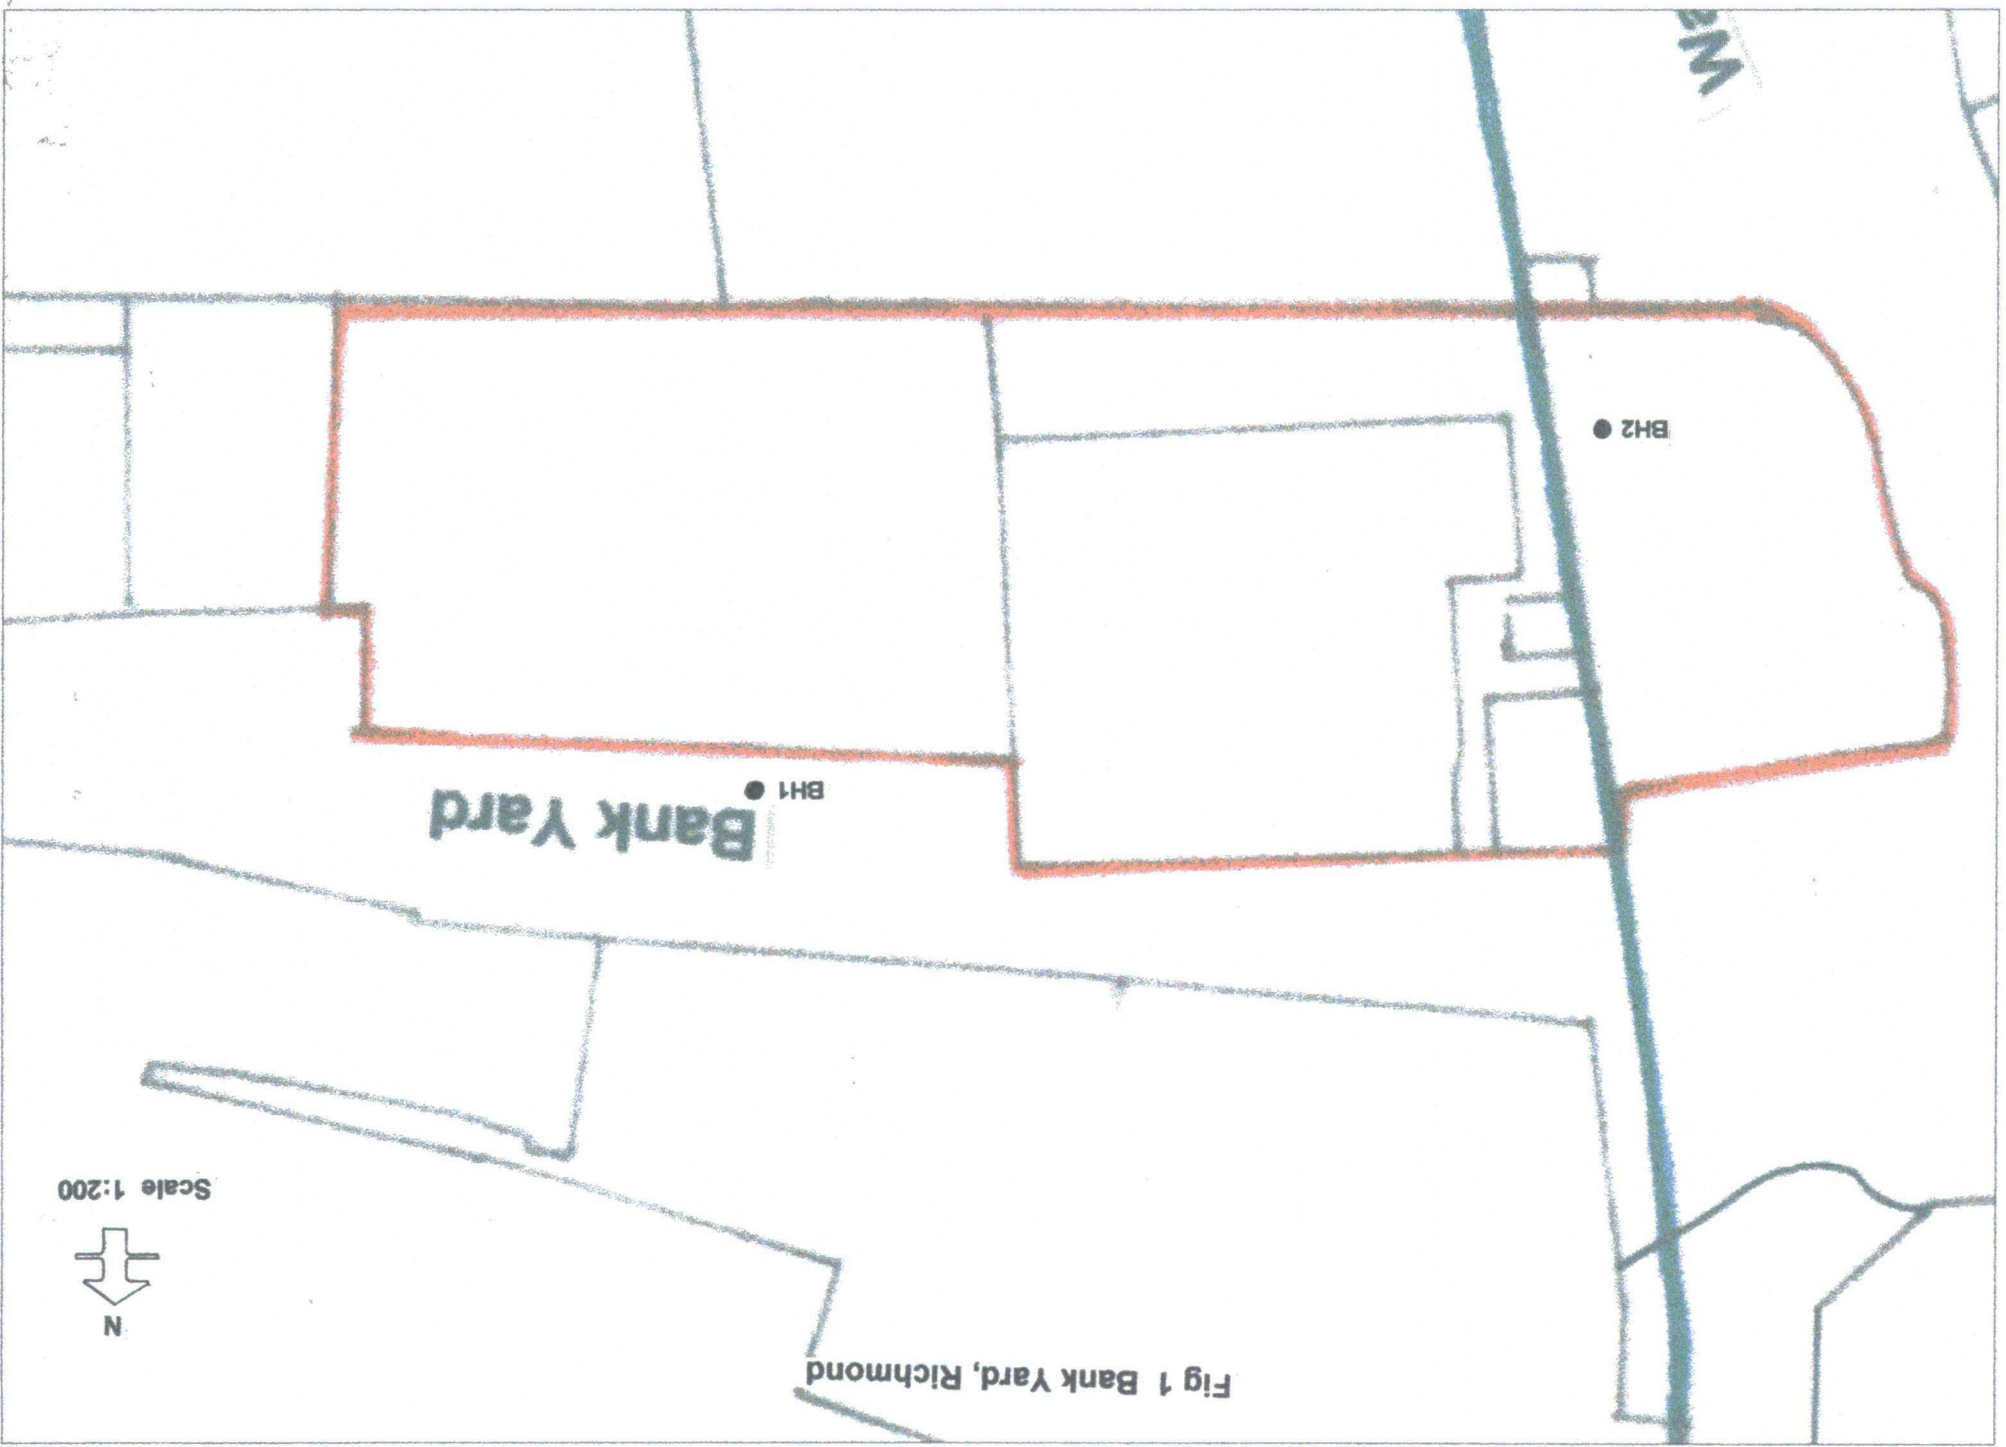
Fig 1 Bank Yard, Richmond

1.1 In advance of the proposed development at bank Yard, Richmond, site investigations were made by Moorehead Sutton and Laing. These consisted of two bore holes drilled on the site (see fig 1). One was located in the cobbles outside the former public conveniences (BH1), and the other was in the built-up area at the rear of the plot (BH2). The work was carried out on 19th April 1999 and was observed for any deposits of archaeological interest.

Bank Yard ● BH1

● BH2

- 2.1 The cobbles, which were set into dry concrete, were removed by hand and the borehole was started by hand digging. The settings for the cobbles reached to c.150mm below the surface. Beneath was a brownish grey dry gritty sand, containing some brick. From a depth of c.500mm the sand became darker; very dark grey to black; and contained small stones, fragments of cut wood and fragments of plastic. From about this depth a drilling machine was used to extract the soil from a core of between 100 and 150 mm in diameter.

- 3.1 The second bore hole was excavated in the same way as the first. An abortive start was made in the centre of the built-up area before establishing a position near to the southeastern edge of the area.
- 3.2 The surface was made up of gravel over loose stony silty sand containing brick, angular sandstone chips, glass and bone fragments. This continued to a depth of a little over 1 metre. Below was a darker brown silty sand with stones, bone and charcoal extending to approximately 2.5 metres.
- 3.3 By 2.65 metres the soil turned to soft, slightly dirty brown clay with some small stones. At the base of the bore hole at 4.5 metres sandstone bedrock was encountered.
