SAXTON CHURCH OF ENGLAND PRIMARY SCHOOL

AN ARCHAEOLOGICAL EVALUATION OSA REPORT No. 98EV09

National Grid Reference: SE 4758 3686

November 1998

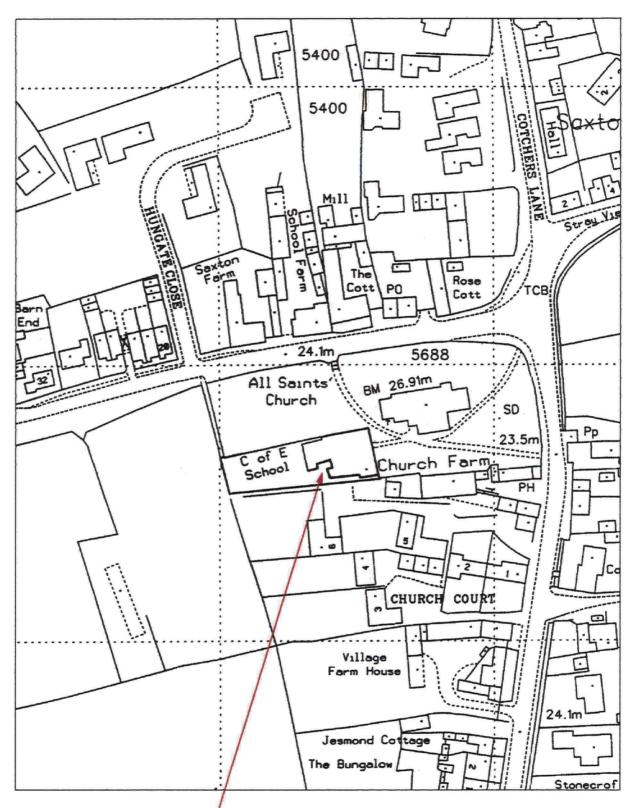
Figure 2. Location of evaluation trench.

A single trench was excavated, entirely by hand. This was L shaped in plan, measuring a total of 8 linear metres. This trench measured 0.80m in width and 0.80m in depth. Its dimensions and location were designed to take in the area of the proposed foundations for the school extension. The trench location is illustrated in Figure 2.

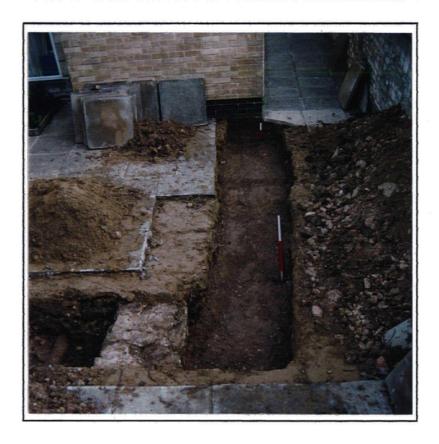
Contexts [1003] - [1004] represent the vestigial remains of a wall and the mortar / ash floor of a building (see plate 1). The floor [1004] was sealed by a mixed deposit of loose light brown sandy clay loam [1002] which was late 19th to early 20th century in date. This building is remembered by Mr and Mrs Roebuck, who act as the school caretakers and key-holders. It was a brick built washroom of Victorian date and was demolished in the 1960s when the school was extended. They have photographic records of this building in their possession.

Plate 1. General view from west showing modern features Scale of 1.00m

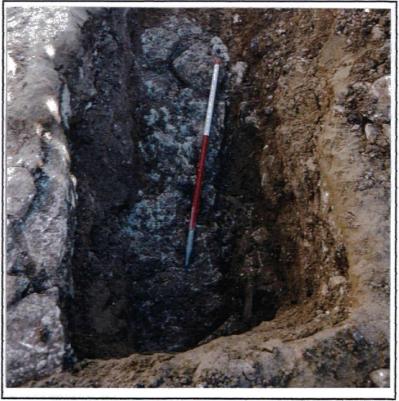
Context [1008] is undated but is stratigraphically earlier than the 19th century dump [1007] and may therefore be post medieval or perhaps earlier. The top of this feature was observed 0.80m BGL (25.47m AOD) at the base level of the proposed foundation trenches. It comprised a rough alignment of large angular limestone blocks set in a matrix of crushed limestone (see Figure 3 and plates 2 and 3). Although only partially within the excavation area its orientation appears to be approximately east / west. As this feature lay at the bottom level that was required for the purposes of this evaluation exercise it was not possible to undertake further excavation work in order to try and interpret this feature. Although it may represent the foundations of a building it is equally possible that it may be capping a grave. The east - west alignment gives some limited weight to this latter theory.

Plate 2. Detail of limestone feature [1008], scale 1.00m,

The excavation of the foundation trenches revealed traces of the floors and walls of a 19th school outhouse. Local people remember this building being demolished in the 1960s. The only feature of any archaeological significance was an alignment of limestone boulders set in crushed limestone at the base level of the foundation trench. This has been tentatively interpreted as a possible capping for a grave. It is recommended that this feature should be left in situ when the proposed new foundations are constructed.

Given that the only feature of archaeological potential was uncovered at the base level of the proposed foundations and will not be affected by them, on the basis of the evidence of this evaluation exercise it is the opinion of this author that the proposed development will not impact on any archaeological features or deposits.

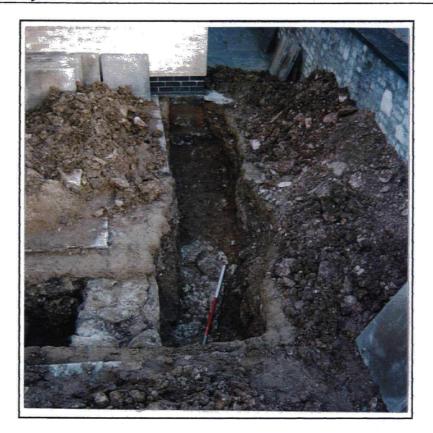
It was clear that all of the deposits that were excavated to the prescribed depth of 0.80m BGL were 19th century or later. The limestone alignment observed at the base level [1008] is probably earlier than that date on the basis of the stratigraphic evidence although as no dateable material was excavated this cannot be a certainty. It seems definite therefore that if deposits of pre-Conquest date exist on this part of the site that they are lower than 0.80m BGL (25.47m AOD).

It was equally clear that no human remains or grave cuts were present within the area of the proposed foundation trenches. The single limestone feature that was observed at the base level of the excavation may perhaps be interpreted as the capping of a grave. The fact however that no disarticulated human remain were recovered during the excavation work would perhaps indicate that burials never did take place on this southern perimeter of the site, even when it was part of the churchyard, prior to the construction of the first school in the 1860s.

Plate 3. General view of excavation from west at completion level. Scale of 1.00m

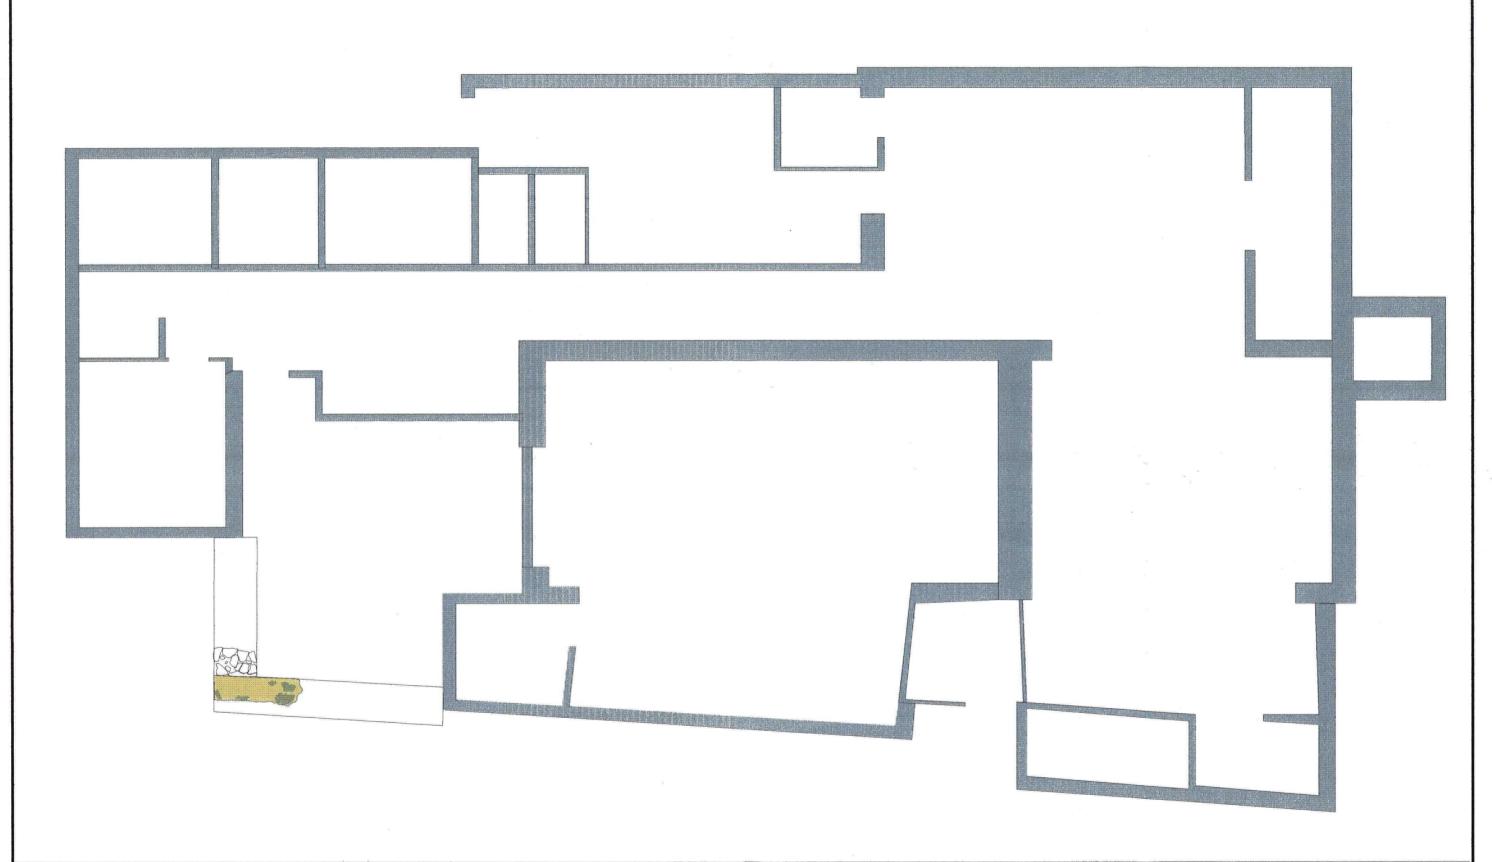
Figure 3

Location of evaluation trench, Saxton Primary School

[1008] Limestone feature
