**Cowling Road
Cowling and Burrill
Nr Bedaie
North Yorkshire
(SE 2375 8750)**

Archaeological Watching Brief Report

**MAP
2004**

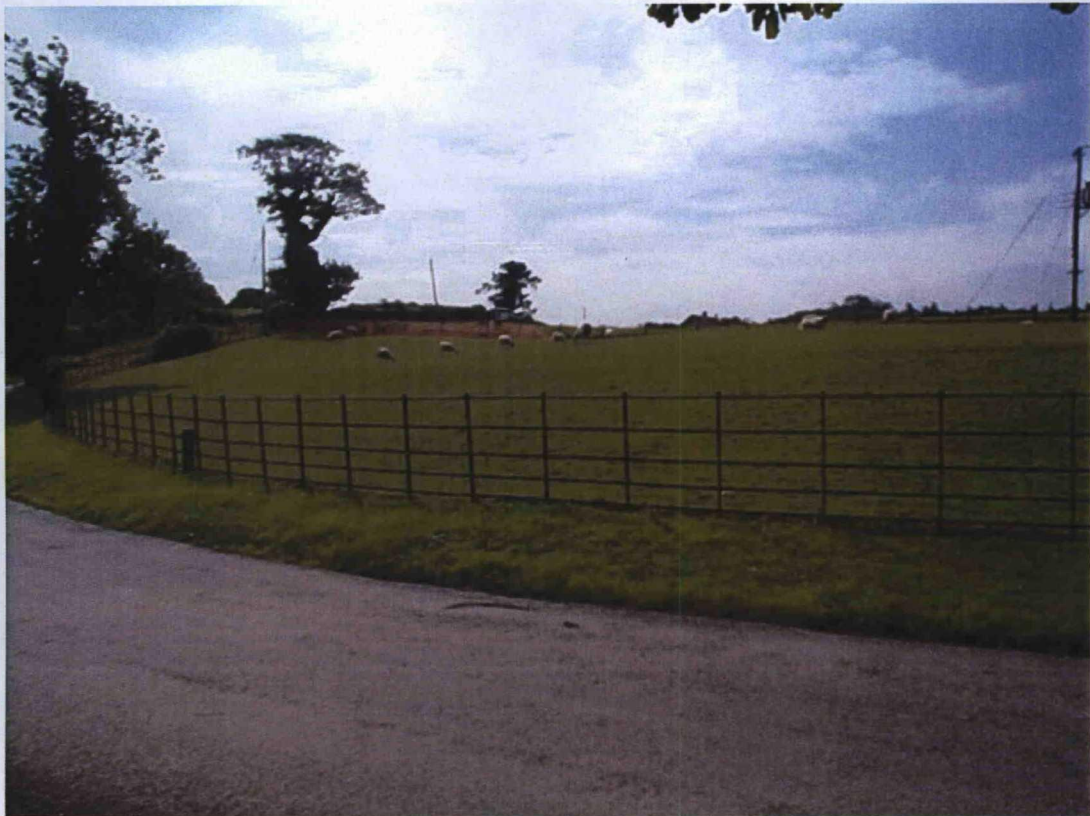
- 5.1 Excavations in the field to the south of Cowling revealed a 0.10m deep deposit of turf and topsoil (context 1000). This sealed a deposit of mid grey-brown silty natural subsoil that extended to the base of the trench (context 1001). Deposit 1000 contained one sherd of Nottingham type stoneware and one sherd of marbled slipware, both dating to the 18th century. No archaeological features or deposits were identified.

Plate 1. General view of Cowling Road and trench field, facing South East

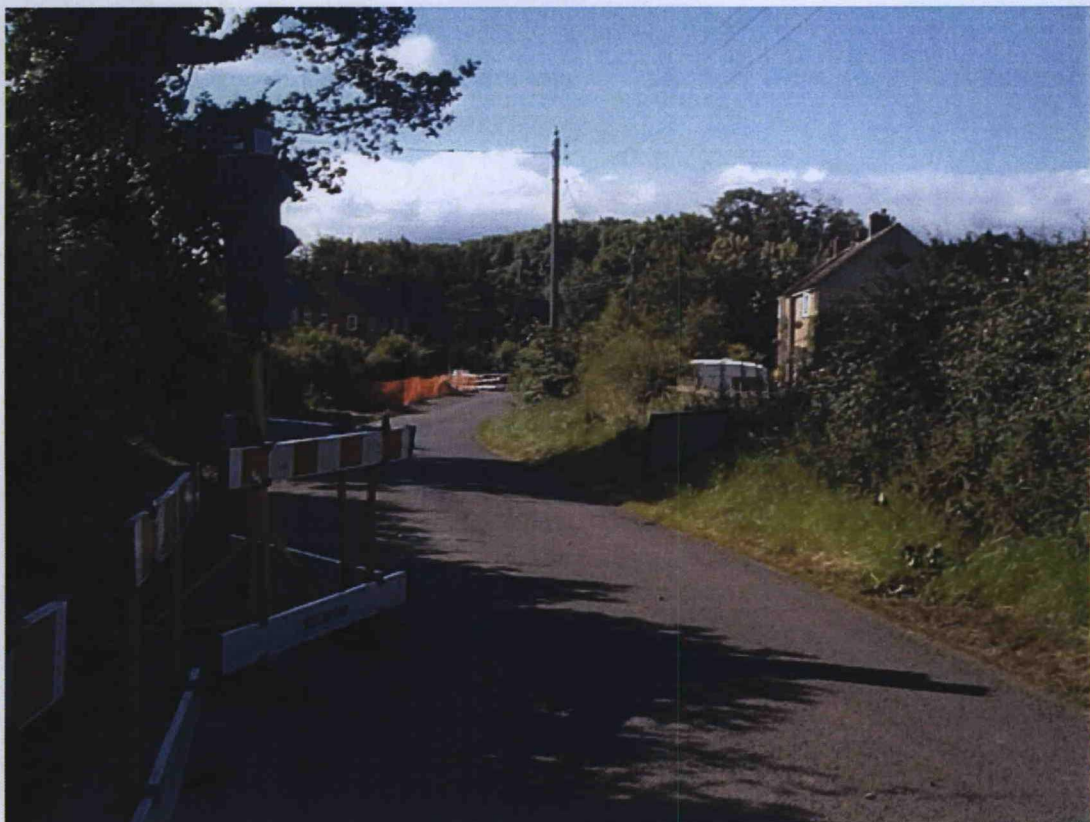
- 5.2 The trench was carried across Cowling Road and was then excavated along the eastern edge of the carriageway as far as Burrill. This section of the trench revealed a 0.10m tarmac and modern hardcore road surface (context 1002) overlying a second 0.20m deposit of hardcore (context 1003). Below the road make-up was a natural silty subsoil (Deposit 1001).

Plate 2. View of Cowling to Burrill stretch of road, facing South

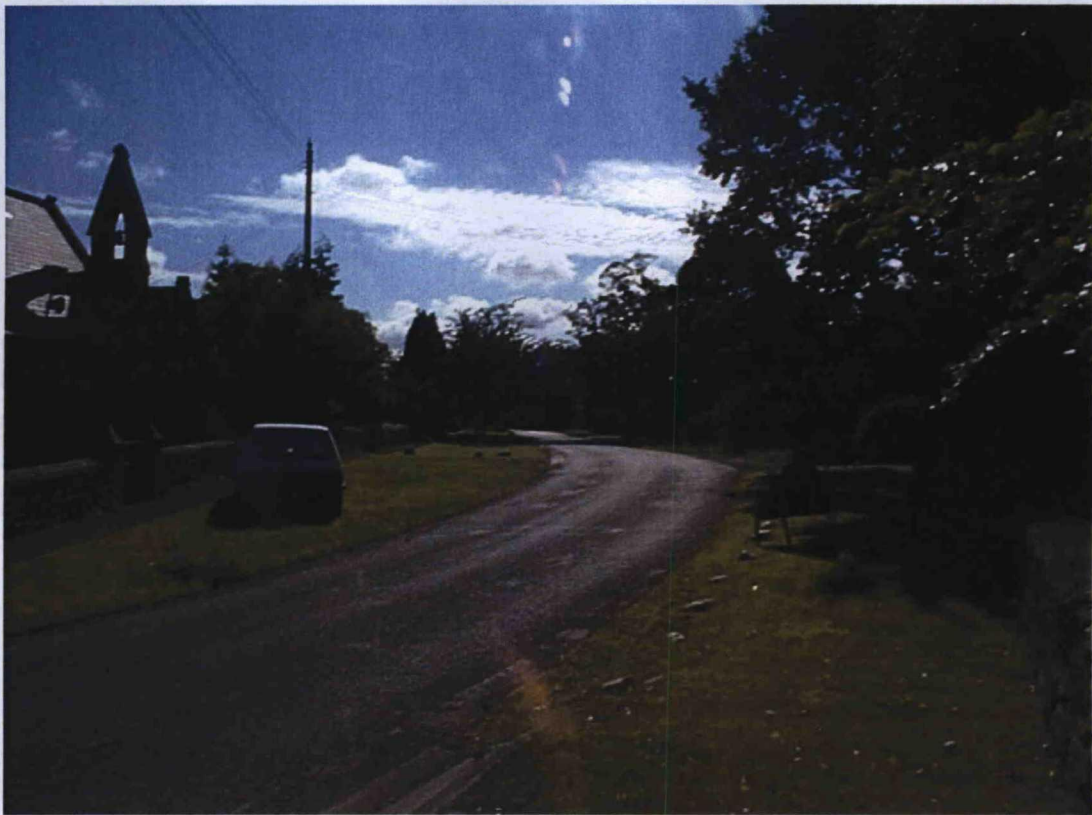
Plate 3. Burrill village, showing area of former green, facing East

deposits. As the Ordnance Survey First Edition map shows, the central part of the current excavation took place on what was until relatively recently open space formed by the village green at the heart of the village. Consequently, no structural remains were encountered. If the buried remains of earlier village buildings survive, they are more likely to be located closer to the existing buildings at the limits of the former village green.

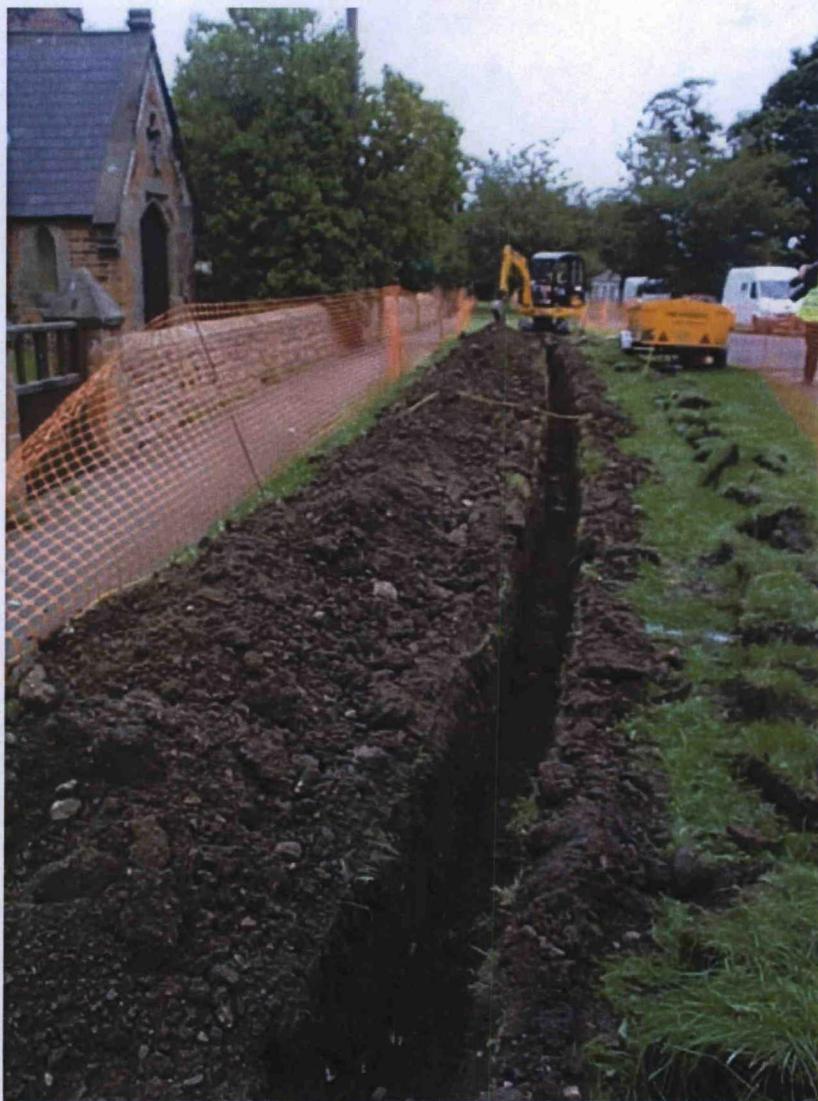
- 5.3 Within the village of Burrill itself, the road widened out and had large grass verges on either side. The cable trench was excavated through the northern verge as far as the junction with the Bedale road. Excavations revealed a 0.10m deep deposit of turf and topsoil (context 1004), which sealed a 0.30m deep deposit of dark grey-brown humic subsoil (context 1005). Deposit 1005 in turn sealed the underlying natural subsoil (Deposit 1001).

- 5.4 Deposit 1005 was only observed within the main built-up focus of the village, and contained sherds of blue and white transfer ware, marbled slipware, Nottingham type stoneware and black wares, that ranged in date from the mid 18th century to circa 1900. The deposit clearly represented occupation detritus and other material that had built up in the village centre over the past two or three centuries.

Plate 4. Burrill village excavation through roadside verge, facing East

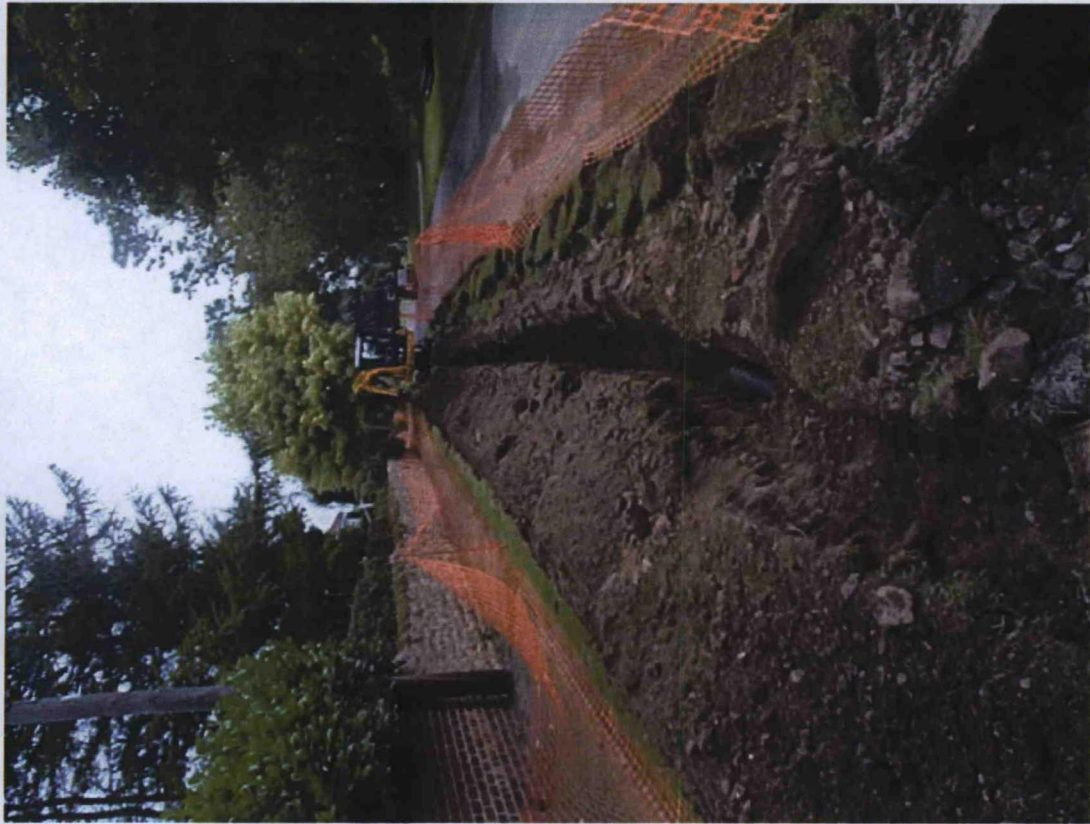
Plate 5. Burrill village excavation through roadside verge, facing East

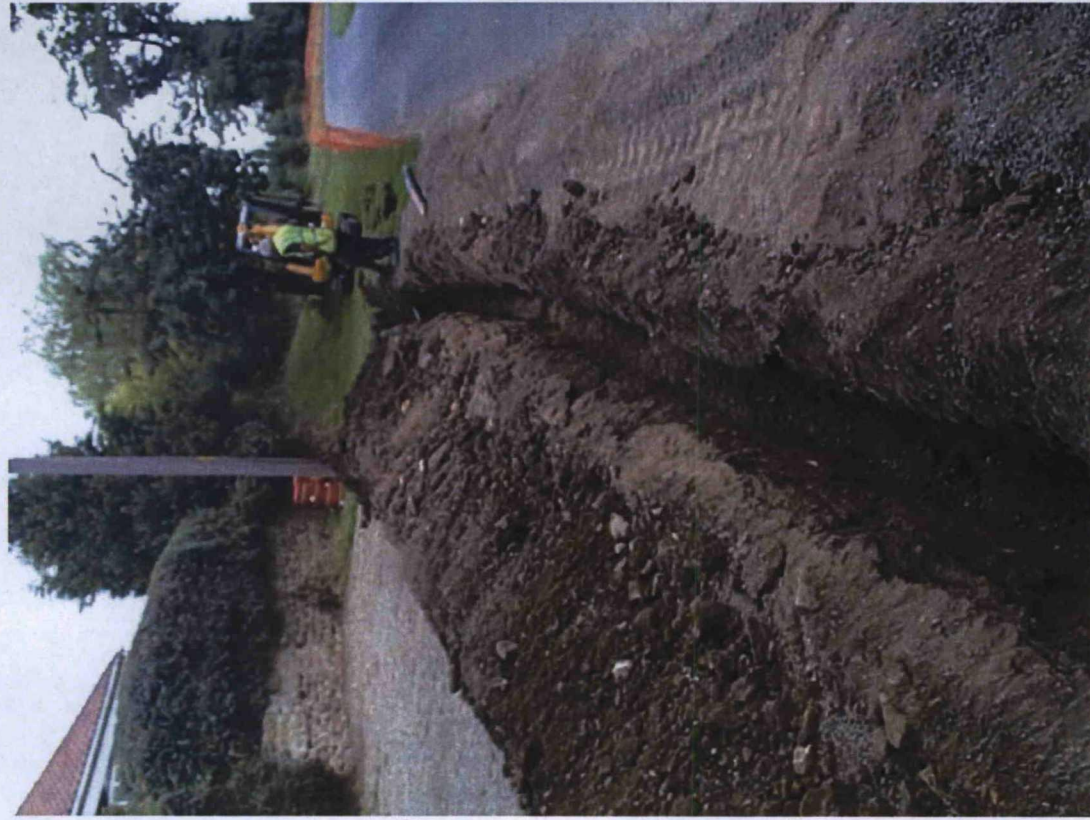
Plate 6. Burrill village excavation through roadside verge, facing East

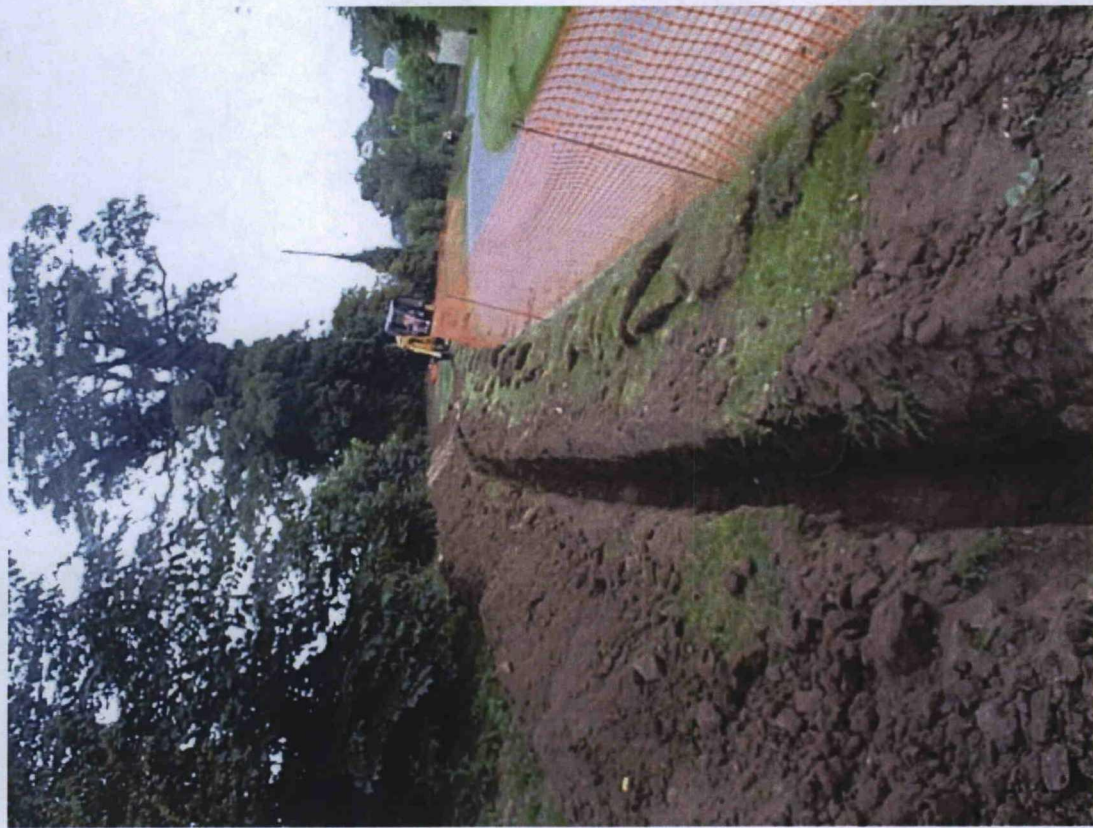
Plate 7. Burrill cable trench to east of village centre, facing East

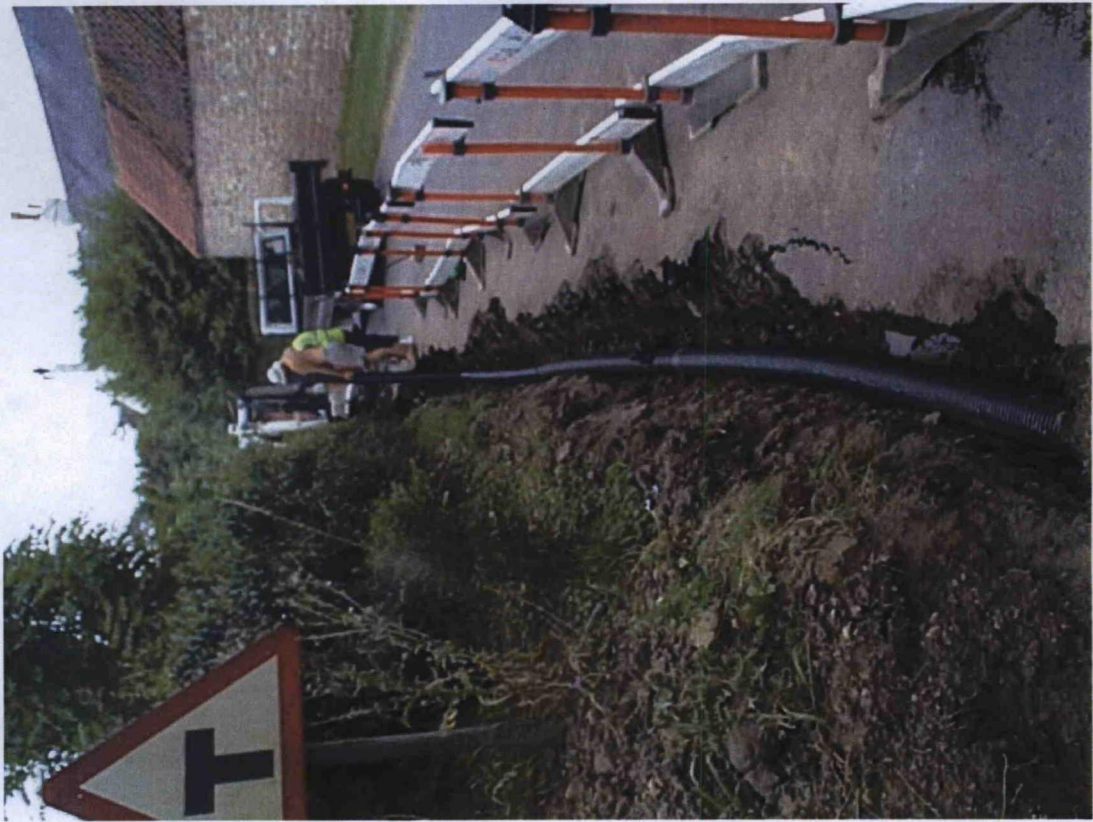
Plate 8. View of cable trench close to junction of Cowling and Bedale roads
