HALL GARTH FARM

ARCHAEOLOGICAL EVALUATION

**HALL GARTH FARM
BIRKIN
NORTH YORKSHIRE**

**SITE CODE: BHG04
NGR: SE 5310 2655**

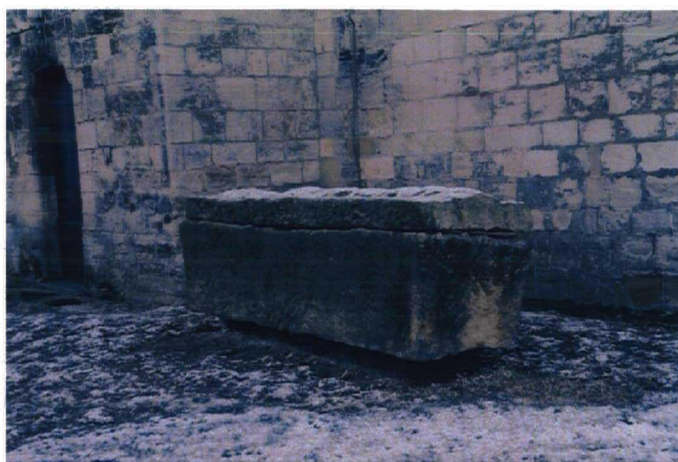
Plate 1 Roman sarcophagus outside St Mary's church

Hall Garth lies on the northern bank of the Old Eye, shortly before it joins the River Aire to the southeast. Little is known of the early history of the immediate area, though the discovery of a stone sarcophagus, of Roman date in a nearby field, may indicate Roman activity in the area (YAJ 1901; find spot in a field centred at SE 5445 2690: NYSMR card index). The millstone grit sarcophagus is now located at the northwest corner of the St Mary's Church (Plate 1).

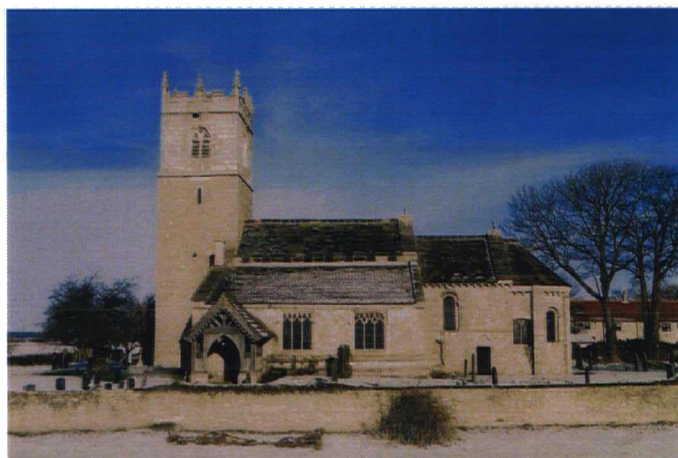
Plate 2 St Mary's church looking north

Historical studies of Birkin are somewhat dominated by St Mary's church, considered by Pevsner to be 'one of the most impressive Norman churches in Yorkshire', and retaining much of its Norman plan and structure (Pevsner 1959, 104) (Plate 2). The church is a Grade I listed building, and was previously held under the patronage of the families of Byrkin and Everingham (Forrest 1871, 88).

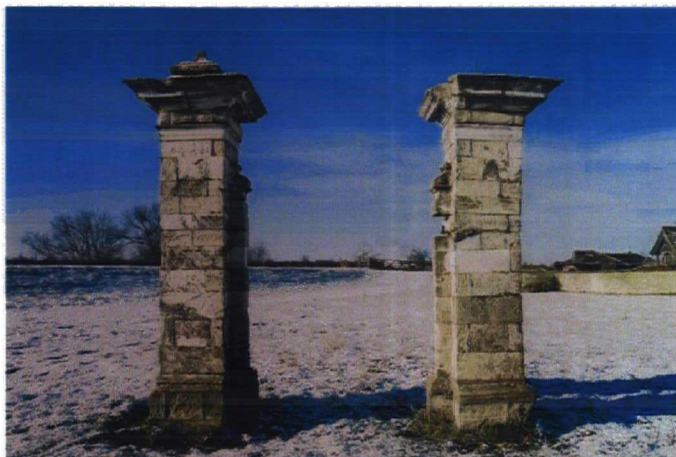
Plate 4 Late 17th century gateposts

Mary's Church, and have been compared to similar examples at Kellington dated to *c.*1698 (Pevsner 1959, 105). They are described as plain piers with a pulvinated frieze and stepped cornice with ball finials (NYM 9913) (Plate 4).

The date at which the hall was demolished is not known. The existence of late 17th century pillars has led to the assumption that the hall would have remained in existence into the 18th century. Church Hill Cottages, which survived on the site into the 1960s, are thought to have been constructed on the earlier location of the hall, and are marked as such on the Ordnance Survey map of 1907 (see Plate 3). Prior to their demolition at some point in the 1960s, a 'coursed plinth of an earlier building' was observed, incorporated in the north and south fronts of the brick-built cottages (NYSMR card index). Other than these cottages, and buildings to the north of the churchyard, no structures are shown on the earliest maps consulted: the 1845 tithe map and the 1850s Ordnance Survey edition.
