St.GREGORY'S CHURCH NORTH END BEDALE

A Report on an Archaeological Watching Brief

ST GREGORY'S CHURCH, NORTH END, BEDALE, NORTH YORKSHIRE.

A REPORT ON AN
ARCHAEOLOGICAL WATCHING BRIEF

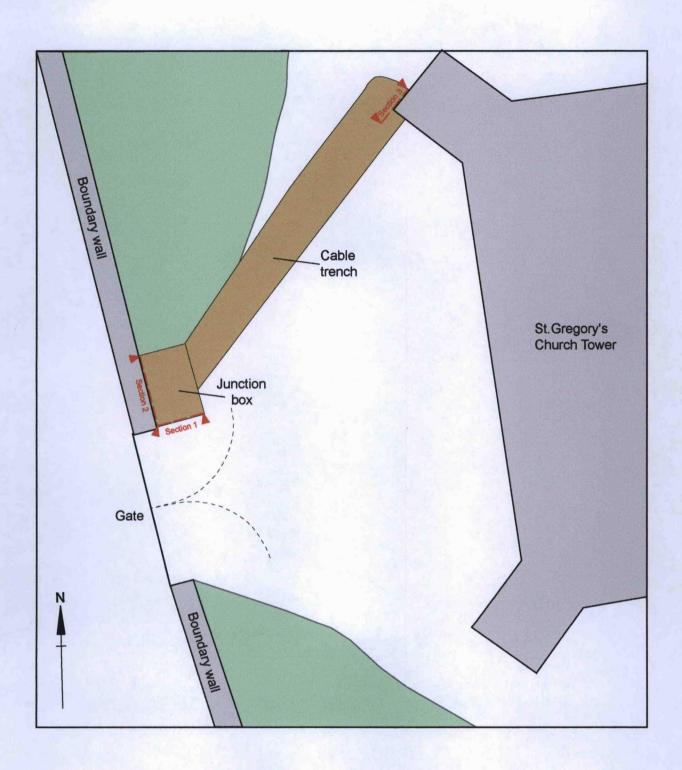
The junction box was located on the east side of the boundary wall, at the north side of a gate into the churchyard, west of the tower. It measured $1.3m \times 0.9m \times 0.55m$ in depth and was excavated by hand. The trench for the cable was excavated from the junction box to the north-west comer of the tower and measured $6.5m \times 0.8m \times 0.5m$.

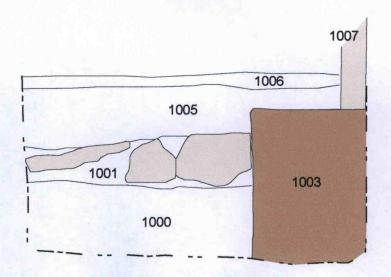
Section 1, against boundary wall

The earliest deposit located within the trench was a friable mid-grey brown silt sand with occasional stone fragments and charcoal flecks (1000) (see Section 1). Embedded in this deposit in the southern half of the trench was a series of large sandstone cobbles and sub-rectangular sandstone slabs (1001). They appeared to have been split to produce a flat surface and appeared to have been cut through by the brick foundation of the gate into the churchyard. It is possible that these sandstone blocks represent an earlier path or yard. The northern end of the trench had been disturbed by the excavation of a service trench and the deposits within it consisted of mixed, friable dark grey brown silt sand with inclusions of sandstone fragments and mortar flecks (1002).

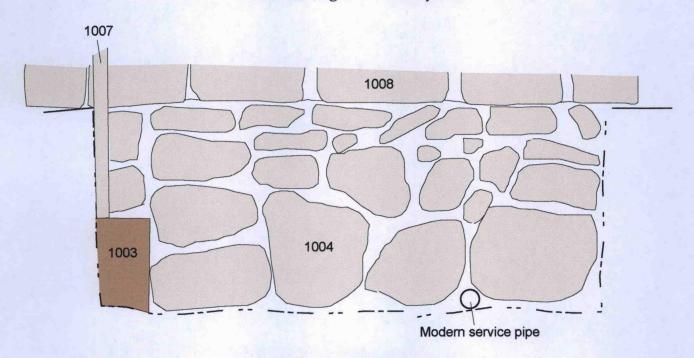
Section 2, along boundary wall

The west side of the trench (Section 2) was formed by the foundations of the existing church boundary wall (1004) and the brick foundations for the gate into the churchyard (1003). The foundations of the wall (1004) consisted of large, sub-rounded sandstone cobbles bonded in a hard white mortar laid in roughly four courses with the spaces between the larger stones filled with smaller stone fragments. These foundations overlay the brick plinth foundation of the gate (1003). The bricks in the foundations for the gate measured 220mm x 100mm x 80mm and were bounded with a hard white mortar. Bonded to this was the dressed stone of the gate post (1007). It is probable that the gate and the boundary wall (1008) are of contemporary construction.

Directly above the brick foundations and the sandstone cobble path was a deposit of friable, dark grey silt sand (1005) with flecks of mortar that was overlain by the pea grit gravel of the present church path (1006).
