TANFIELD BRIDGE WEST TANFIELD NORTH YORKSHIRE

A Report on an Archaeological Watching Brief

REPORT NUMBER 2004/69

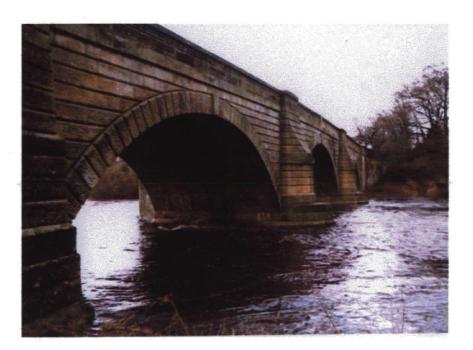
Cover illustration: The east side of Tanfield Bridge, from the north bank of the River Ure

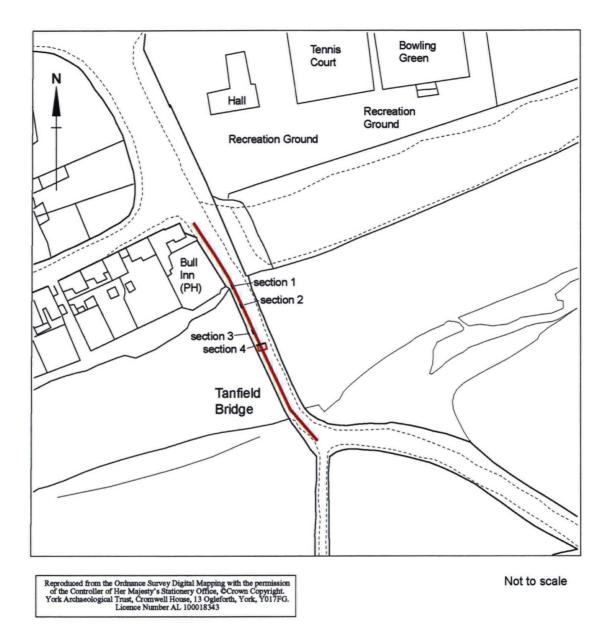
Fig. 2: Location of trench observed during the watching brief with approximate locations for the sections.

A hand and machine-dug trench was excavated to a maximum depth of 0.71m below ground level. The trench was located c.2m from the west side of the bridge and was observed for the whole length of the bridge. Three sections were recorded in the trench, two at points where the nature of the archaeology was seen to change (Fig.2). An exploratory test pit was located 1.30m north-east of the boundary stone marking the centre of the bridge. This test pit measured 1.10m by 47m and a section (Section 4; Fig.3) within it was recorded.

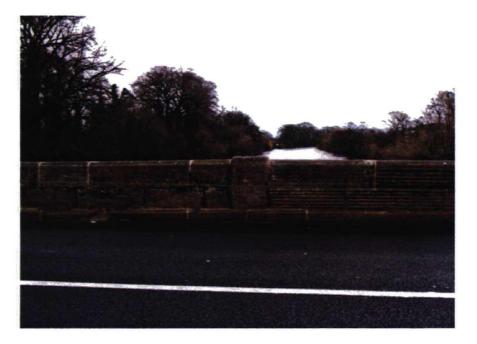
Plate 2: The inner, west side of Tanfield Bridge from showing the division between the North and West Ridings

The date of either late 18th century or 1842 for the widening is proposed by Eric Branse-Instone in his report for the English Heritage Monument Protection Programme following an inspection of the bridge in 2002. The boundary at the centre of the bridge is marked by an inscription on the inner face of each side of the bridge. The stone on the upstream side reads 'Division of the W. and N. Riding' and the stone on the downstream side reads 'Division of the N. and W. Riding' (Plates 2 and 3).

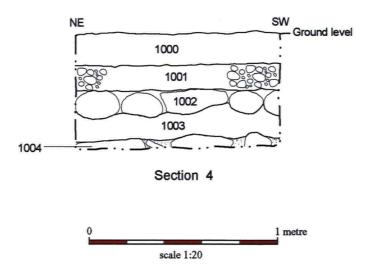
Fig. 3: Sections 1, 3 and 4.

The section through the north-western end of the trench (Section 1, Fig. 3) revealed redeposited natural (1005) beneath the tarmac (1000) at 0.11m below ground level to the base of the trench at 0.71m (Fig. 3). Context 1005 consisted of small, medium and large cobbles within a matrix of pale to mid grey brown and pale orange brown, coarse-grained sand.

Two additional sections were recorded within this trench. Section 2 revealed that the deposits were identical to those recorded in Section 1. However, Section 3 (Fig. 3), recorded 9.30m from the north-western edge of the bridge was positioned at the point where additional deposits were encountered. This section recorded 80mm of mortared cobbles (1009) at the base of the trench beneath dark coarse river sand (1008) appearing at 0.42m below ground level. This deposit was 0.15m in depth on the south-eastern edge of the trench and gradually sloped down towards the base of the trench on the north-west side. Lain on this deposit were cobble setts (1007) beneath re-deposited natural (1005) and tarmac (1000).

A test pit was excavated 1.3m north-east of the boundary marker in the centre of the bridge and the south-east facing section (Section 4, Fig 3) revealed the continuation of 80mm of mortared cobbles (1004) beneath 0.13m of dark coarse river sand (1003). Again, lain on this deposit were the cobble setts (1002) which measured 0.13m in depth. These context were underlying 0.12m of hardcore (1001) and 0.17m of tarmac (1000). The observation of the trench excavation revealed that the cobbled setts continued for a further 10.80m towards the south-eastern end of the bridge.

This watching brief encountered an earlier road surfaces found existing beneath the modern tarmac, although no dating evidence was found for this surface. Section 3 revealed that these deposits did not extend the full length of the trench as there appear to have been disturbed by modern deposits. Contexts 1002 and 1007 represent the road surface and context 1003 and 1008 are the sand bedding. Context 1004 and 1009 are compact mortared cobble, these are thought to be the infill of the stone piers which support the arches of the bridge
