# 189a HIGH STREET NORTHALLERTON NORTH YORKSHIRE

## A Report on an Archaeological Watching Brief

**189a HIGH STREET  
NORTHALLERTON,  
NORTH YORKSHIRE**

**A REPORT ON AN ARCHAEOLOGICAL  
WATCHING BRIEF**

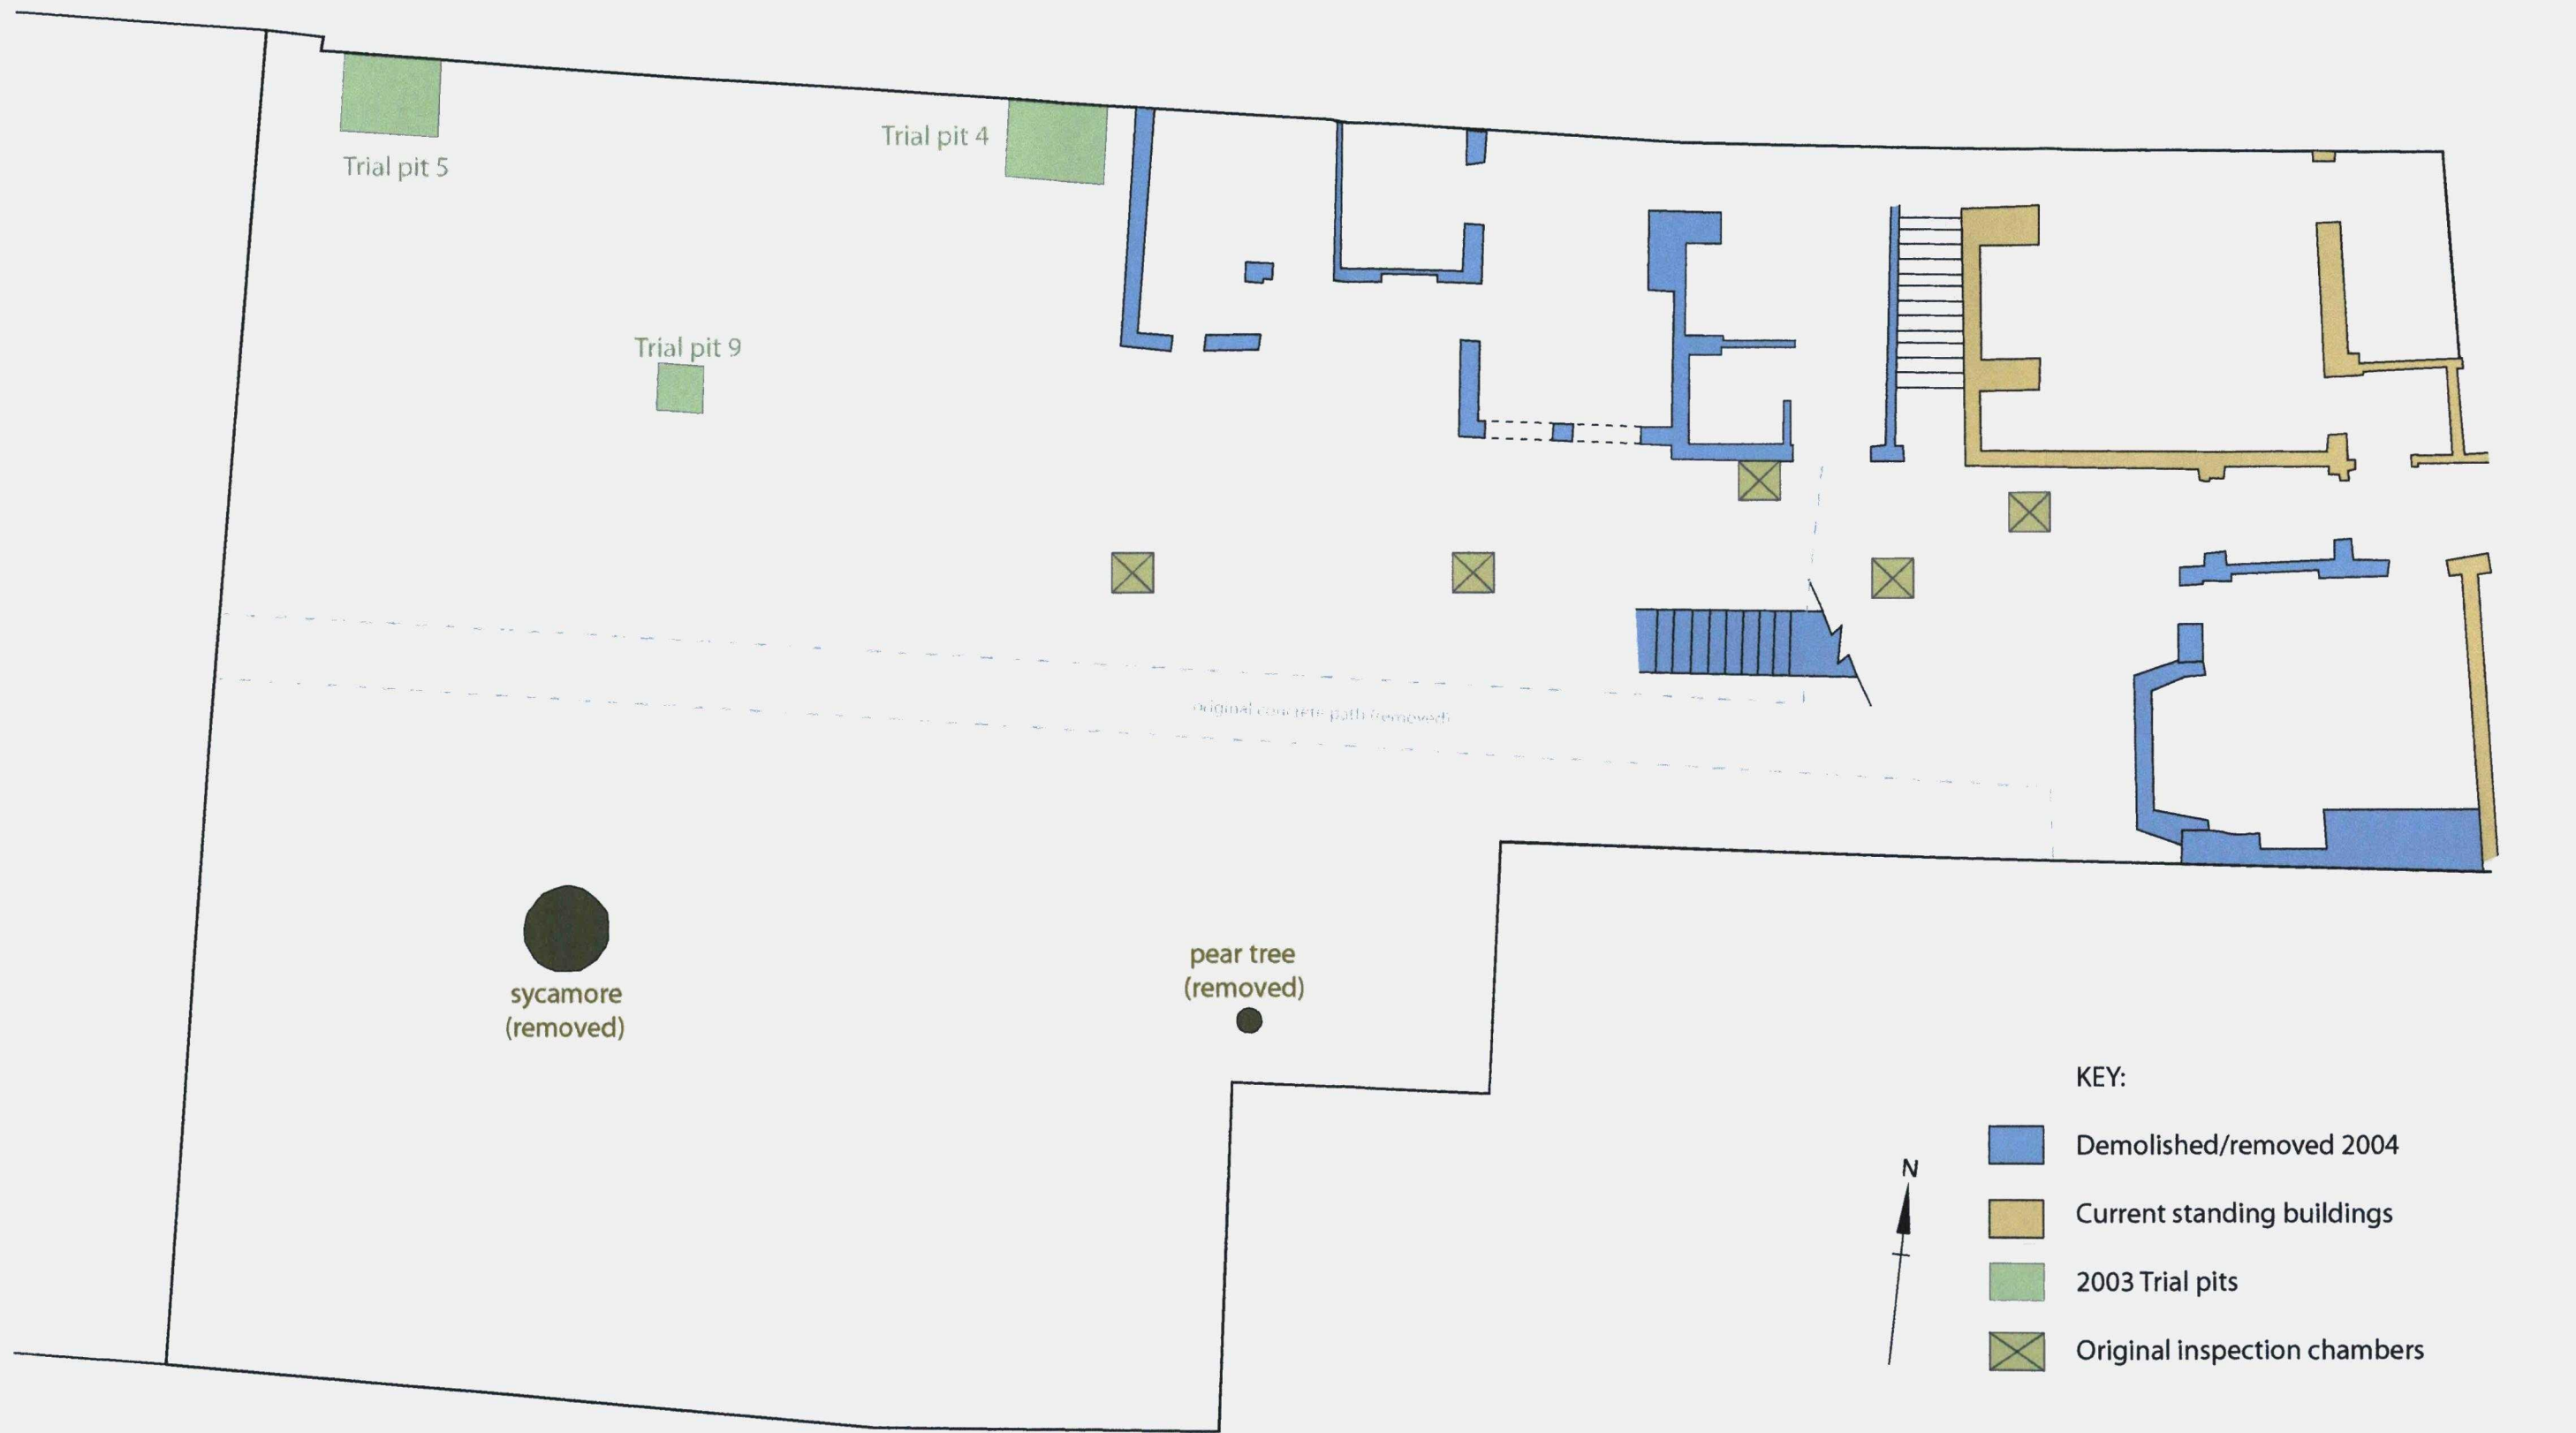
Fig.2 Building layout and 2003 excavations discussed in text

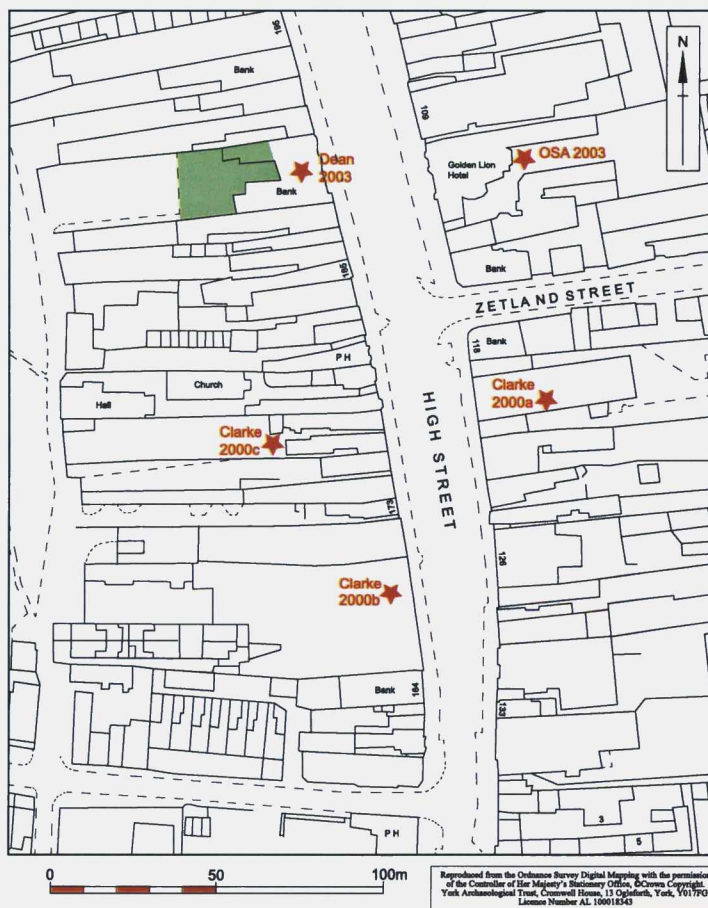
Fig. 4 Previous archaeological observations around current site (shaded) discussed in text

Archaeological work in Northallerton has shown that buried deposits do survive in the area around the High Street. An evaluation to the east of the High Street in East Road exposed medieval pits and structural features (Taylor-Wilson 2000). At 120-120a High Street an archaeological watching brief did not identify any archaeological deposits (Clarke 2000a) but at 167-170 High Street a 19<sup>th</sup> century garden soil was exposed directly above a truncated natural subsoil (Clarke 2000b). Post-medieval structural remains were observed during a watching brief at the rear of 176 High Street (Clarke 2000c). At the Golden Lion public house a watching brief identified medieval material (OSA 2003). A previous watching brief at 189a High Street, Northallerton (Dean 2003) within the building and the yard exposed

a variety of archaeological deposits. Within the building there was evidence for earlier floor surfaces and in a pit adjacent to the northern wall of the property the foundations for an earlier building. Within the yard at the rear of the property, test pits suggested that there was evidence for post-medieval structures and yards surviving.

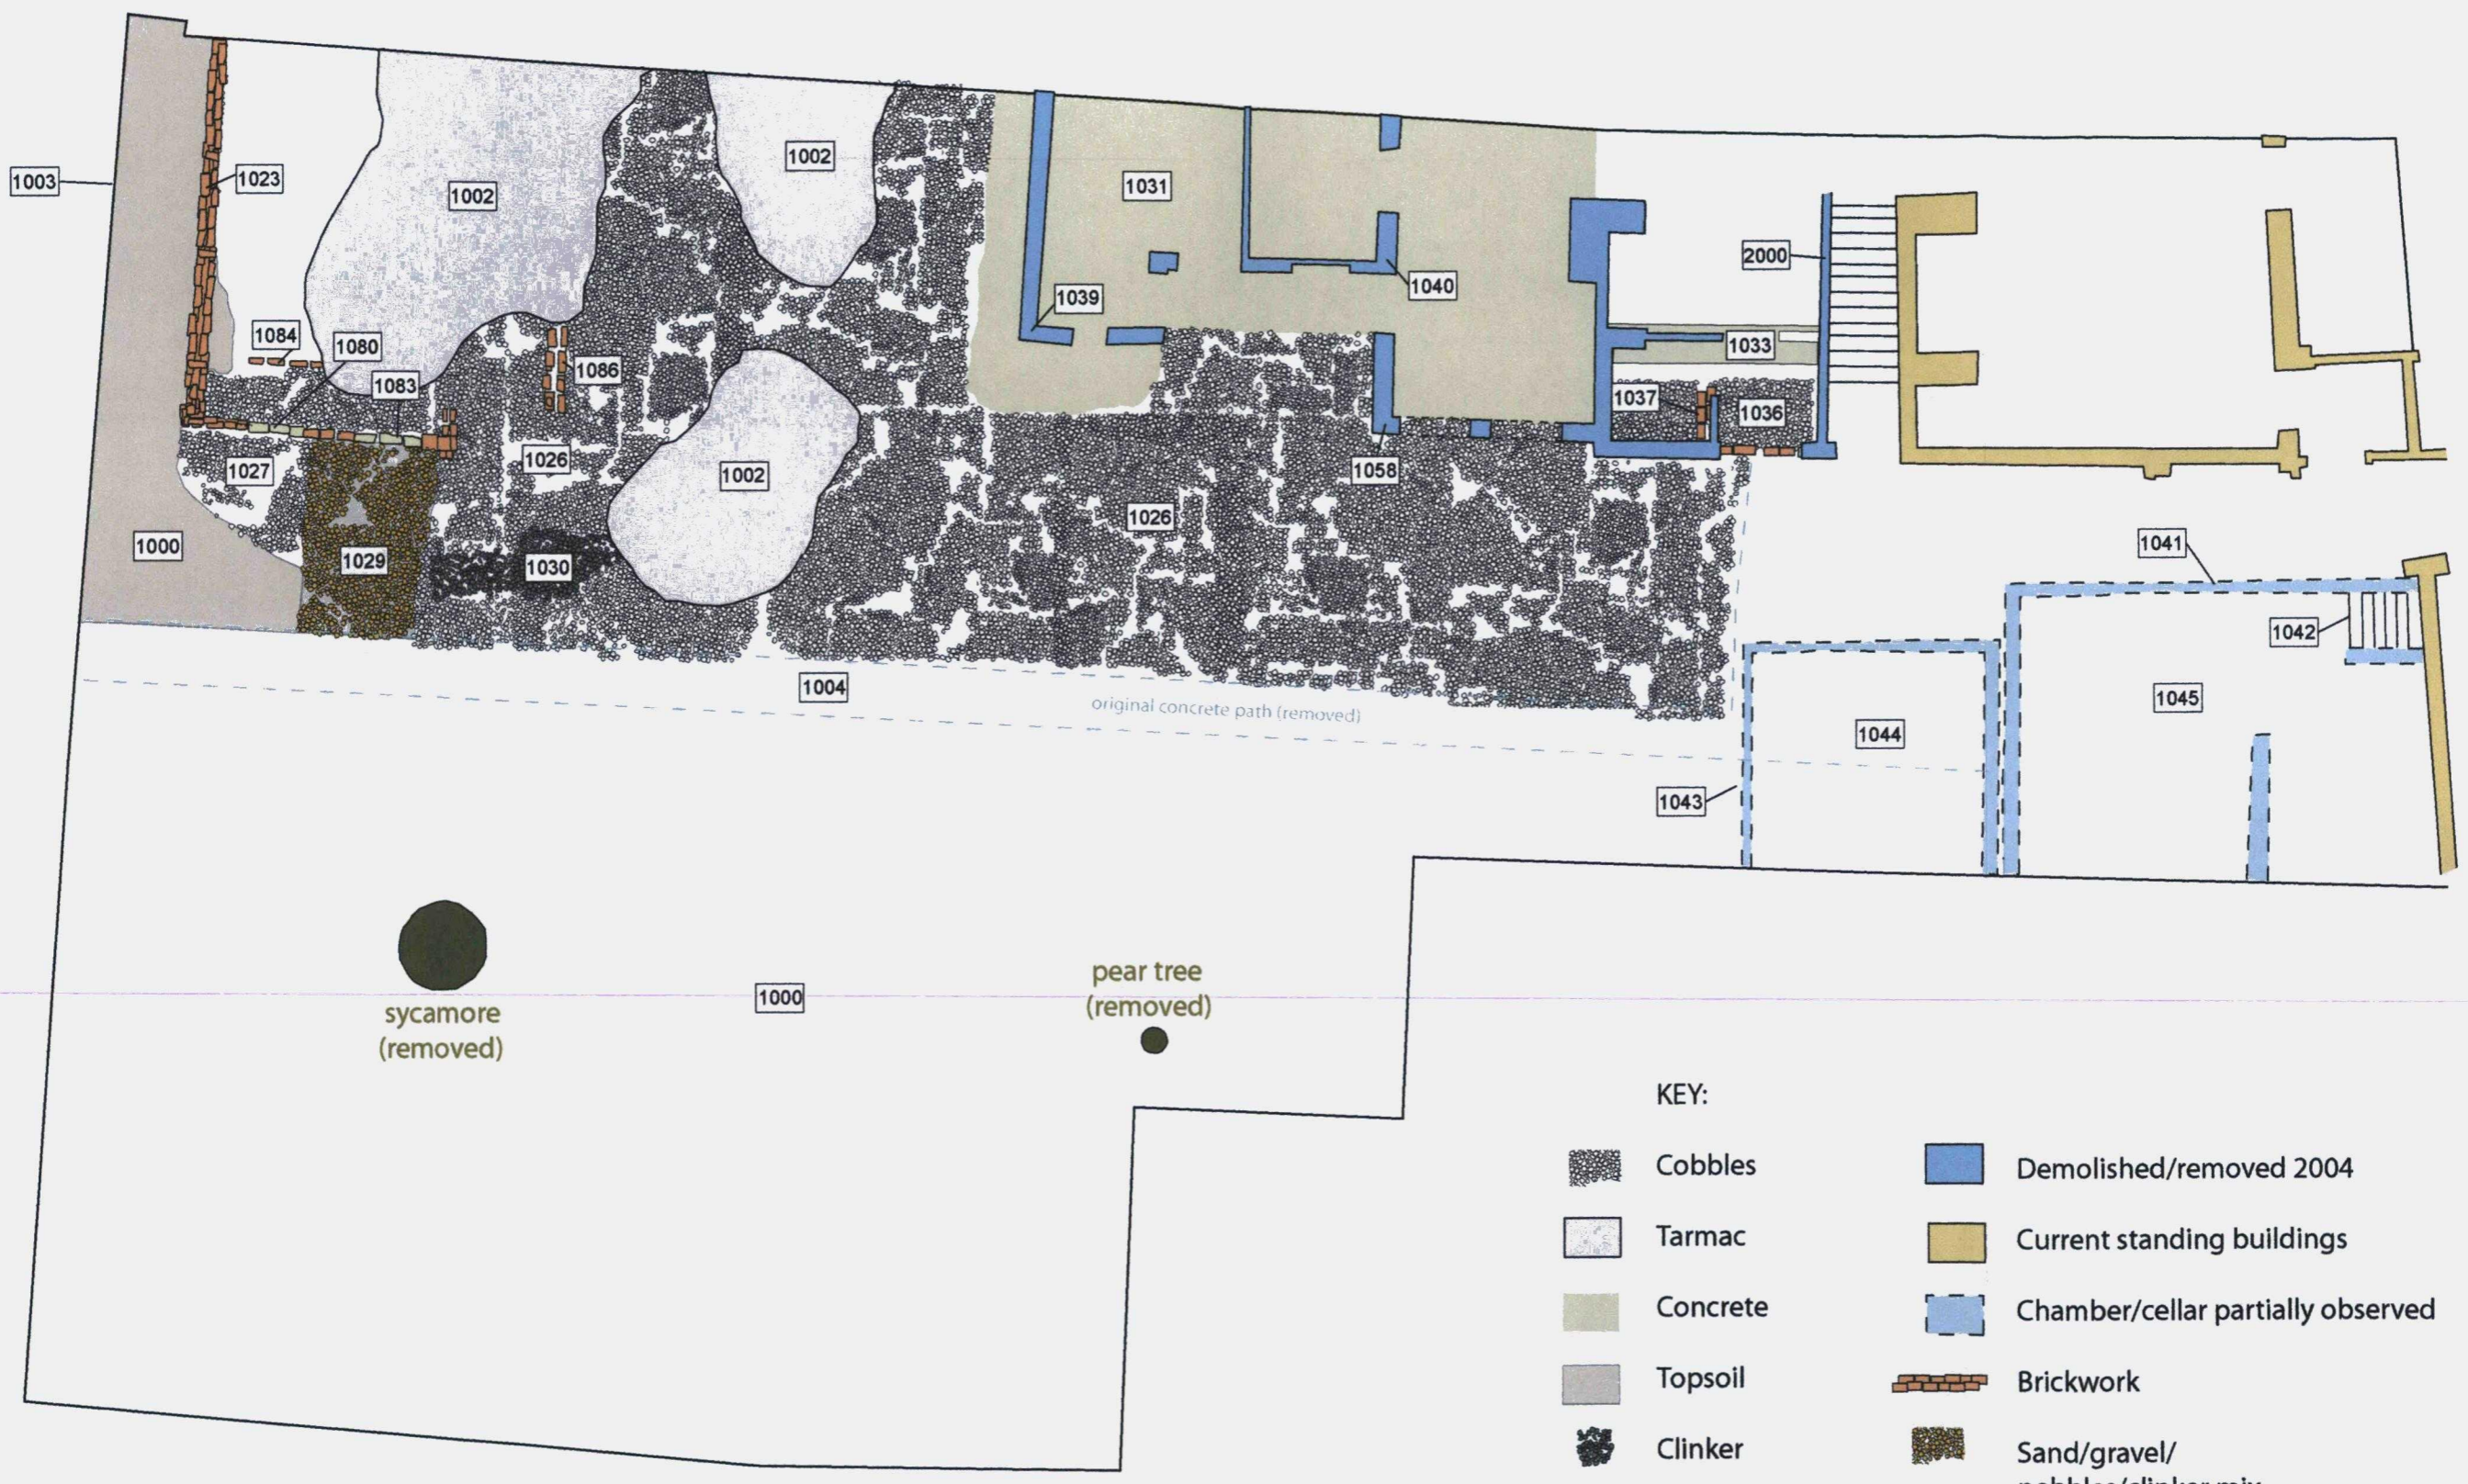
Fig.7 Composite plan of features observed during ground reduction

The earliest archaeological deposit exposed was the well-preserved remains of a cobbled yard surface (1026, 1027 and 1036). This cobbled yard was observed in the whole of the area defined by the kerb stones on the western edge of the site, the demolished buildings (1038 and 1040), the boundary wall to the north, and the line of the concrete path (1028) to the south, and extended to the rear of the upstanding buildings of 189a High Street. This cobbled yard consisted of evenly sized sub-rounded cobbles set within a firm dark grey silt with frequent inclusions of clinker.

The foundations for the demolished structure (1038) cut through the cobbled surface 1026. Structures 1038 and 1040 are probably contemporary and it is reasonable to assume that both are alterations to 189a High Street. The northern and western areas of Structures 1038 and 1040 had a concrete floor (1031).

At the western limit of the yard area adjacent to the car park there were the remains of a structure that is shown on the 18<sup>th</sup> century map and the 1911 Ordnance Survey map. Three walls of this structure (1023, 1080 and 1081) were defined in the top soil strip. Wall 1023 was the external wall on the western side of the building and was aligned north-south. The wall was constructed from bricks measuring 220mm x 80mm x 100mm set in a soft white mortar. This wall survived to a height of three courses laid in two courses of headers separated by one course of stretchers. The internal face of the wall was lined with a hard pink grey plaster covered by blue paint. Butting against the inside of the wall was a tiled floor (1022) that was directly below the topsoil (1000). This floor was only exposed in one area against the western wall of the building and the majority of the area within the building consisted of cobbles (1082). This wall forms part of the structure observed in Test Pit 5 in the 2003 watching brief (Dean 2003).

Bonded to this wall was the southern external wall aligned east-west (1080). Unlike Wall 1023 this wall had a series of doorways into it. The brick work at the western end where it was bonded to Wall 1026 consisted of bricks of the same dimensions bonded in the same courses and mortar. The doorways were defined by sandstone slabs that formed thresholds into the building. The first of these (1081) was at the western end of the wall, 0.8m from the corner with Wall 1026 and consisted of two sandstone slabs. One slab measured 0.4 x 0.2m and the other slab measured 0.5m x 0.2m. The doorway was 0.9m wide and was separated from the next door by the base of a brick column, 300mm wide, constructed of two bricks adjacent to each other with a third brick laid across the end. The next doorway (1083) was 1.5m wide and the threshold consisted of three sandstone blocks. The largest of these sandstone blocks was 0.6m long and 0.2m wide. The other two blocks in the threshold were 0.7m long and 0.4m long and again 0.3m wide. All of the thresholds showed signs of wear. An exploratory trench

excavated on the outside of wall 1023 exposed two York stone slabs (2030 and 2031) abutting the wall 0.4m BGL.

A possible internal wall (1084) was exposed 0.9m to the north of and parallel to Wall 1080. This wall was constructed of a single course of bricks laid lengthwise of similar bonding and dimensions to those described above and also had evidence of plaster adhering to it. The space between the two walls consisted of cobbles (1085). 1.2m to the east of Wall 1084 were two parallel rows of bricks (1086) set into a cobbled surface (1026). It may be that these bricks are part of a drain within the building. These cobbles and bricks were seen in the 2003 watching brief.

On the southern side of wall (1080) butting up to it a rectangular area was exposed. This started 0.2m to the west of the entrance (1083) and finished at the eastern end of the entrance, 1028. This rectangular area was 2.8m long and 2m wide, and extended to the area of the former concrete path (1004). Within this area was a compact sand with frequent inclusions of small stones and clinker (1029) which probably represents a floor level. On the western side of 1028 was a cobbled surface (1027). On the eastern side of 1028 was a clinker path (1030) 0.6m wide that appeared to be curving towards the rear of 189a High Street.

Overlying the cobbles, 1026, the clinker path, 1030, Wall 1084 and the possible drain, 1086 was a layer of tarmac (1002). This tarmac was very soft and smelt strongly of bitumen. Overlying all the deposits within the yard was a topsoil (1000) that consisted of friable mid-brown silt sand with inclusions of brick rubble and mortar. Prior to the removal of the top soil the ground had sloped down by c.0.5m from the edge of the car park into the yard area. Adjacent to the edge with the present car park the topsoil was up to 0.2m thick and was directly above Wall 1023. In the rest of the yard area there was approximately 0.2m-0.4m of topsoil.
