**Aldborough Roman Town
Aldborough
North Yorkshire
SE 4160 6660**

Archaeological Watching Brief

May 2005

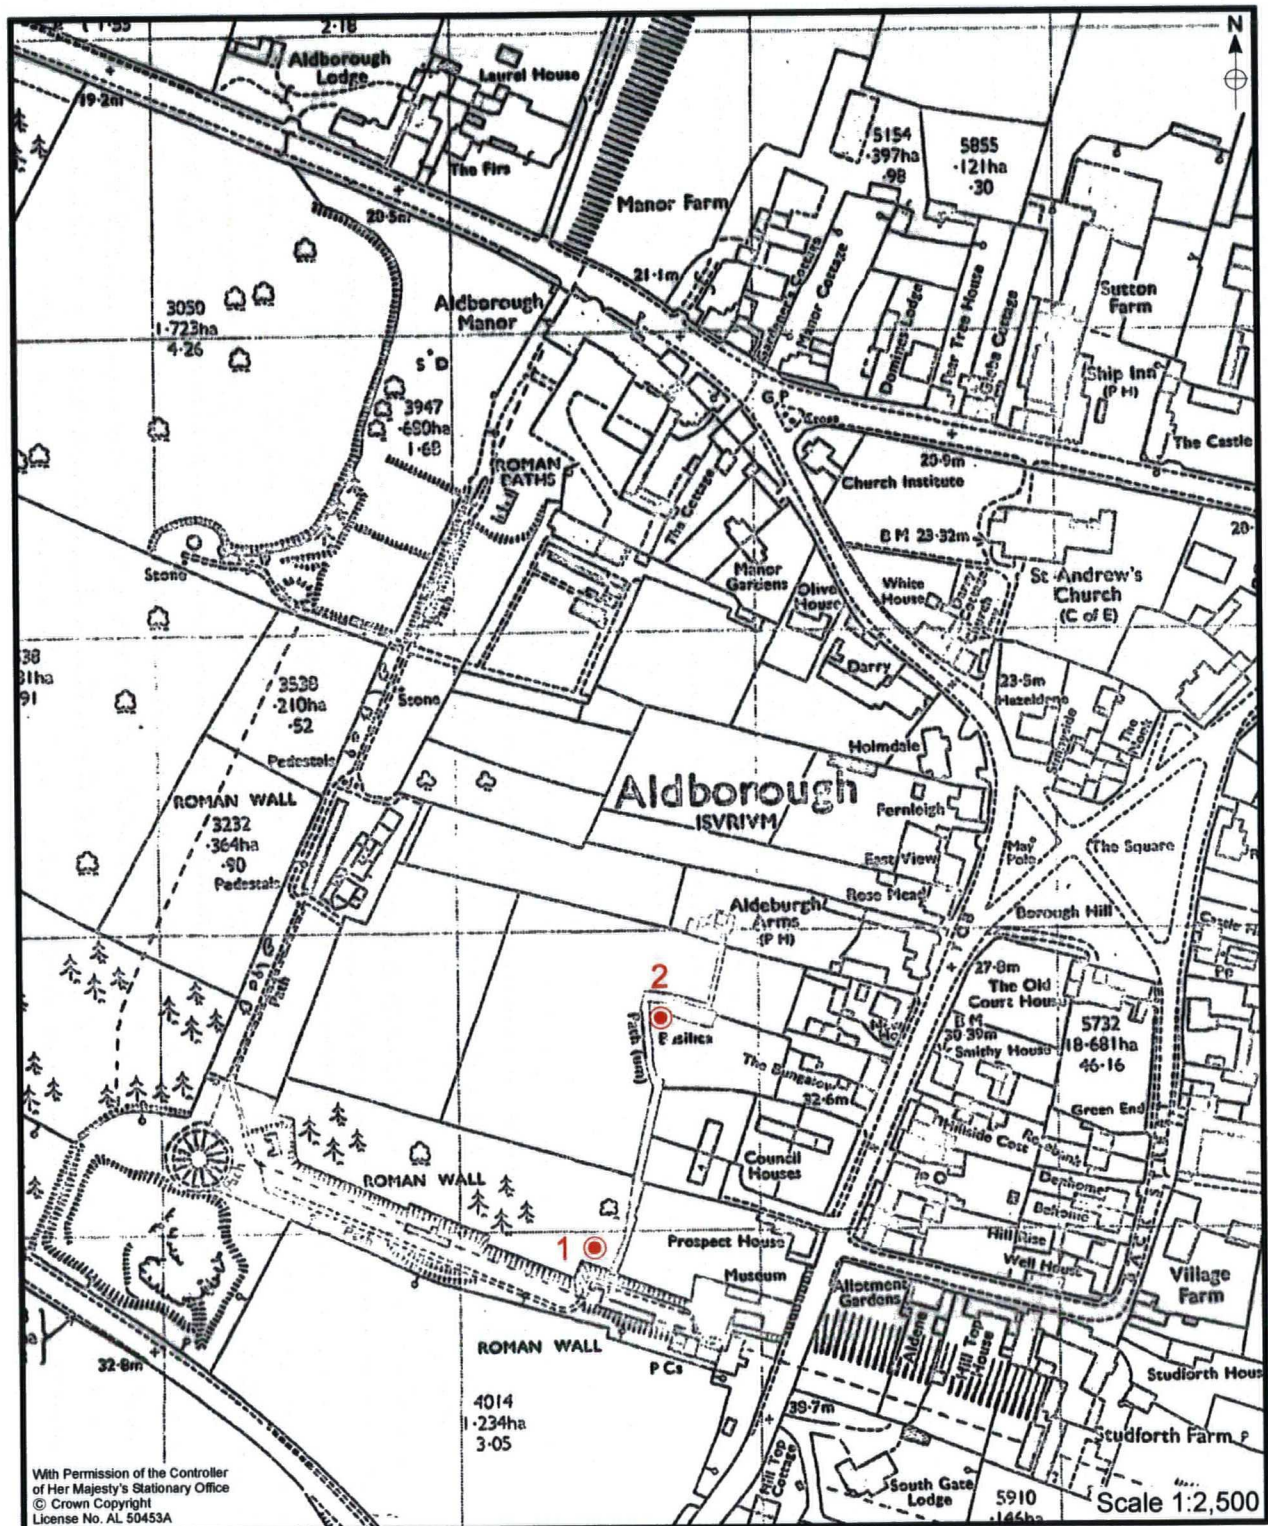
Figure 2. Watching Brief Areas

- 1.1 The site of Aldborough Roman Town is situated to the north of the town of Aldborough,, North Yorkshire. at SE 4160 6660 (Fig. 1)
- 1.2 The areas located for the Archaeological Watching Brief were at the eastern end of an upstanding earthwork (part of the defensive wall to the town) and in an open area to the east of the mosaics (Fig. 2).
- 1.3 The Archaeological Watching Brief was undertaken by MAP Archaeological Consultancy Ltd on the 10th of March 2005, at the bequest of English Heritage.
- 1.4 All maps within this report have been reproduced from the Ordnance Survey with permission of the Controller of Her Majesty's Stationery Office, Crown Copyright, Licence No. AL50453.

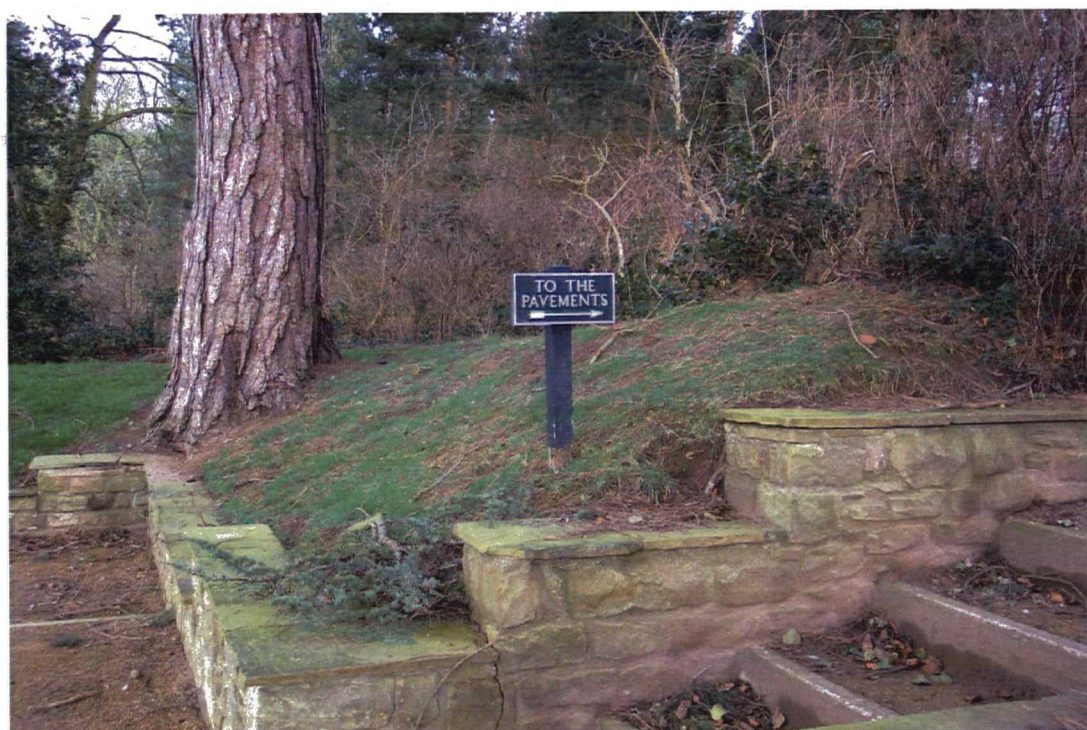
- 4.1 Two postholes (Pls. 1 - 2) were excavated by hand. Posthole 1 was into a previous housing whereas Posthole 2 was excavated into in situ deposits. The postholes measured 0.28m in diameter and 0.46m in depth. All work was carried out by hand in the presence of an archaeologist.

- 5.1 Posthole 1 was a re-excavation of an existing posthole. Only re-deposited topsoil and brick rubble was observed.
- 5.2 Posthole 2 revealed a deposit of 7.5YR clay loam containing small brick and decayed sandstone fragments. This deposit was sealed by a 0.23m deep deposit of topsoil.
- 5.3 No archaeological features or any artefacts were identified during the Watching Brief..

Plate 1. View of sign to be replaced. Facing west.
