**Newburgh Priory  
North Yorkshire  
SE 5438 7659**

**Archaeological Watching Brief**

*An Archaeological Watching Brief was carried out at Newburgh Priory, North Yorkshire on the 29<sup>th</sup> June 2005. The work was undertaken prior to the erection of a catering marquee in a former Abbey building, now a walled garden. The work involved the excavation of two small trenches where no archaeological deposits or features were observed and no finds were recovered.*

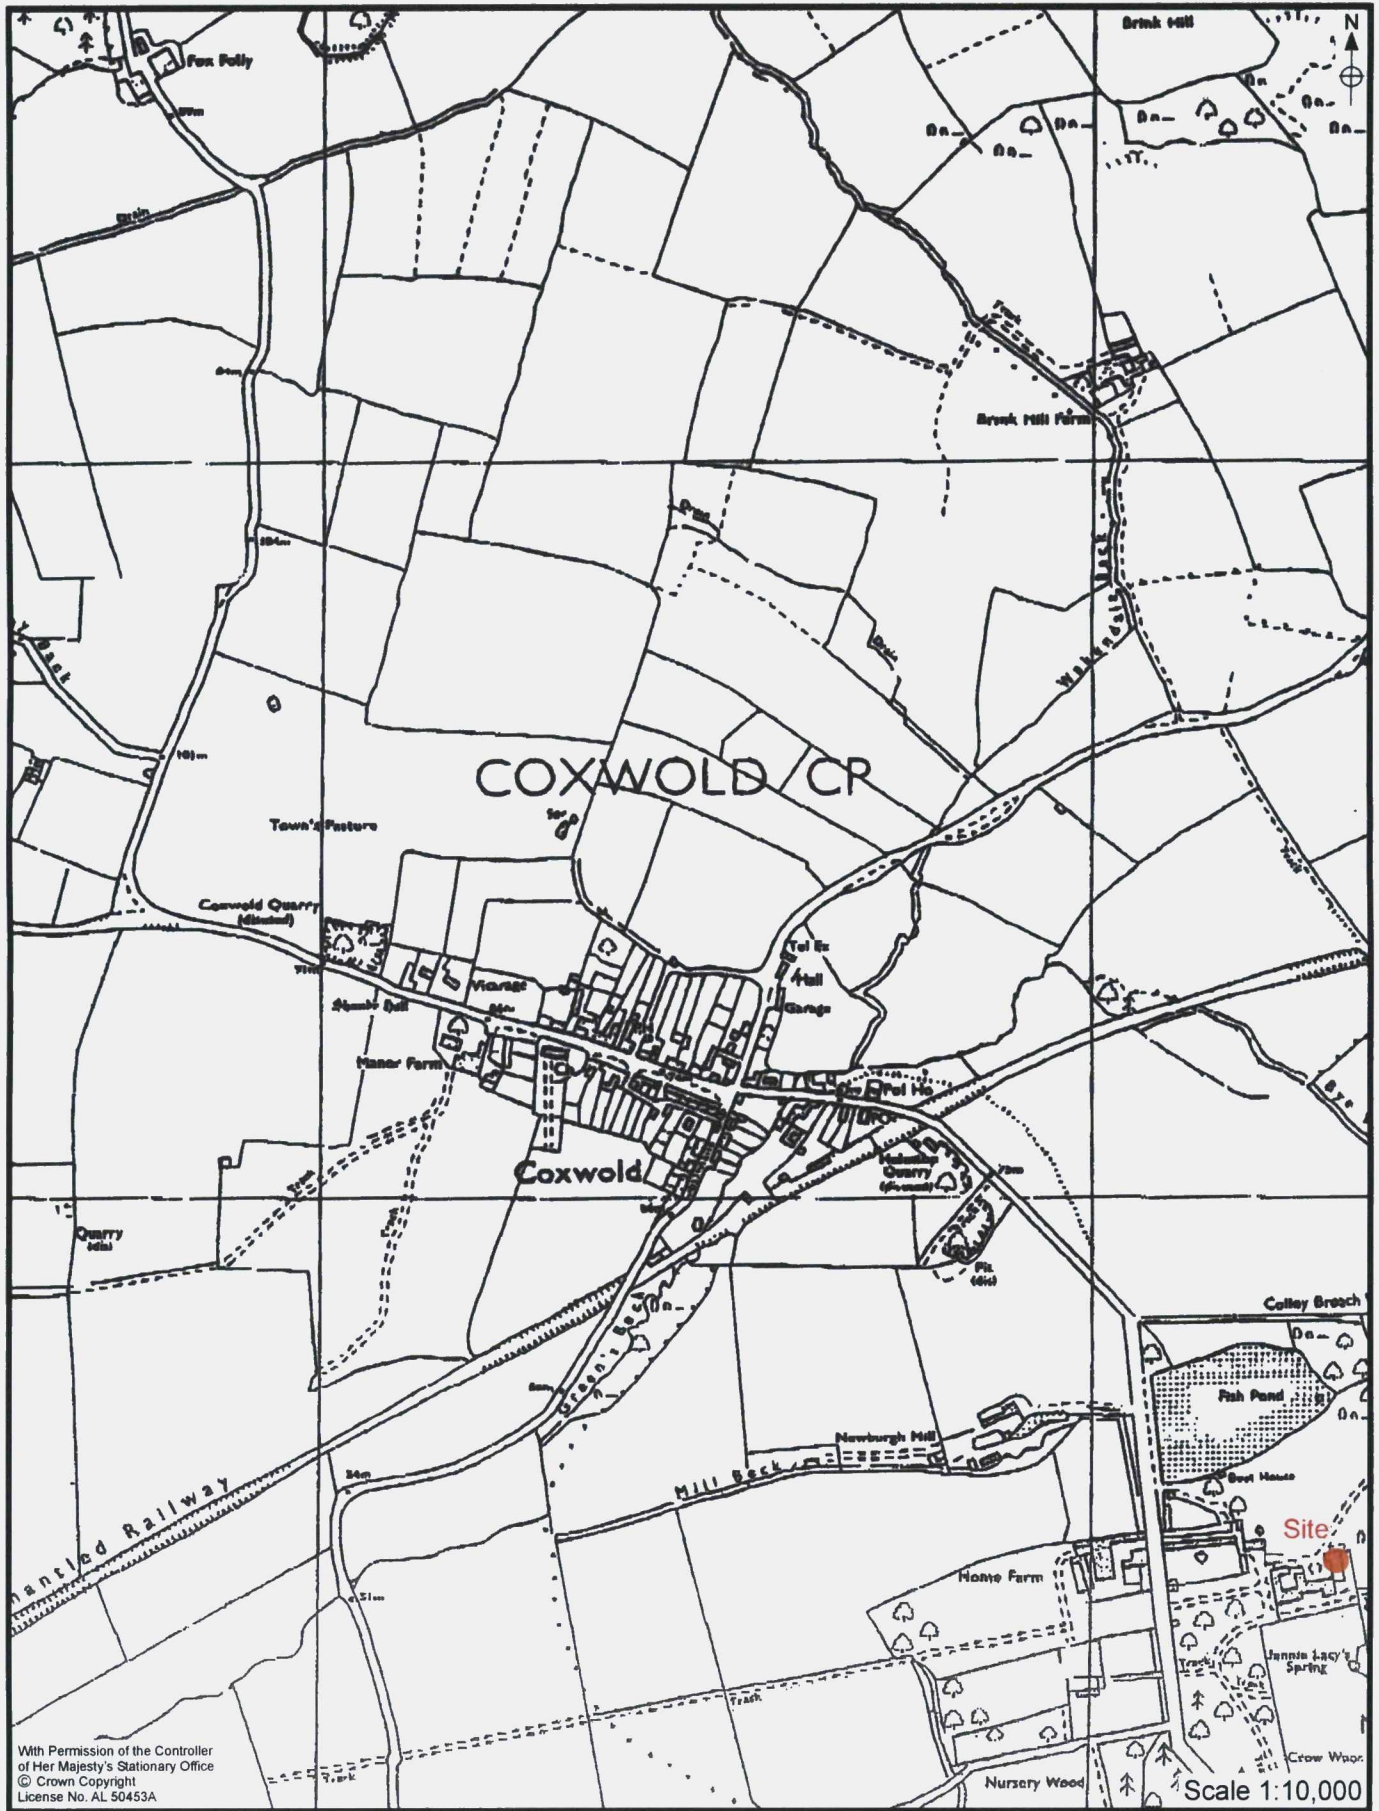
Figure 2. Area of Watching Brief

- 1 1 MAP Archaeological Consultancy Ltd carried out an Archaeological Watching Brief at Newburgh Priory, North Yorkshire (SE 5438 7659, Figs 1 & 2). The work involved the excavation of two small trenches within a semi-derelict building, now used as a walled garden, to investigate the presence of any archaeological features or deposits.
- 1 2 The work was carried out in advance of the erection of a catering marquee in order to determine if the stakes for the marquee would damage archaeological features, specifically a tiled floor surface associated with the Priory building.
- 1 3 All work was funded by Newburgh Priory.
- 1 4 All maps within this report have been produced from The Ordnance Survey with the permission of the Controller of Her Majesty's Stationery Office, Crown Copyright License No AL 50453A.
- 1 5 The work was carried out on the 29th of June 2005.

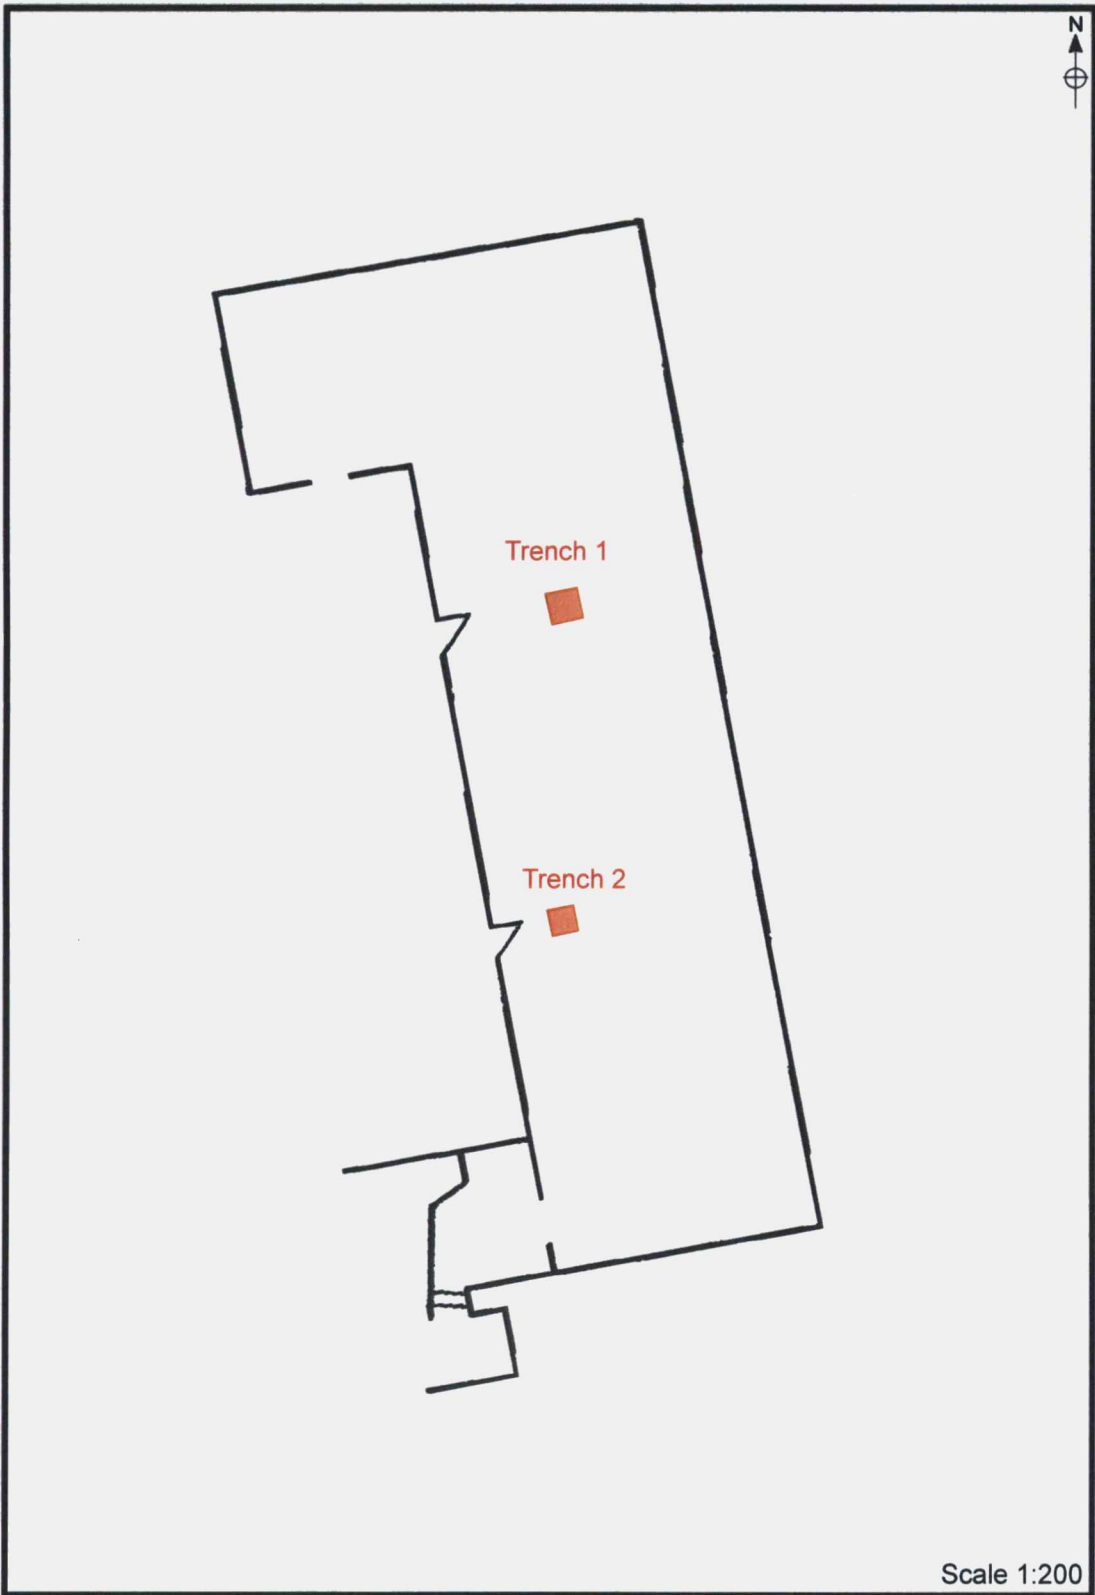
Figure 3. Watching Brief Trench Location

3.1 The two trenches (Trenches 1 and 2) were hand excavated under archaeological supervision in a walled garden that had formerly been one of the priory buildings, now semi derelict with no floors, ceiling or roof. The trenches were excavated on two separate flagged pathways, one towards the north of the garden, the other to the south. A drawn, written and photographic record was made of all deposits encountered.

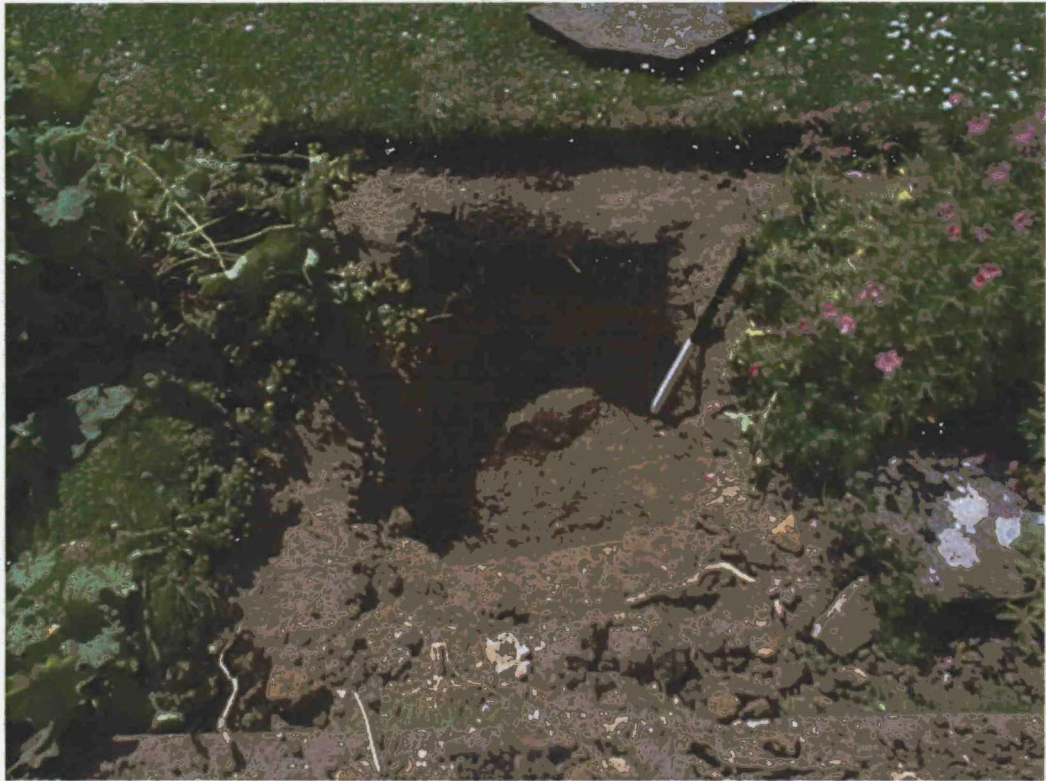
**Plate 1.** Watching Brief Trench 1, Facing North

4.1.1 Trench 1 measured 0.9m long, 0.8m wide and excavated to a depth of 0.55m. No archaeological features were observed; the only deposits seen were 0.2m of topsoil (context 001) that overlies a 0.25m deep pale stoney deposit (context 002). A number of modern brick and fractured drain pipe fragments were the only finds noted from deposit 002, which were discarded. Deposit 002 overlies the natural limestone bedrock.

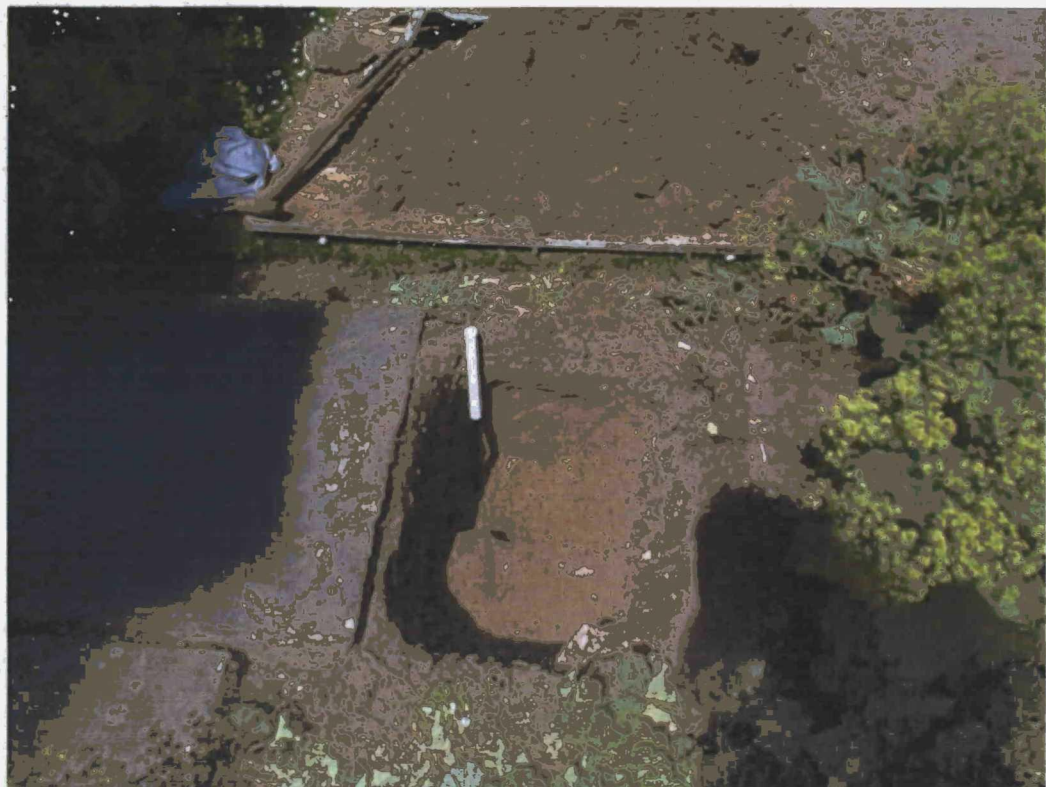
**Plate 2.** Watching Brief Trench 2, Facing North

4.2.1 Trench 2 measured 0.8m long by 0.75m wide and excavated to a maximum depth of 0.65m. The findings were the same as Trench 1, topsoil (context 001) overlying a pale stoney deposit (context 002) that sealed the natural limestone (context 003). A 3 inch diameter iron water pipe ran on an east to west alignment through the centre of the trench and appeared to run below the path. Modern finds including brick and pipe fragments were noted in Deposit 002 but were not kept as finds.
