**JUNCTION OF  
BROOK STREET / GOWTHORPE  
SELBY  
NORTH YORKSHIRE**

**A Report on an  
Archaeological  
Watching Brief**

**JUNCTION OF  
BROOK STREET / GOWTHORPE,  
SELBY,  
NORTH YORKSHIRE**

**A REPORT ON AN  
ARCHAEOLOGICAL WATCHING BRIEF**

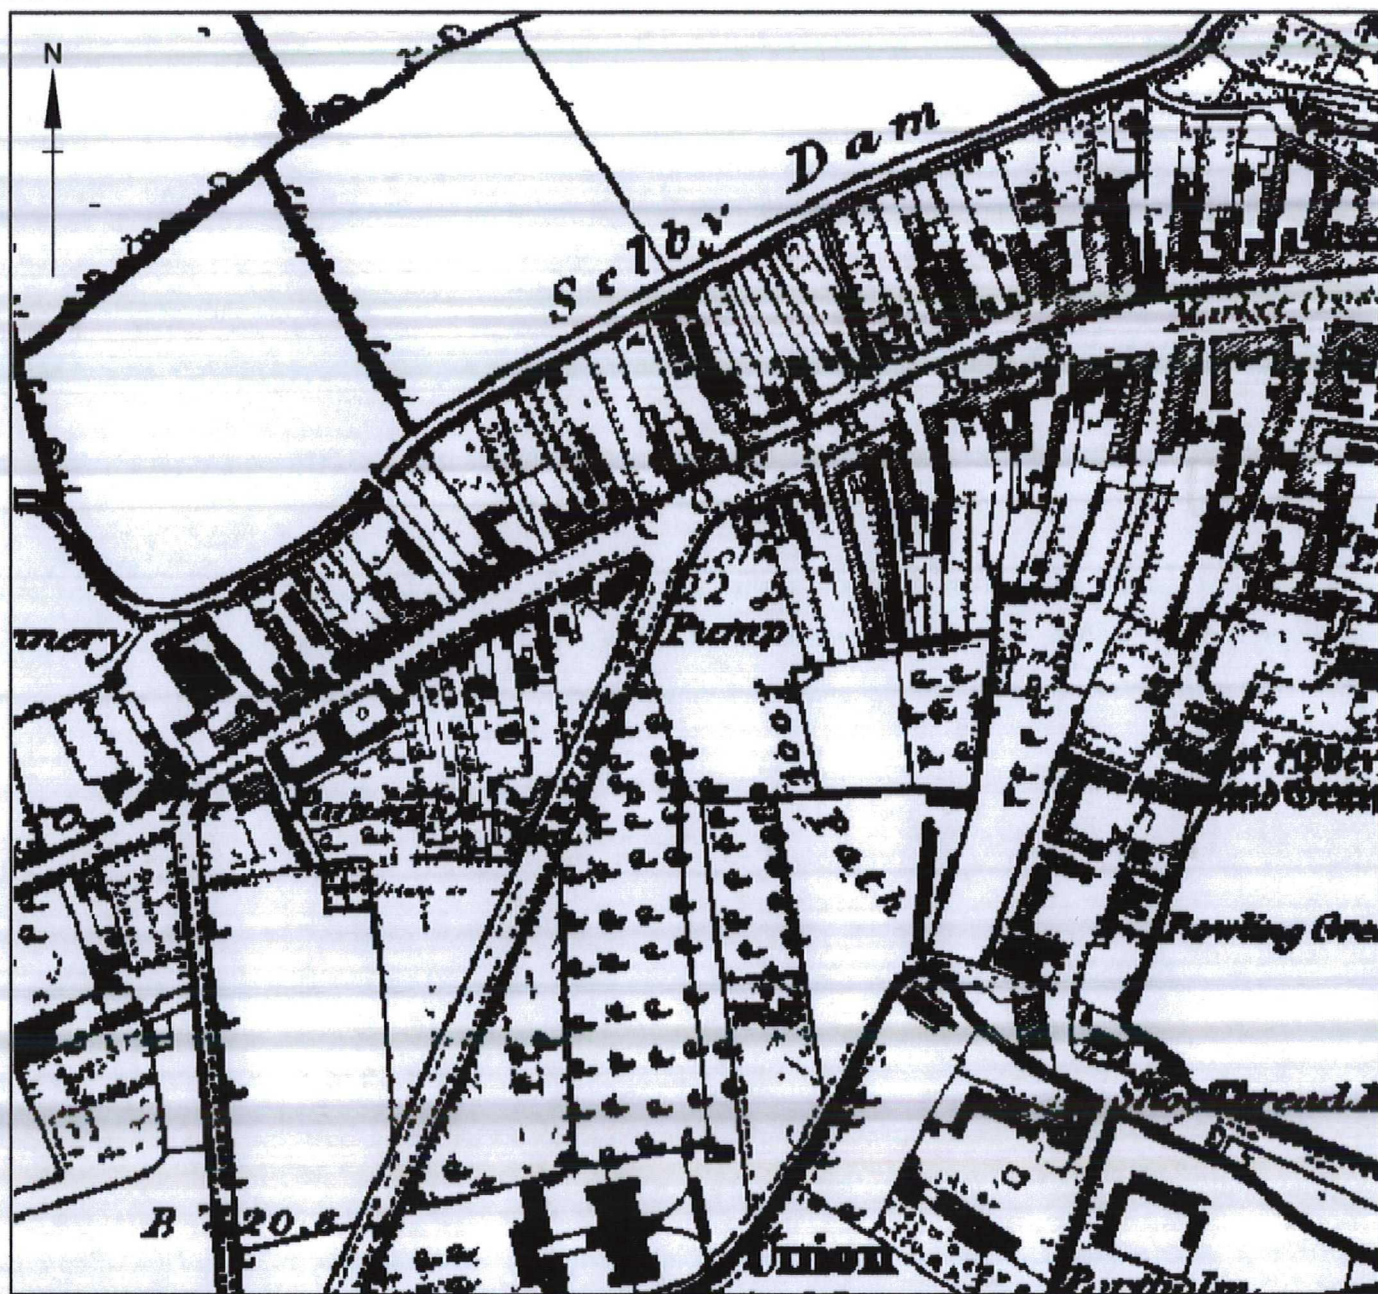
Fig. 2 A section of the 1852 Ordnance Survey plan of Selby (not to scale)

The 1852 Ordnance Survey (Fig 2) map shows that the area of the former school had already started to be developed by the mid-nineteenth century with a large building shown in the apex of the triangular plot of land formed by Gowthorpe and Brook Street, although the majority of the area was still open fields. It is possible that the two cottages adjacent to the school that form part of the development area are also shown in the map. These two cottages are probably part of the programme of building along Gowthorpe that started in the 1820s (<http://www.pastscape.org>). The 1852 Ordnance Survey map would also suggest that Brook Street is a 'new' street as it clearly cuts through property boundaries extending from Gowthorpe. Comparison with the modern Ordnance Survey map clearly shows how built up this area has become.
