Silbury Hill

**The Collated Archive Record of the Archaeology
Revealed during the Collapses of the
Northumberland Shaft in 2000**

English Heritage
Fort Cumberland
Portsmouth
Hants
PO4 9LD

March 2006

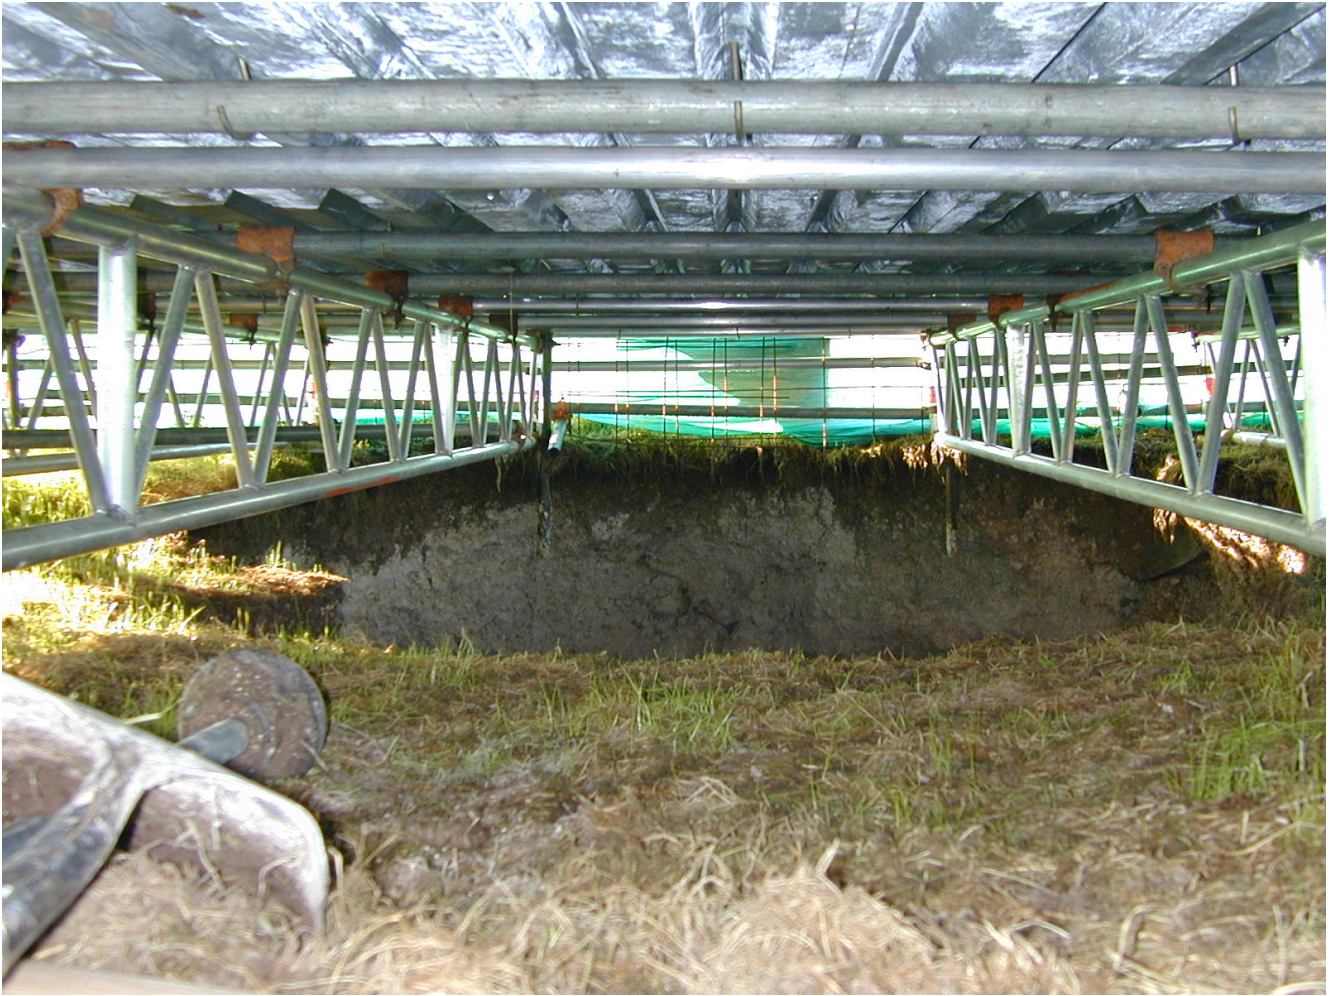
Fig 01 overview of collapse 2

- 2.2.1 At the beginning of December a further collapse occurred when the overhang to leave a bell –shaped hole undermining the scaffold capping. This event was recorded photographically by staff from English Heritage. (Fig 01)
- 2.2.2 In addition a clandestine video recording was made and later published
- 2.2.3 A secure chain-linked fence was erected around the collapsed area under a watching brief by EH staff (Cromwell 2000)

- 2.1.1 On 29th May 2000 a squarish hole, recorded as approximately 2.25m wide and 10.3m deep, appeared on the top of Silbury Hill
- 2.1.2 On 31st May 2000 a scaffold and corrugated iron structure was erected to provide a secure capping over the top of the shaft (Fig 01). This work was carried out with archaeological supervision provided by the National Trust but no records were created.
