**Collated Archive and Updated Report on the
Evaluation through Coring of Physical and
Geophysical Anomalies on the Northern Aspect of the
Mound**

Compiled by Fachtna McAvoy, Matt Canti, and John Vallender

English Heritage
Fort Cumberland
Portsmouth
Hants
PO4 9LD

May 2006

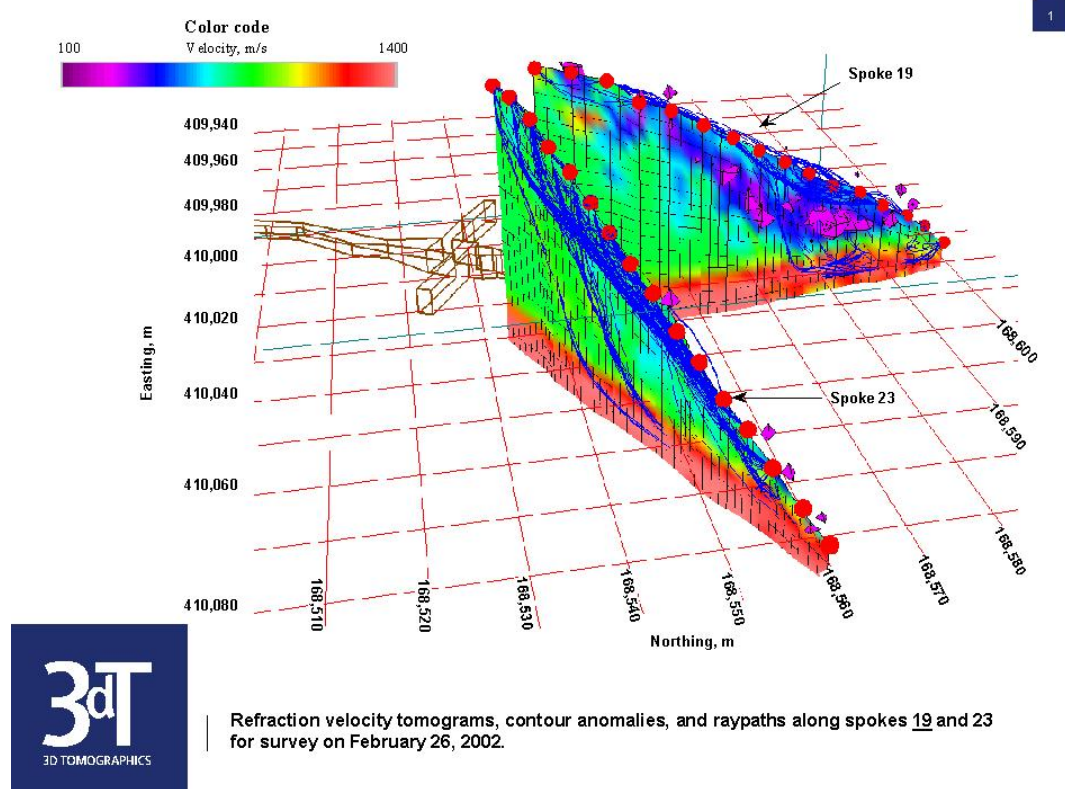
Figure 2: the northern geophysical anomaly (after Skanska 2002a)

- 2.2 The depictions of the results of these surveys show low velocity signals on part of the northern slope. These signals are interpreted as representing material that could be less dense or compacted than that which generally forms the mound, and from which higher velocity signals have been obtained.

- 2.3 In broad terms the zone of low velocity signals is a large scoop on the side of the hill (Figs 1 and 2). This begins some 35m upslope and broadens to a width of c 20m towards the base. The depth of penetration of this zone into the mound has not been entirely satisfactorily established but could extend down to the old land surface.

- 2.4 Explanations for the presence of this anomaly (Skanska 2002a) include:
 - A previous slope failure that has been infilled at a later stage.
 - A construction feature which has been infilled (of Neolithic age or later).

- A zone of low density material, due to changing construction techniques or drainage.
 - An area seriously affected by burrowing and physical weathering/attack.

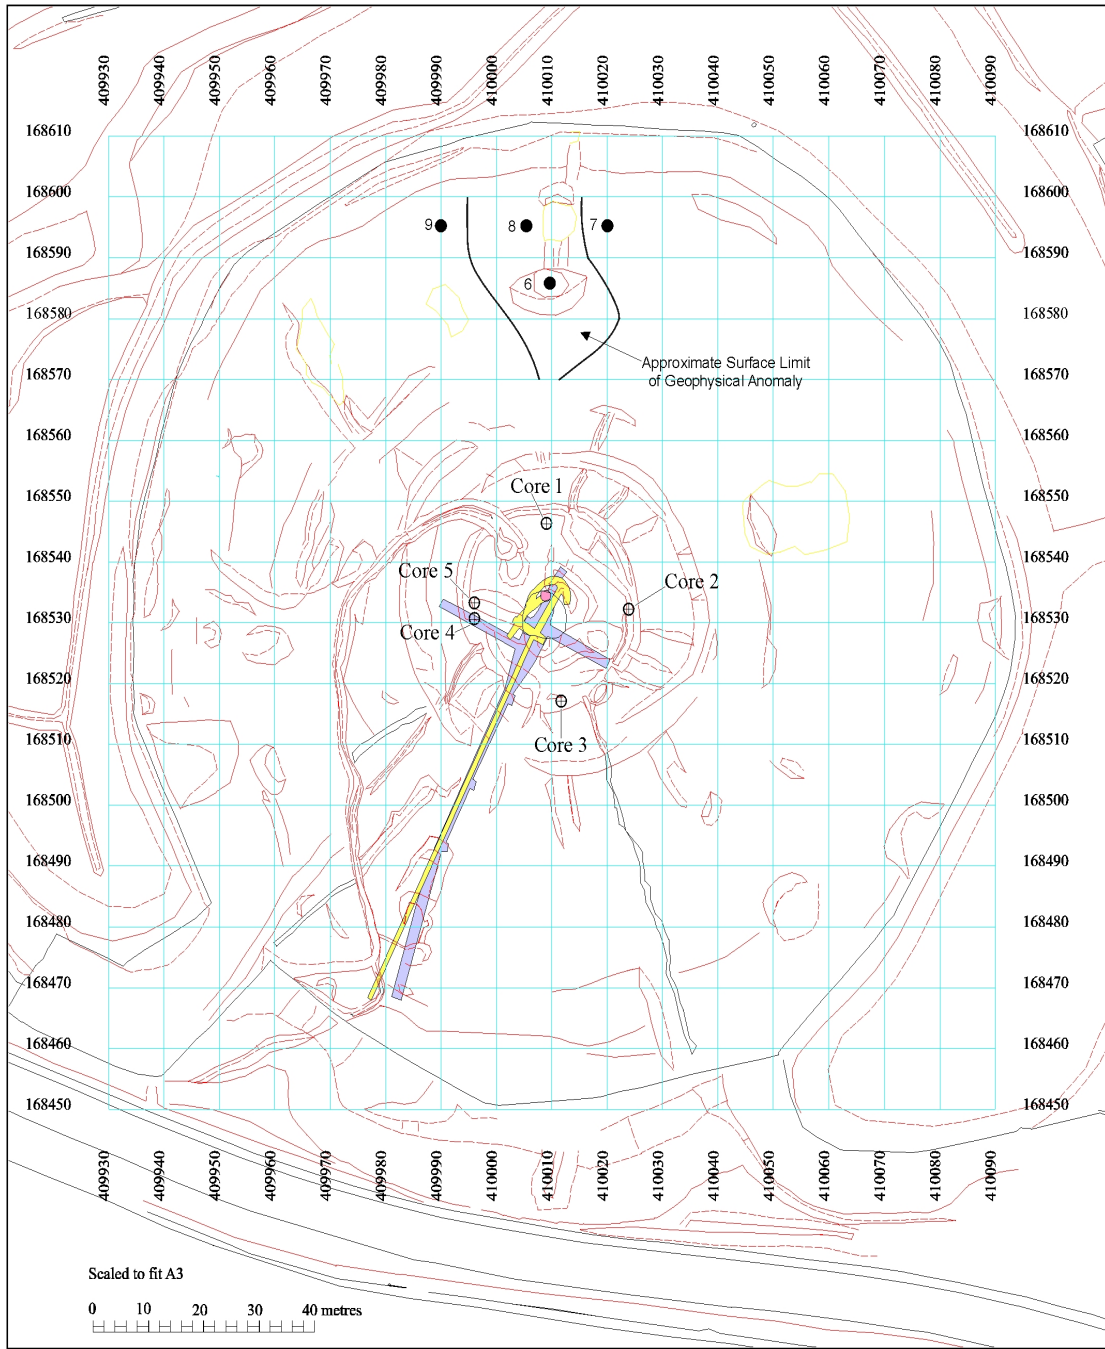
Figure 3: physical anomalies and core locations

- 2.5 The most prominent of the physical anomalies is a platform c 14m long and 5m wide, the largest of a number of such platforms or scars identified on the hill slopes (Figs 1 and 3). Field (2002) has put forward some suggestions regarding the nature of this feature:

- 2.6 Below the platform is a trench-like scar leading to an apron, which itself has a lower scar on the same alignment that appears to cut the old ground surface. It is possible that at least part of this scarring is a result of a hitherto unlocated excavation trench dug by Professor Richard Atkinson in 1970.

- 3.1.4 This did not affect the overall core location strategy. Core 11 was sited 3.2m upslope from the pegged location, which was found after the core had been taken. Core 10 was sited in the centre of a line between cores 9 and 11 (Fig 3).

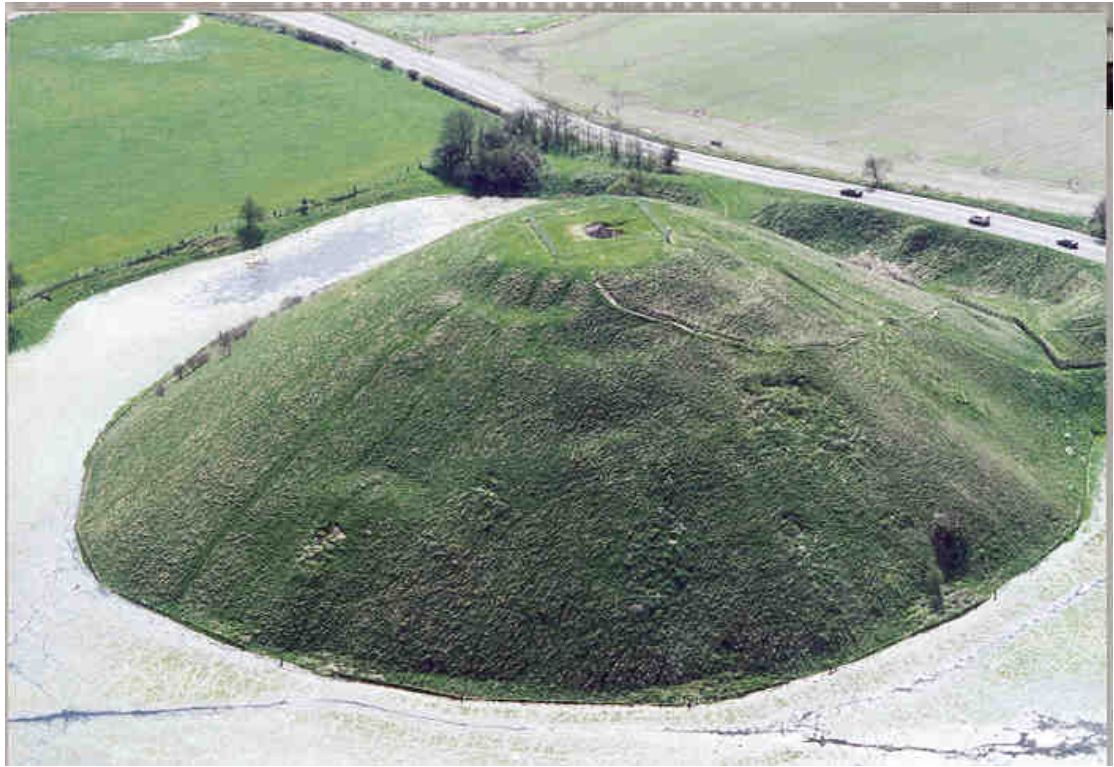
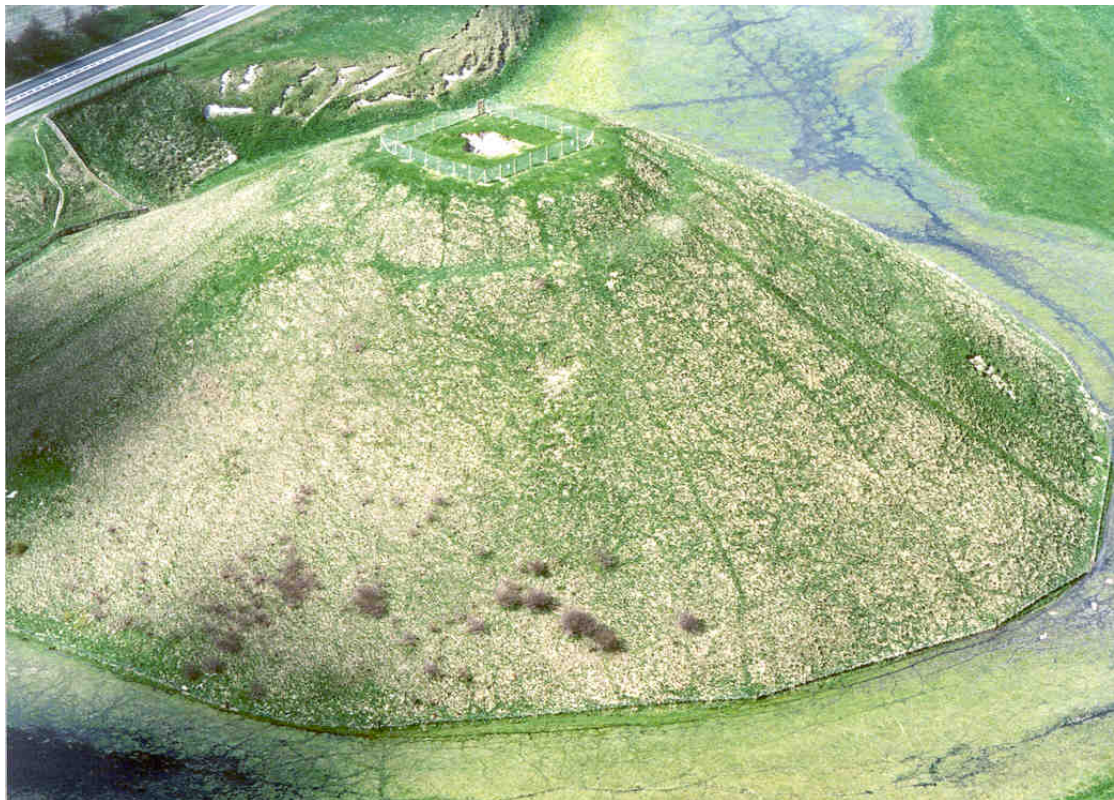
Figure 4: overviews of the northern physical anomalies (photos: Brian Edwards, April 2001)

- 4.3 It should be noted that there are distinctive differences in the colour of the vegetation on the hill (Fig 4) with some areas being much greener. On the northern aspect this could be reflect the presence of deeper soil deposits that are either more water-retentive, or nutrient-enriched from animal habitation.
- 4.4 The mound deposits seen in these new cores can be regarded as being as stable as those seen elsewhere but of course the coring process introduces a considerable amount of compaction and compression.

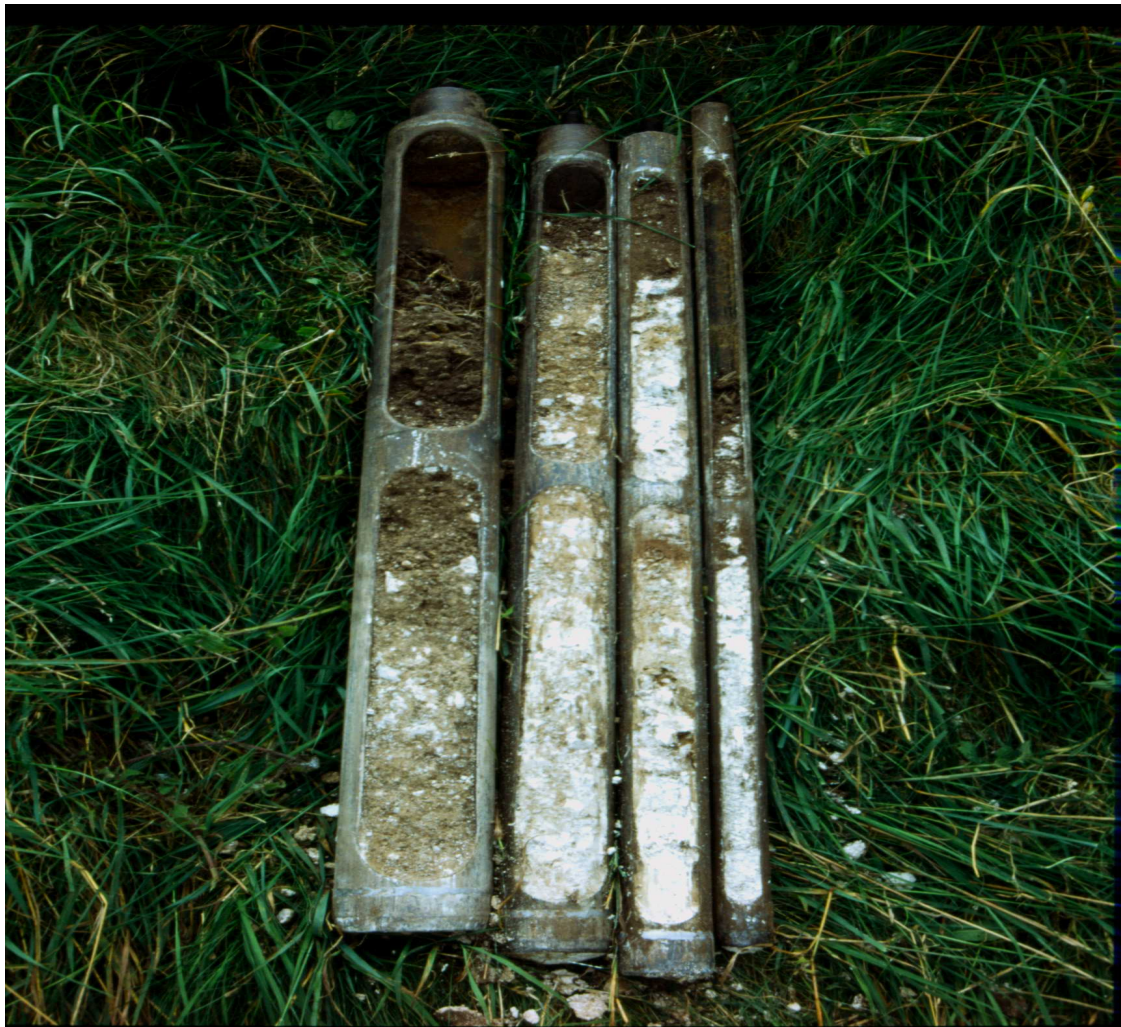
Figure 5: core 8

3.2.2 **Core 8**, located on the 'platform' and within the geophysical anomaly, has predominantly 'soil' deposits to a depth of 1.35m, below which are the chalk deposits of the mound to an obtained depth of 4m. A re-deposited subsoil layer, 0.04m thick, at a depth of 2.55m, divides these chalk deposits.

Depth from surface (m)	Deposit description
0 – 0.27	Dark brown (10 YR 4/3, field moist) silt loam with <2% 0.01-0.1m subangular to subrounded chalk stones. 0.04m smooth boundary to:-

0.27 – 0.49	Dark brown (10 YR 4/3, field moist) silty loam, with 5-10% 0.01-0.1m subrounded to rounded chalk stones. 0.03m smooth boundary to:-
0.49 – 1.35	Dark yellowish brown (10 YR 4/4, field moist) silty clay loam, with 10-15% 0.01-0.22m subangular to rounded chalk stones. 0.04m smooth boundary to:-

1.35 – 2.55	White (10 YR 8/2, field moist) silty clay loam with up to 50% subangular and subrounded chalk stones, 0.01-0.4m. Occasional streaks of dark yellowish brown (10 YR 4/4, field moist) silty clay loam. 0.02m boundary to:-

2.55 – 2.59	Brown (7.5 YR 5/4, field moist) silty clay loam, stoneless. 0.01m smooth boundary to:-
2.59 – 4	White (10 YR 8/2, field moist) silty clay loam with up to 50% subangular and subrounded chalk stones, 0.01-0.4m. Occasional streaks of dark yellowish brown (10 YR 4/4, field moist) silty clay loam.

- 'Soil' dominated deposits were found to vary in depth from 0.3m in core 9, to 1.35m in core 8, where they would be consistent with the infill of a dug feature such as a platform.
- Conversely chalk and subsoil 'mound' deposits, directly comparable with those seen in the earlier Skanska cores, were seen in all of the cores. These deposits were found at depths of 0.3m in core 11, 0.35m in core 10, 0.53m in core 9, and 1.35m in core 8, where they were truncated by human and/or animal activity.

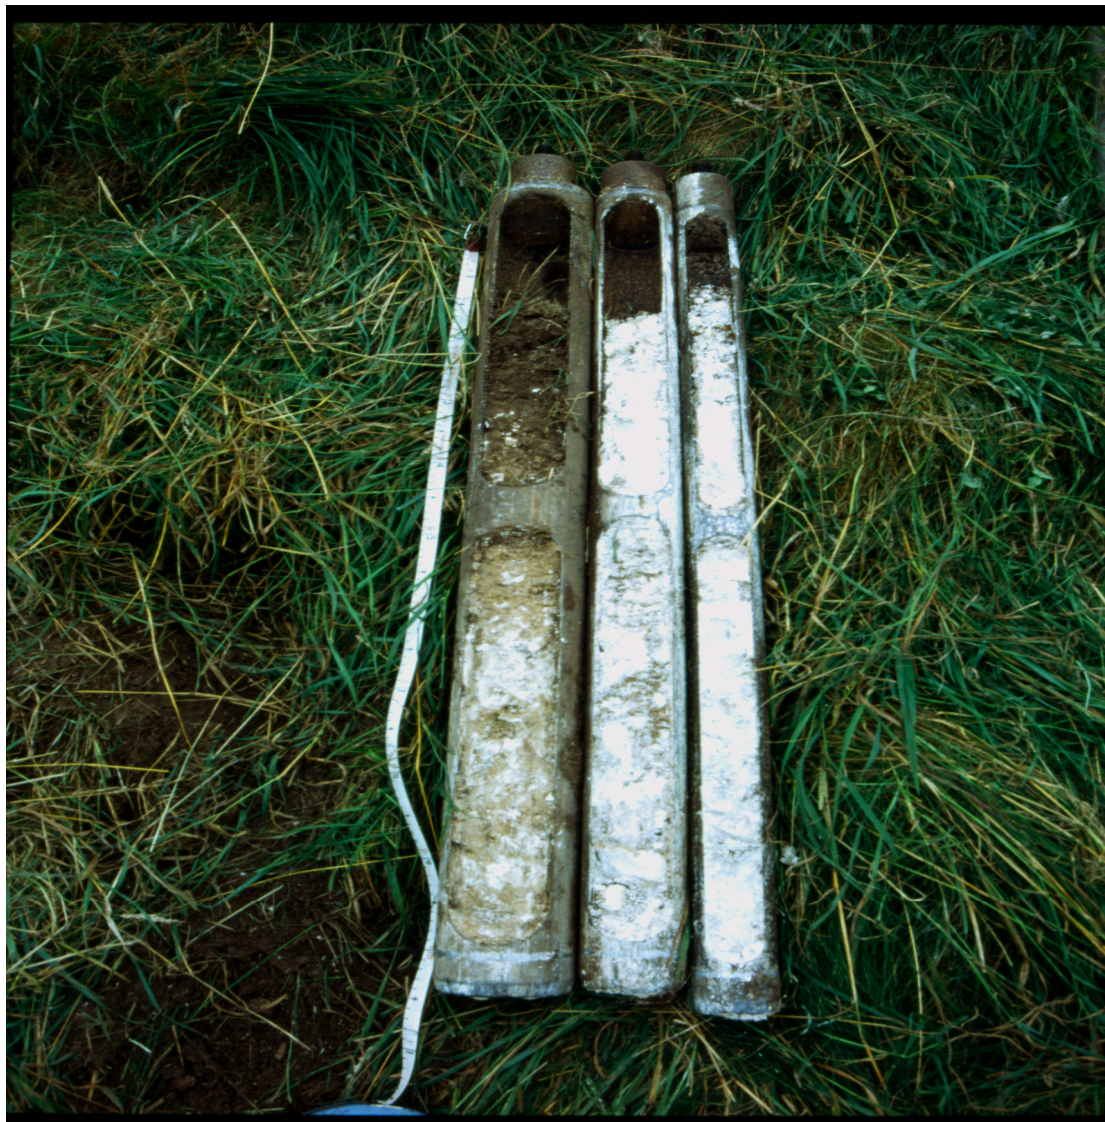
Figure 6: core 9

3.2.3 **Core 9**, beyond the eastern limit of the geophysical anomaly, has predominantly soil deposits to a depth of 0.53m, below which are the chalk deposits of the mound (with a slightly greater soil content for the first 0.47m) to an obtained depth of 3m.

Depth from surface (m)	Deposit description
0 – 0.17	Dark brown (10 YR 4/3, field moist) silt loam with <2% 0.01-0.1m subangular to subrounded chalk stones. 0.04m smooth boundary to:-
0.17 – 0.53	Dark yellowish brown (10 YR 4/4, field moist) silty clay loam, with 10-15% 0.01-0.2m sized subangular to rounded chalk stones. 0.03m smooth boundary to:-
0.53 – 1.0	Mix of dark yellowish brown (10 YR 4/4, field moist) silty clay loam, with 10-15%, 0.01-0.2m sized subangular to rounded chalk stones and white (10 YR 8/2, field moist) silty clay loam with up to 50% subangular and subrounded chalk stones up to 0.3m in size. Boundary not visible.
1.0 – 3.0	White (10 YR 8/2, field moist) silty clay loam with up to 50% subangular and subrounded chalk stones, 0.01-0.4m. Occasional streaks of dark yellowish brown (10 YR 4/4, field moist) silty clay loam.

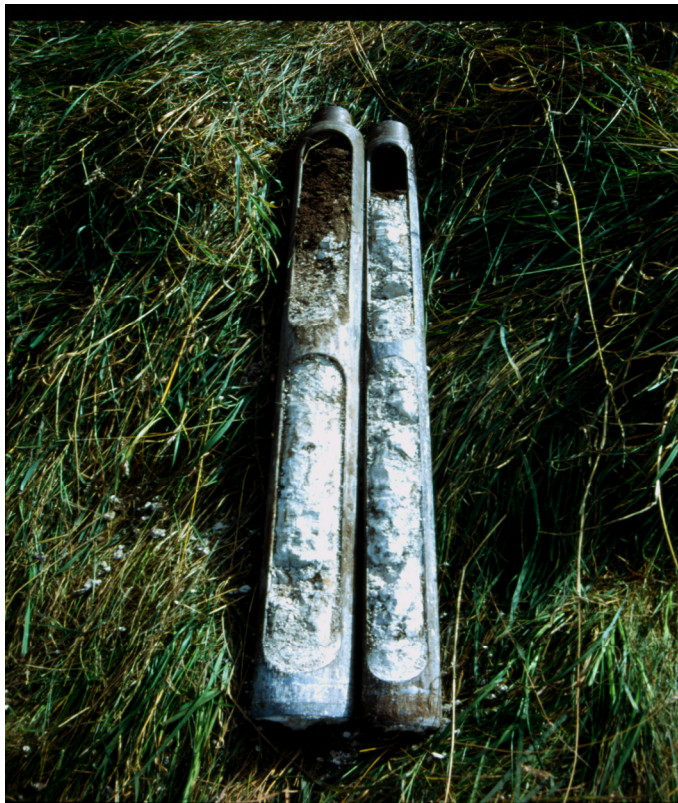
Figure 7: core 11

3.2.5 **Core 11**, beyond the western limit of the geophysical anomaly, has very shallow soil deposits to a depth of 0.3m, below which are the chalk deposits of the mound to an obtained depth of 2m.

Depth from surface (m)	Deposit description
0 – 0.3	Dark greyish brown (10 YR 4/2, field moist) silt loam, no stones. 0.05m smooth boundary to:-
0.3 – 2.0	White (10 YR 8/2, field moist) silty clay loam with up to 70% subangular and subrounded chalk stones, 0.01-0.2m.
