**The British Queen  
Public House, 34 Picton  
Street, Camberwell**

**Level 2 - 3 Historic  
Building Recording**

AB Heritage Project No:60163

Date:22/11/2017

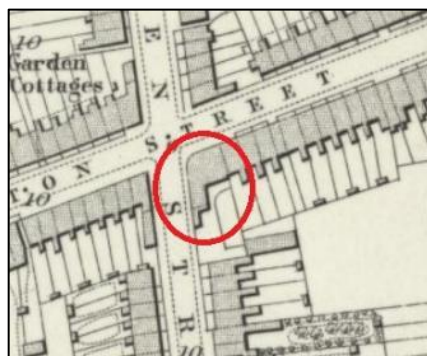
- 3.1.4 The earliest historic map that depicts the British Queen public house in any detail is the 1<sup>st</sup> edition of the 25" OS map, which was surveyed in 1869-71 and published in 1874 (Plate 1). This map shows that at this time, the ground plan of the building comprised the main bar area at the northern end of the building and a probable separate lounge area at the rear, southern end. A small outbuilding was shown attached to the rear elevation.

**Plate 1: 1<sup>st</sup> edition 25" OS map, 1874 (site circled in red) (Reproduced by permission of the National Library of Scotland)**

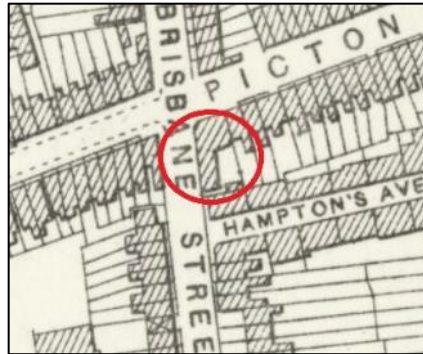
- 3.1.5 The 2<sup>nd</sup> edition of the OS map, which was surveyed in 1883-4 and published in 1897 (Plate 2), demonstrates that since the 1874 edition of the map, Hampton's Avenue had been inserted to the south of the public house, reducing the length of the service yard at the rear of the property. The rear of the building had been extended to a small degree and a small outbuilding is shown in the south-east corner of the remaining service yard area. It is likely

that the entrance to the service yard, on the eastern elevation was created at this time. The map also shows that Queen Street had been renamed Brisbane Street since 1874.

**Plate 2: 2<sup>nd</sup> ed. OS map, 1897 (Reproduced by permission of the National Library of Scotland)**

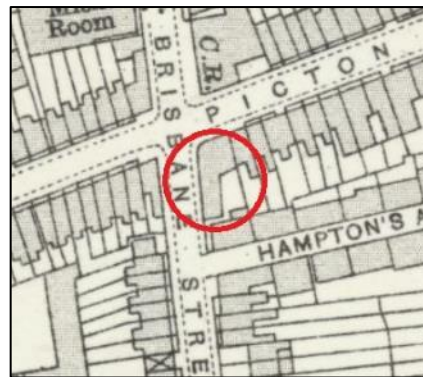
- 3.1.6 The 3<sup>rd</sup> edition of the OS map, surveyed in 1913-14 and published in 1916 (Plate 3), shows the ground plan of the building had changed little, if at all since 1897.

**Plate 3: 3<sup>rd</sup> ed. OS map, 1916 (Reproduced by permission of the National Library of Scotland)**

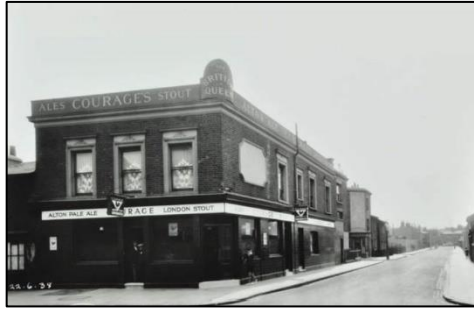
- 3.1.7 A black and white photograph of the north and west elevations of the public house, taken in 1938 (Plate 4), illustrates that at this time the lower sections of the elevations were faced with dark coloured glazed tiles and the upper section was exposed stock brick, above a probable timber cornice.

- 3.1.8 The ground floor main entrance on the corner of the elevations had a double door with multi-glazed upper sections. The ground floor bar windows are shown to have had etched designs on the lower sections. Above the bar frontage, the first-floor windows are shown with moulded stucco surrounds and entablatures. A large square, stucco, sign is shown on the west elevation, with moulded concave corners and edging. Above a moulded stucco cornice, a parapet displays the name sign cartouche, with the painted lettering of the pub's name, 'The British Queen'. The remainder of the parapet displays the painted lettering for the Southwark based Courage's Brewery.

**Plate 4: Photograph of The British Queen, 1938 (The London Metropolitan Archives, 2017)**

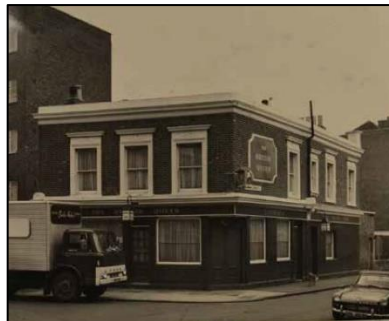
- 3.1.10 A black and white photograph of the northern and western elevations of the public house, taken in 1977 (Plate 5), illustrates that the general appearance of these elevations had changed little since 1938, except for the parapet had been removed and the front door and ground floor windows had been replaced. Lanterns were located above the side doors on both elevations.

**Plate 5: Photograph of The British Queen, 1977 (London Borough of Southwark Archives)**

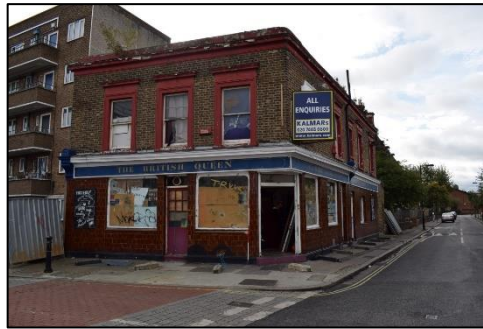
- 4.1.1 The main north elevation faces north onto Picton Street, with the main west elevation facing west onto Brisbane Street (Photo 1). The ground floor parts of these elevations are fronted in orange-brown glazed square tiles, with rounded glazed tile window sills, moulded glazed tile cornice and moulded stucco skirting around the base of the elevations (Photo 2).

**Photo 1: The north & west elevations of the British Queen Public House (scale 2m)**

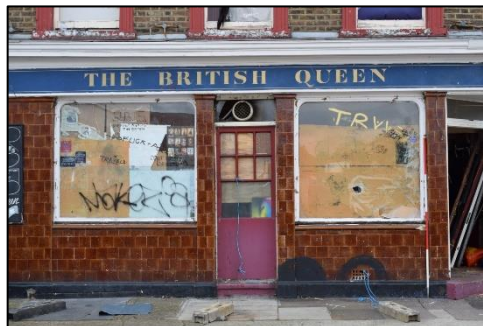
- 4.1.2 The painted timber window frames have rounded upper corners (Photo 2) but the plain glazing is modern. A metal cover in the pavement adjacent to the north elevation denotes the location of the hatch to the dray chute leading down into the basement (Photo 2)

**Photo 2: The ground floor windows, glazed tile detailing on the north elevation & the basement chute hatch (below left window)**

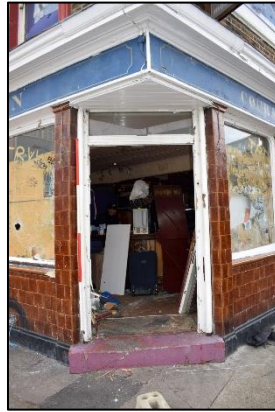
- 4.1.3 The main bar entrance is located on the corner of the north and west elevations, with a terrazzo concrete threshold, probable original timber surround and a timber panelled porch ceiling. The porch has been created by the signage panel above and small cast iron columns flank the main entrance on both sides. A rectangular glazed light is present above the entrance. The doors have been removed (Photo 3).

**Photo 3: The main bar entrance**

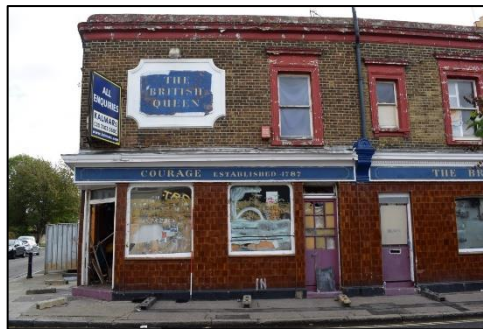
- 4.1.4 Two separate entrances are located on the west elevation. These have the original timber frames. Both doors have multi-light glazed upper sections and panelled lower sections. One of the doors is the same design as those shown on the 1938 photograph so dates to at least the early 20<sup>th</sup> century. This door has a rectangular hinged light over the doorway (Photo 4).

**Photo 4: North end of the west elevation (early door centre)**

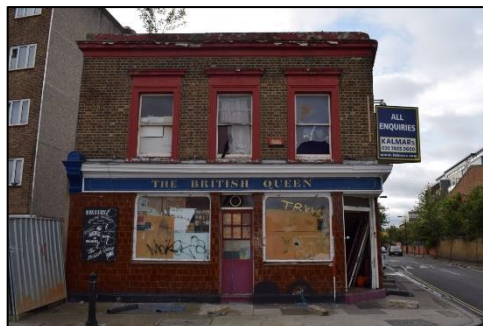
- 4.1.5 At ground floor level on the north elevation, two large windows are present with a central separate doorway. The original door and window frames are present but as elsewhere, the window glazing has been replaced. The doorway contains another door dating to at least early 20<sup>th</sup> century, with multi-light upper section although the lower part of the door glazing has been altered (Photo 5).

**Photo 5: The north elevation of the British Queen Public House**

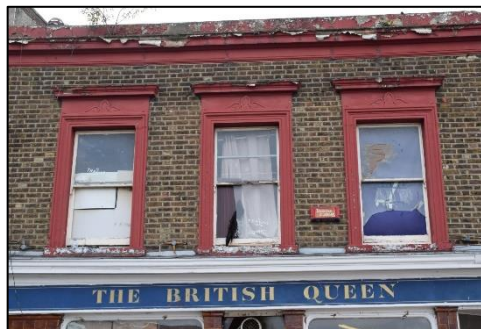
- 4.1.7 At first-floor level, the Flemish bonded stock brickwork is exposed. The windows are double hung timber sash windows with horns on the upper sash section and likely date to the late 19<sup>th</sup> century. Each first-floor window has a moulded stucco surround and entablature. The larger windows have a moulded scroll design above the window, but this is absent from the single, smaller window on the west elevation, instead this has two small cobles beneath the window sill (Photo 4). There is no evidence for the former lanterns that were located above the separate entrances.

**Photo 6: 1<sup>st</sup> floor windows with moulded stucco surrounds & cornice**

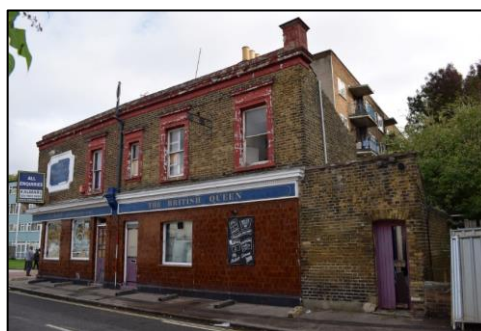
- 4.1.8 A moulded stucco signage board is located at first-floor level on the western elevation. This had moulded edging and corners and currently houses a timber name sign (Photo 4). A stucco moulded cornice is present at roof level, with a small parapet behind (Photo 6).
- 4.1.9 A small, apparently stucco, square moulded chimney pot is present on the south-west corner of the parapet. However, this is a purely decorative feature as it is not situated above the internal chimney flues. A functional stock brick chimney stack with several circular ceramic pots is visible in the centre of the roof. A metal sign bracket, from which the sign is absent, is present at first-floor level, towards the southern end of the western elevation.

**Photo 7: The southern end of the west elevation, with decorative chimney pot and pub sign bracket**

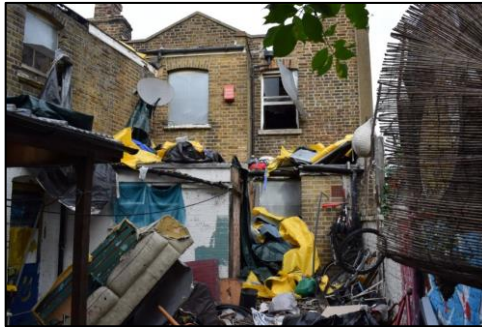
- 4.1.10 A section of single storey stock brick wall is present at the southern end of the building. This has a doorway with cambered brick lintel, which leads into the rear service yard (Photo 7).
- 4.1.11 The rear elevation comprises several elements, all constructed from stock brick, except for a modern addition to the early – mid 20<sup>th</sup> century WC block, located on the rear of the original element of the building. The earliest part of the building has a combination of gables with

single pitched and gable rooflines. The early – mid 20<sup>th</sup> century WC block, located on the rear of the original element of the building has a flat roof, as do the late 20<sup>th</sup> century WC extensions (Photo 8).

- 4.1.12 The windows are largely timber double hung sashes with cambered brick lintels, except for the window on the eastern side of the elevation, the lintel for which appears to have been rebuilt as a curved arch (Photo 8). The modern extensions have casement windows. A modern veranda has been constructed against the southern end of the elevation. Stock brick walls form the boundaries of the service yard on the east and southern sides (Photo 8).

**Photo 8: Rear elevation from the service yard**

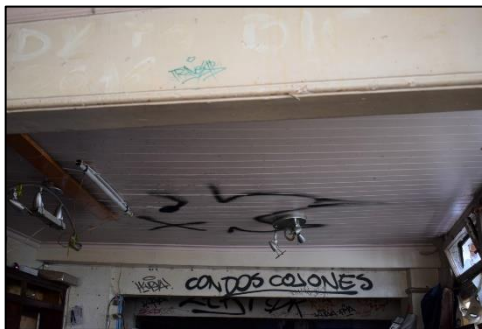
- 4.1.13 The plan of the ground floor interior comprises a large open plan bar area at the front (north) end of the building. This has a timber panelled ceiling and boxed in structural cross beams across the ceiling in the centre of the room (Photo 9). Narrow timber floorboards survive in areas of the room. A high level of original simply moulded timber architrave survives in this part of the building including skirting board, door and window frames, some picture and dado rail and cornices. Several narrow cast iron columns, present in the area of the basement entrance, add additional structural support.

**Photo 9: Panelled ceiling and boxed in structural cross beams within the ground floor bar**

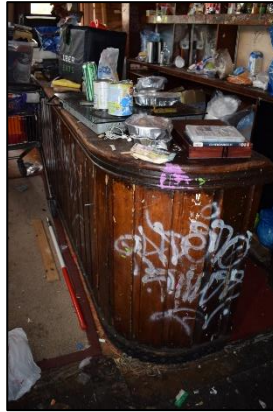
- 4.1.14 The primary surviving feature on the ground floor is the bar, which is located centrally within the ground floor plan. Most of the bar survives as a curving timber structure with flat counter surface, with moulded edge. Below this is vertical timber tongue and groove panelling above a moulded timber plinth, which has traces of painted decoration (Photo 10).

**Photo 10: Southern end of the bar with decorated plinth (scale 1m)**

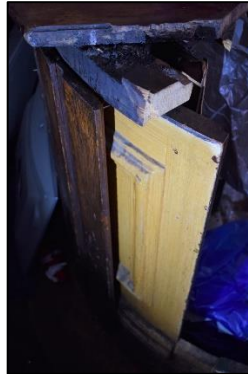
- 4.1.15 Areas of damage to the panelled sides of the bar, reveal earlier panelling beneath, which has a square architrave design (Photo 11). No features associated with the dispensing of alcoholic beverages have survived.

**Photo 11: Earlier bar panelling exposed beneath later panelling**

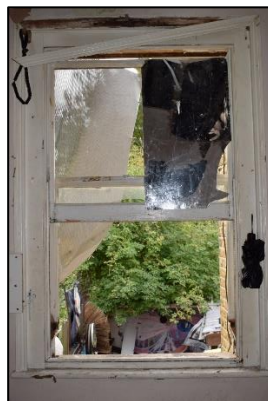
- 4.1.17 The original layout of the first-floor, which appears to have comprised four principal rooms, has been largely portioned to create additional rooms and corridors. Despite this, a large amount of simply moulded timber architrave survives throughout the first-floor including door and window frames, skirting board and picture rail (Photo 14 & 15).

**Photo 15: Surviving 1<sup>st</sup> floor window architrave**

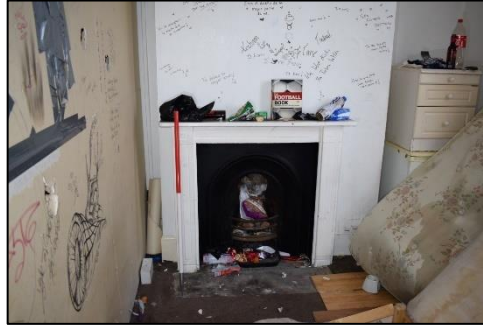
- 4.1.19 At the southern end of the first-floor, two bedrooms retain the original stucco fire surrounds, one of which has the original mid-19<sup>th</sup> century cast iron register grate. The original narrow floorboards are also present in some of the first-floor bedrooms.

**Photo 16: Original 1<sup>st</sup> floor mid-19<sup>th</sup> century stucco fire surround & cast iron grate**

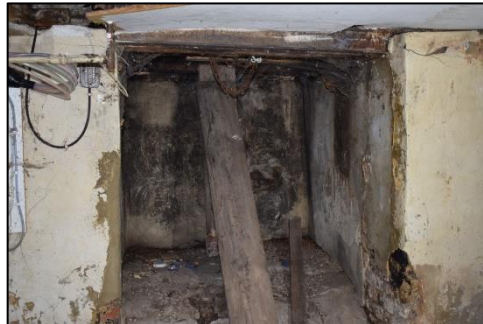
- 4.1.20 The basement floor plan mirrors that of the ground floor bar area, at the northern end of the building. The brick walls are largely plastered but some patches of the brickwork are exposed. There are very few features in the basement relating to the former use to the building, except for a dray chute accessed directly from pavement level, for the unloading of barrels into the basement (Photo 17). However, no rails associated with the chute survive.

**Photo 17: The interior of the basement dray chute hatch**
