**Bedlington Station High  
School,  
Northumberland  
Level II Historic  
Building Record**

AB Heritage Project No:10452

### Level II Historic Building Record

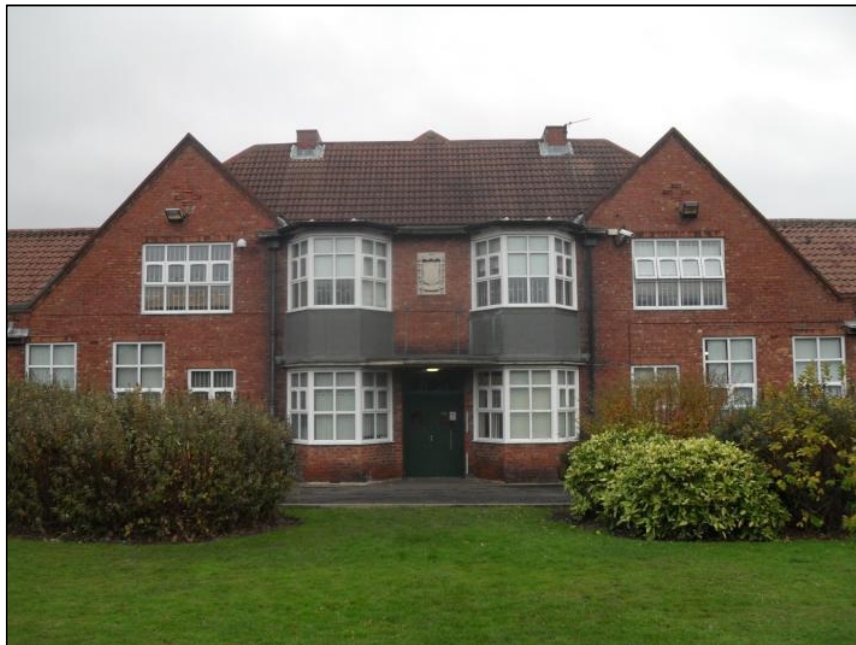
Plate 1: Main Entrance of Building 1, Viewed from South-West (Scale 2m)

- 3.3.1 The main block of the school consists of a quadrangle constructed of Stretcher bonded red brick with concrete eaves and a pitched pan tiled roof. The southwest facing main entrance consist of two pitched gables with projecting, three sided bay windows. A suspended wooden porch with a concave mid-section is located over the main entrance. An art deco style window is situated above the main doorway with a design containing circles and rectangles. A date stone is present above the main entrance with the school badge carved in limestone with the date 1925 (Plate 2). Four projecting bricks detail the top of the gables and 6 short rows of the same are present on the front corners.

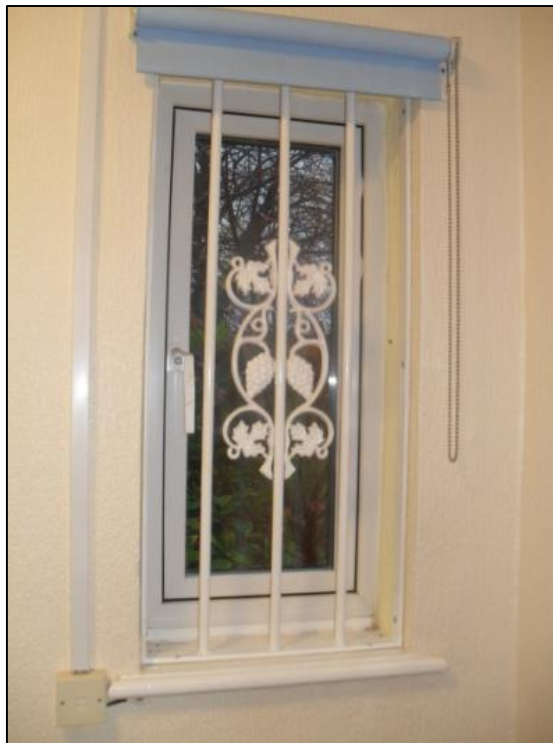
**Plate 5: Details of Window Grill in Building 3; Viewed from East**

- 3.3.10 The exterior of the building is the same construction as Buildings 1 & 2. A gabled porch is located on the south side of the building with projecting brick detail. A coal store is located on the north side of the building. The loft was not accessed during the survey.
- 3.3.11 The interior is mostly modernised and consists of classrooms, offices and storerooms. All of the windows have ornate cast iron grills (Plate 5) of the same design as present in the stairway of the main block (Building 1).

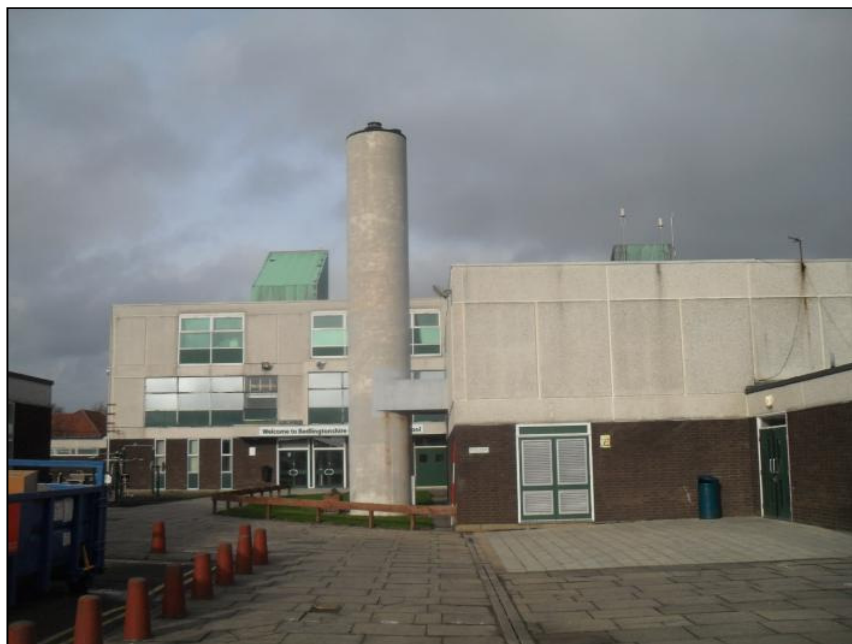
**Plate 6: View of Buildings 9 & 10; Viewed from South-East (Scale 2m)**

- 3.3.18 The 1970's buildings are all of the same design and construction. They consisted of dark brown, Stretcher bonded bricks and concrete with large single glazed windows. A large concrete boiler tower is located adjacent to the west end of the Sports Block (Building 10) (Plate 6). The interior of these buildings are modern.

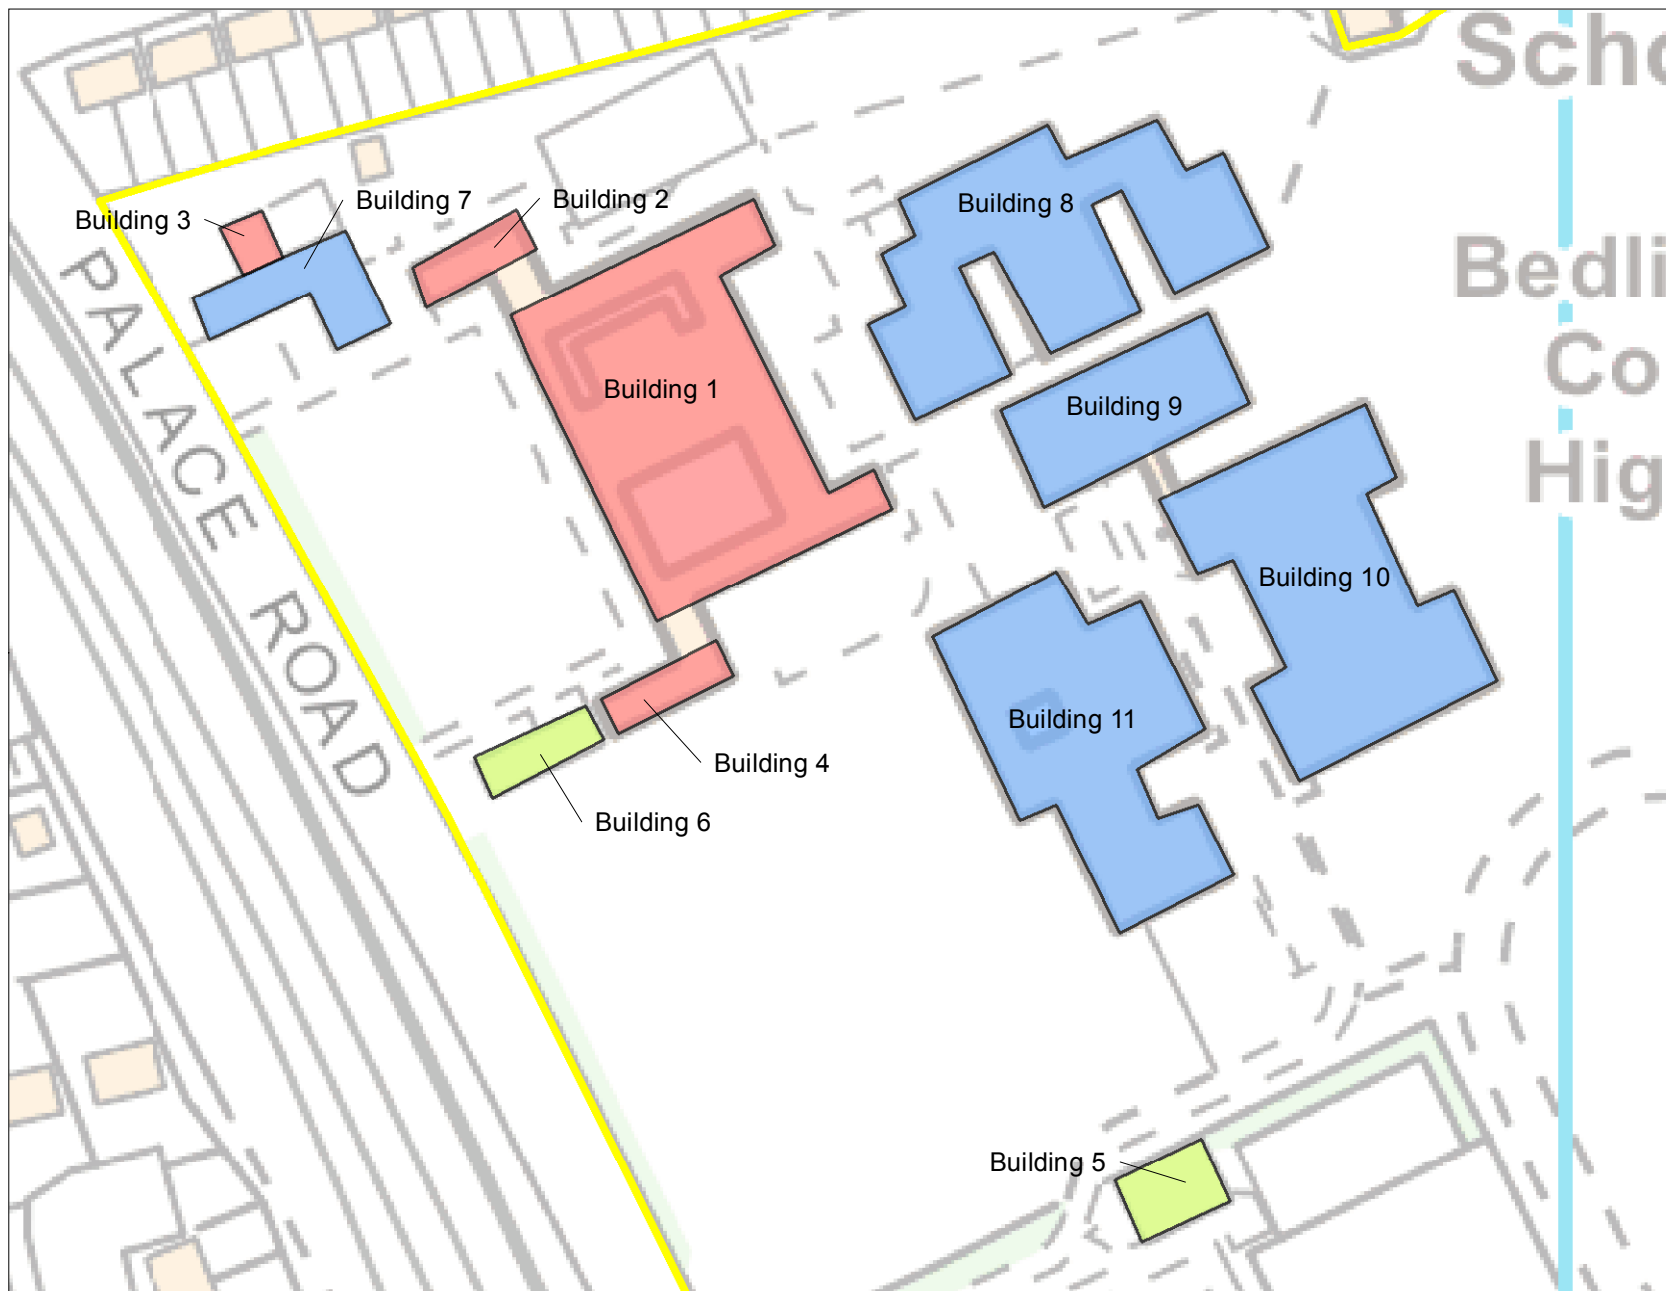
Figure 8: Phase Map

- 3.2.10 The 1960 25-inch Edition of the Ordnance Survey Map shows the complex with extensions on the east side of the main block (Building 1). There is an additional building on the south side of the complex and the former air raid shelters are depicted along the north and east boundaries.
- 3.2.11 The plans and elevations for the late 20<sup>th</sup> century additions to the school date to 1972-73. These show the additional buildings on the east and south side of the complex much as they are depicted on the modern map.
- 3.2.12 The 1993 6-inch Edition of the Ordnance Survey Map shows the school complex much as it is shown on the modern edition of the map. Several of the ancillary buildings shown on the 1960 Edition of the map are no longer extant, including the south part of Building 3 which has been replaced by a building on the same location (Building 7).

- Site Boundary
- Phase 1: 1925
- Phase 2: 1934-1960
- Phase 3: 1970s

- 3.2.2 The Governors meeting minute books examined at the Northumberland Record Office indicate that the first phase of the school (Buildings 1 – 5, Figure 8) was constructed during first half of 1925 and preparations were made toward the end of that year for the appointment of the staff, including the first Head Master (Mr Arthur. J. Williams). Prior to this, the site had been undeveloped agricultural land. Provisions were also arranged for the grand opening of the school, which was carried out by Her Grace the Duchess of Atholl on Wednesday 6<sup>th</sup> October 1926. At the time the school was opened, the 122 pupils were charged £3 per term to attend, not including the 8d charge for their school dinner.
