**Bedlington School,
Northumberland
Archaeological Field
Evaluation**

Client: GALLIFORD TRY

AB Heritage Project No: 10486

Date: 30/03/2015

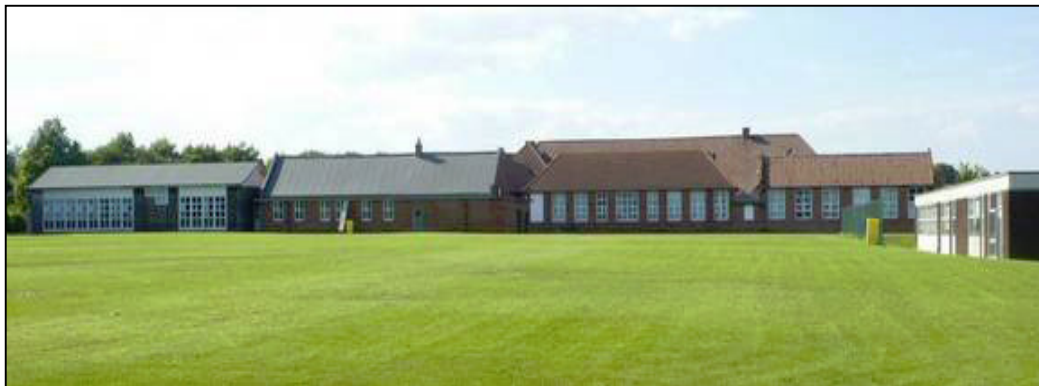
Plate 1 View of evaluation area prior to excavation

- 2.2.1 The proposed development site (hereafter referred to as the site; Plate 1) is located approximately 2km to the east of Bedlington, Northumberland, within an urban environment at centre point NZ 27997 82697; the eastern boundary of the site lies adjacent to the line of the A183.

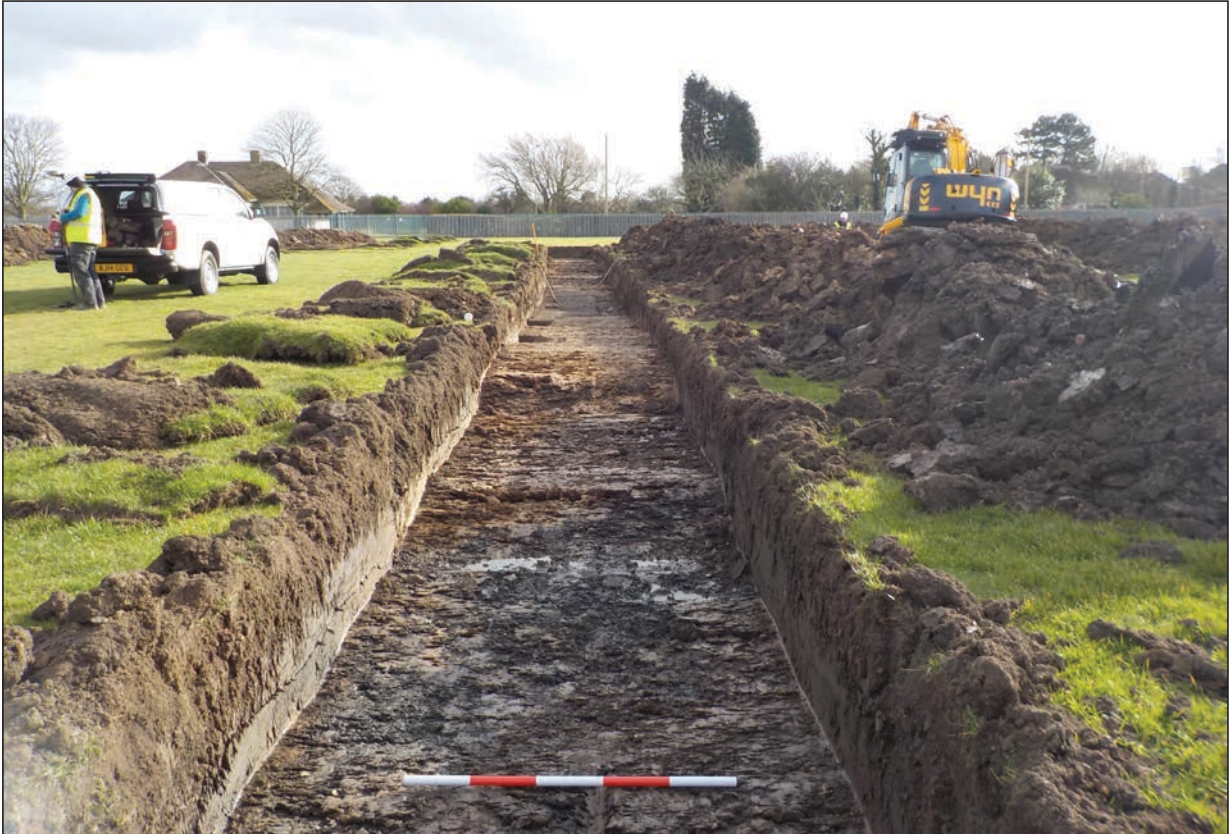
Plate 2 - View of Trench 2, facing SSE

- 6.1.1 A single feature of anthropogenic origin was identified in Trench 2, a shallow linear gully which ran for 13 m north-south before turning east-west. The sterile nature of the fill provides no evidence as to its function.

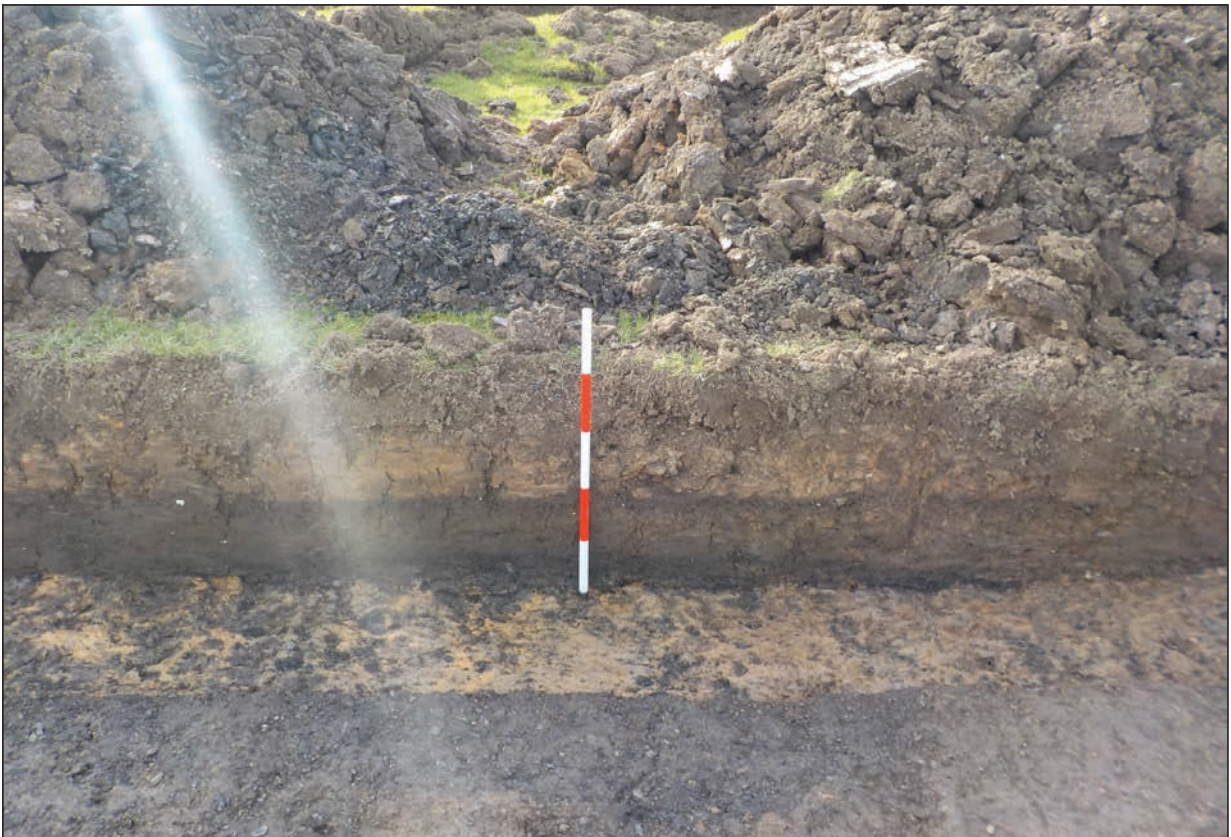
Plate 5 - View of Section face of Trench 2, facing WSW

- 6.1.3 The entire site had been levelled at some point, most likely when the school was originally being constructed and this can be seen as a layer of dark grey clay with inclusions of early modern pottery and coal beneath the topsoil (Plate 5).
