Romsey Railway Station, Romsey, Hampshire Historic Building Recording

Client: AHR ARCHITECTS

AB Heritage Project No:10683

Date:24/11/2015

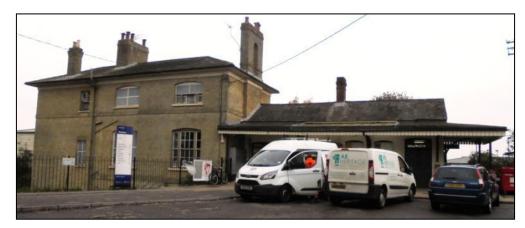
Photo 1: Romsey Railway Station from the south

- 1.1.3 The station building at Romsey is considered to be a substantially intact example of a Classical style station building (Photo 1), with the Stationmaster's House part of the complex retaining a large amount of original joinery. The attached booking hall (Photo 1) and the waiting room on the northern (up line) platform retain the original fretwork canopies supported on cast iron columns (Historic England, 2004). The station also boasts a rare surviving fenestrated chimney (Photo 1) (Hampshire Archaeology & Historic Building Record (ABHR), 2004). The station buildings have changed little since the 1880s.

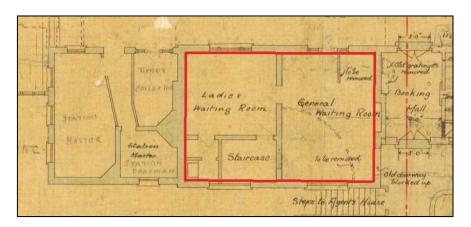
Plate 3: Extract from L&SWR Romsey Station Improvements Drawing 1. The rooms to be altered are outlined in red (Network Rail Corporate Archive)

- 3.3.3 The plan shows the layout of the present waiting room and lobby has changed very little since the 1880s. The present waiting room was then known as the General Waiting Room. An additional partition wall extended to the south from the waiting room door and a part circular, possible temporary screen was located on the southern side of the waiting room. Both of these features were earmarked for removal on the 1880s plan (Plate 3).

- 3.3.4 There is an additional partition shown within the area of what is now the ladies WC that is no longer extant (Plate 3).
- 3.3.5 The drawing of the north elevation of the station building (Plate 4) shows that the doorway on the north side of the waiting room has remained relatively unchanged since the 1880s, apart from the fact that they have been refenestarted with the insertion of some additional glazing bars.

- 4.1.1 The waiting room is located within the original 1840s Stationmaster's House part of the station building. Analysis of the historic plans (Plate 3) has identified that the layout of the room has changed little since the 1880s, with the removal of a short partition wall that extended to the south from the waiting room door and a part circular, possible temporary screen that was located on the southern side of the waiting room. There is no clear evidence for the features that were removed during the 1880s.

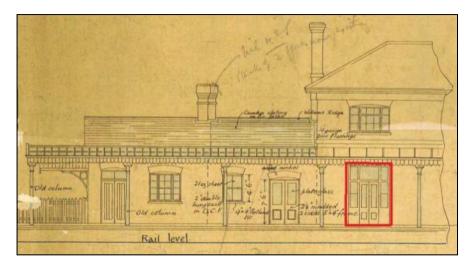
Plate 4: Extract from L&SWR Romsey Station Improvements Drawing 1. The doorway to be removed is outlined in red (Network Rail Corporate Archive)

- 3.3.6 The drawings of the southern and northern elevations of the station building (Plate 4), have identified that the doorways of the present station booking office, have been altered since the 1880s.

- 5.1.2 The historic drawing of the north elevation of the station building, likely dating to the c.1880s (Plate 4), has identified that the doorway on the north wall of the waiting door is laid out in its original position. The door itself may be the same door as that shown on the elevation drawing (Plate 4 & Photo 5).

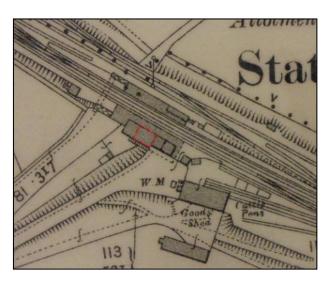
Plate 5: Extract from 25" OS map published 1909. The building to be altered is outlined in red (Romsey Local Studies Library)

- 25" OS map sheet 16:4, surveyed 1865-6, revised 1908 & published 1909 (Plate 5)
- 3.3.7 The edition of the OS map published in 1909 shows the station buildings much as they are shown on the 2nd edition on the map published in 1897. The station building has been substantially extended to the south-east, with an additional small extension on the north-east side of the Stationmaster's House part of the building, following the implementation of the proposed improvements outlined on the previous plan.

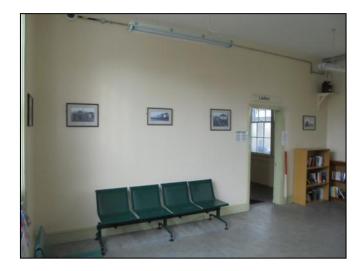
Photo 4: View of the interior of the waiting room, from the south-east, scale 1m

- 4.1.2 The interior of the waiting room has painted walls of plaster or plasterboard with a large original wooden sash window in the southern wall, with panels of four lights on either side of the main sash window. The floor has a linoleum covering.

- 4.1.3 Skirting board is present around the base of all of the internal walls and architrave is located around the door and window frames.
- 4.1.4 A double casement door is located on the northern wall of the waiting room (Photo 5 & 6).

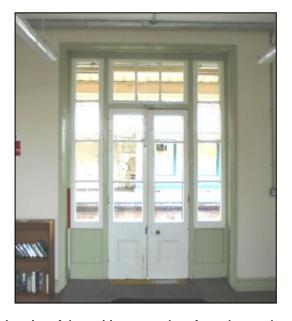
Photo 6: Interior of the waiting room door from the south, scale 1m

The frame has a rectangular three light overlight window above the door and rectangular four light side panels. The lower section of the door and doorframe has a wooden panel.
- 4.1.5 It is possible that the door is the original one shown on the 1880s elevation (Plate 4), although the door frame appears to have been refenestrated with additional glazing bars inserted.
- 4.1.6 A brass mortice lock and hook plate are located on the interior of the door, although part of the lock has been replaced (Photo 7). Brass knobs are present on both sides of the western of the two doors.

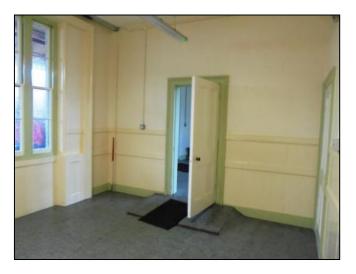
Photo 8: The lobby viewed from the south-west, scale 1m

- 4.1.8 The interior of the lobby has painted plaster or plasterboard walls with joinery consisting of mid height panelling, skirting boards and dado rail. Architrave is present around the door and window frames and two large sash windows are located in the northern and southern walls, in the same design as the window in the waiting room, (Photo 8). A small area of the panelling on the western wall of the lobby has been removed in an unrelated event (Plate 9).

- 4.1.9 An unused doorway in present in the south-east corner of the lobby that leads to a disused staircase. A WC is located in the south-west corner with mid height tiling and a toilet and hand basin attached to the western wall.

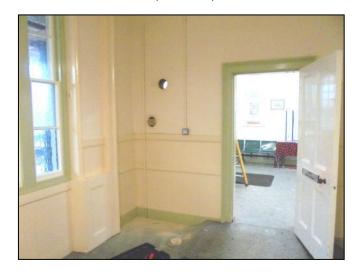
Photo 10: Position of the exploratory holes on the lobby side of the wall, from the west

- 4.2.1 Four exploratory holes, located in the position of the proposed new doorway, in the north-east corner of the lobby, were monitored on the 17th November 2015 by Kerry Kerr-Peterson (Assistant Project Officer, AB Heritage) (See Figure 2). The exploratory holes were made using a 0.16m diameter circular drill mount.
- 4.2.2 Two exploratory holes were made on the lobby side of the wall (Photo 10). The decision was taken during the exploratory works to avoid the disturbance of the original panelling at this stage to avoid any unnecessary damage. Therefore, both of the exploratory holes were positioned above the level of the dado rail (Photo 10).

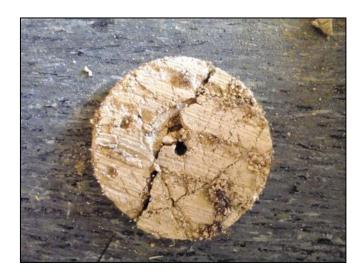
Photo 11: Details of the plaster from the lobby side of the wall, with timber lathe impressions

4.2.3 The holes on the lobby side of the wall identified that the wall is constructed of a series of vertical stud wall timbers with the width of c. 0.15m, spaced c. 0.3m apart. Horizontal timber lathes have been tacked onto the timber studs and covered with several layers of lime mortar based plaster, containing horse hair, to a thickness of c. 0.02m (Photo 11). This is likely to pre-date in introduction of plasterboard during the 1930s.

- 5.1.3 The exploratory works undertaken in the proposed position of the new doorway between the present lobby and waiting room (See Figure 2), have identified that the wall and panelling on the lobby side of the wall are original features of the building, with the wall constructed from lathes and plaster with horse hair inclusions (Photo 11, 12 & 14), pre-dating the introduction of plasterboard during the 1930s.

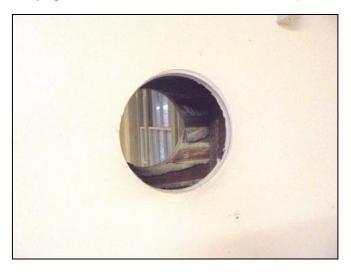
Photo 12: The back of the timber lathes with plaster keying, from the waiting room side of the wall

4.2.4 The upper exploratory hole was drilled through to the waiting room side of the wall (Photo 10 & 13). This identified that the waiting room side of the wall had been constructed from plasterboard, likely to have been replaced sometime after the 1930s. The back of the timber lathes were exposed in the upper of the two exploratory hole on the waiting room side of the wall, with the plaster keying visible on the back of the timber lathes (Photo 12).

- 5.1.4 The exploratory works also identified that the waiting room side of the wall has been replaced with plasterboard. This is likely to have been undertaken as a part of the scheme of refurbishment works carried out during the 1980s.

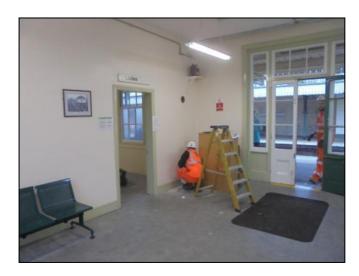
Photo 13: Position of the exploratory holes on the waiting room side of the wall, from the south-

4.2.5 The back of the timber panelling was exposed in the lower exploratory hole on the waiting room side of the wall (in front of the Sisk Rail contractor in Photo 13). This identified that the timber panelling forms the lower part of the wall on the lobby side and that the lathe and plaster part of the walling does not continue behind the panelling (Photo 14).

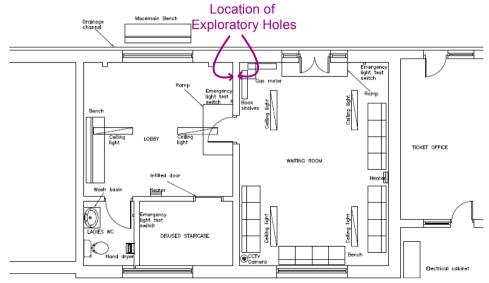
Figure 2: Existing Development Plan & Location of Exploratory Holes

- 1.3.1 The proposed development involves a scheme to improve accessibility to the station facilities. This includes a full refurbishment and change of layout of the ladies WC area to incorporate a new accessible toilet located within the original 1840s Stationmaster's House part of the station building (See Figure 2).

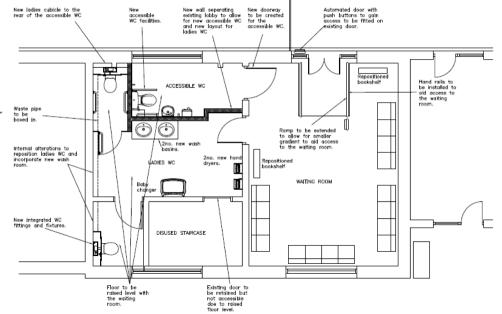
Figure 3: Propsed Development Plan

- 1.3.2 This will include raising the floor level in the lobby to match the adjacent waiting room. Installation of a new wall on the northern side of the lobby to allow for the insertion for a new accessible WC with improved ramped access.

- 1.3.3 There will be an additional ladies WC and the replacement of the doorway on the north wall of the waiting room, with automatic doors proposed for this doorway and the booking hall. New signage will also be installed.

- 1.3.4 The improvements also include the insertion of a new doorway in the north-east corner of the western wall of the waiting room, for improved access to the new, more accessible WC. This will involve the removal of a section of original skirting board, panelling and dado rail on the lobby side of the wall.
