**No. 24 Stone Street,
Gravesend, Kent**

**Level 3-4 Historic
Building Recording**

Client: DAC ARCHITECTS

AB Heritage Project No:10713

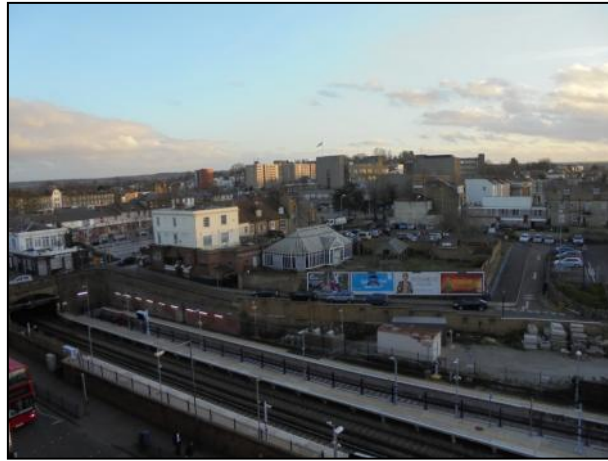
Photo 1: View of No. 24 Stone Street (white building, mid left), from the north

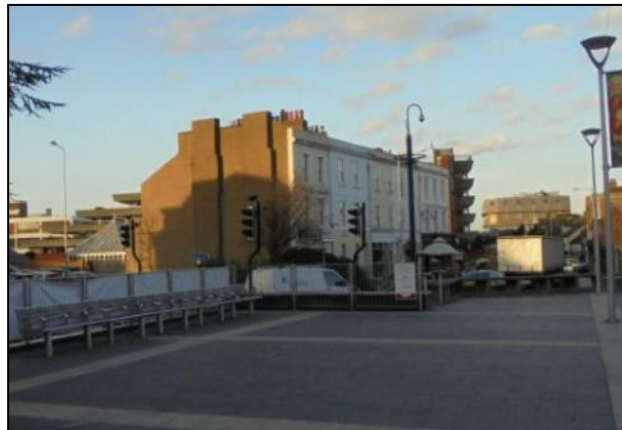
Photo 2: View of No. 24 Stone Street (far end of the terrace) from the Civic Centre to the west

- 1.1.3 No. 24 Stone Street forms the northern end of a Grade II Listed terrace of five buildings (Nos. 20-24), which together, English Heritage (now and hereafter Historic England) considers to form a heritage asset group (Photo 2). No's 21-23 originally formed a part of the earlier Gravesend workhouse, erected in 1797, while No's 20 & 24 were added in 1847, when the workhouse was converted into housing and the remainder of the workhouse complex was demolished.

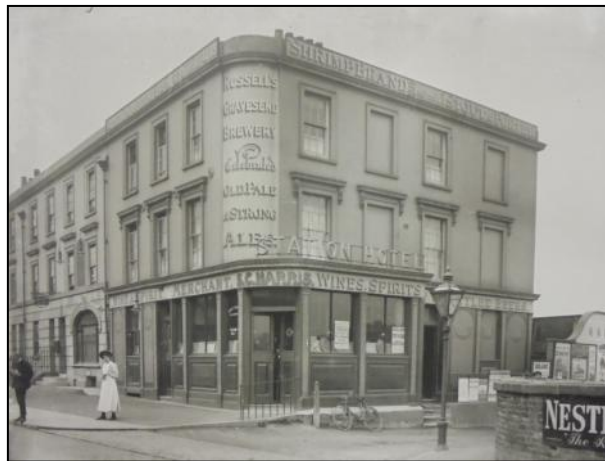
Plate 1: The Station Hotel (No. 24 Stone Street) from the north-east c. 1920 (GLSL)

- 3.3.3 The house at No. 24 Stone Street was established as the Bricklayers Arms public house sometime around 1851 (Baines, 2010). The name of the pub may have been inspired by the profession of the owner at this time, Thomas Carley, who in 1859, is also recorded as a builder (Kelly's Trade Directory, 1859).
- 3.3.4 At this time the address of the property was No. 16 Stone Street and the 1867 Trade Directory recorded the address as No. 16 Victoria Place. Photographic evidence has identified that by c. 1915, the ground floor of the building had a timber panelled frontage with glazed upper sections and vertical pilasters (Plate 1).

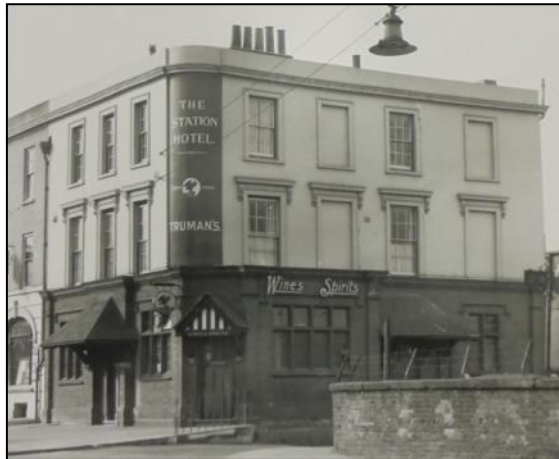
Plate 2: The Station Hotel between c. 1930 and 1960 showing the first floor brick facade (GLSL)

- 3.3.5 The Trade Directories indicate that the name of the pub changed to the Station Hotel between 1918 and 1922. This may have been to promote the business as a hotel, taking advantage of the properties close proximity to the railway station. It is also around this time that the address of the property changed to No. 24 Stone Street.
- 3.3.6 The Station Hotel remained a prosperous establishment through until at least the 1960's; with photographic evidence suggesting that the ground floor timber frontage of the building was upgraded to brick sometime between c. 1930 and 1960 (Plate 2). The extent of the remodelling of the underlying facade carried out during the construction of the brickwork is unclear.

- 6.1.2 Photographic evidence suggests that the ground floor timber frontage was upgraded to brick between c. 1930 and 1960 (Plate 2). Towards the end of the 20th century the pub became known as the Station Inn. It was around this time that the prosperity of the public house began to decline. Local newspapers report a number of episodes of dereliction during the 1970s and the 1990s.

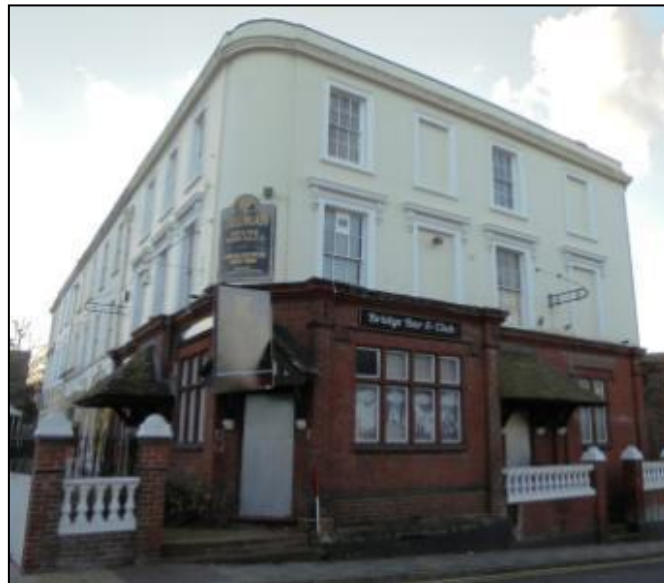
- 5.1.2 All of the windows have raised mouldings. The first floor windows have a cornice above, supported by moulded corbels at each end. The northern elevation has two blind windows on the first floor and a further two on the second floor (Photo 3).

- 5.1.3 The ground floor has a brick facade with timber canopies above the entrances on the northern and eastern elevations (Photo 3). The ground floor of the western facade is obscured by a modern, gothic style brick extension.

Photo 3: No. 24 Stone Street from the north-east

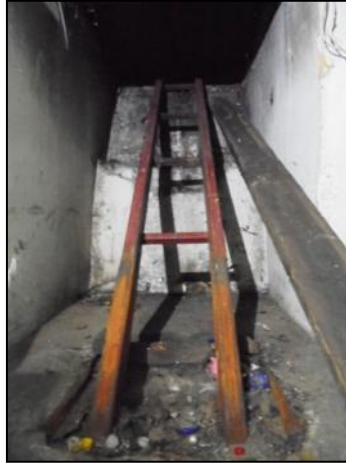
- 5.1.4 The basement is accessed via a flight of steps from the ground floor. There is a concrete floor, painted brick walls and a modern layer of chipboard obscure the ceiling. A likely original brick pillar supports the floor above. A hatch and chute from the pavement level is present in the eastern wall of the basement. Two parallel fragments of iron rail are present within the chute recess (Photo 4) suggesting an earlier mechanism for moving barrels involved the use of a system of rails within the floor of the basement, although no further evidence for this system was observed.

Photo 4: Rails in the basement floor

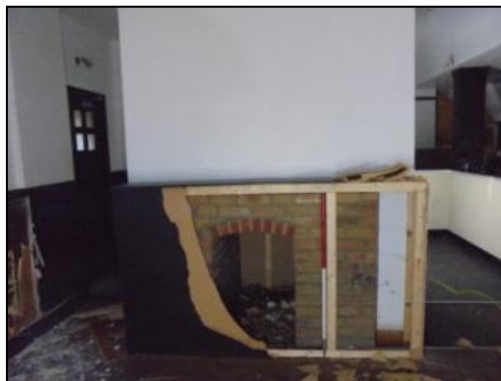
- 5.1.6 The main area of the ground floor has undergone a substantial amount of alterations and there are few original walls or features surviving in this part of the building (Figure 4). No surviving evidence was observed for the social division of the original bar area. A modern brick built extension and conservatory is present on the western side. The entire original part of the ground floor is now open plan with a concrete floor covering by timber flooring. The walls have been covered with several layers of modern chipboard panelling.
- 5.1.7 The original chimney stack, now located on the eastern side of the open plan room has been modified to form a single heath open on both sides (Photo 5).

Photo 5: Main chimney on the Ground floor, scale 1m

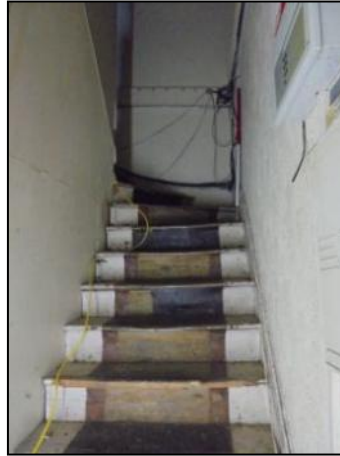
- 5.1.9 The likely original timber stairs are present within the stairwell. Only one tread appears to have been replaced. Remnants of an earlier floral central stair carpet are present with brass edging plates. The position of a narrower, earlier stair carpet is evident (Photo 6).

Photo 6: Stairwell 1 from the ground floor, scale 1m

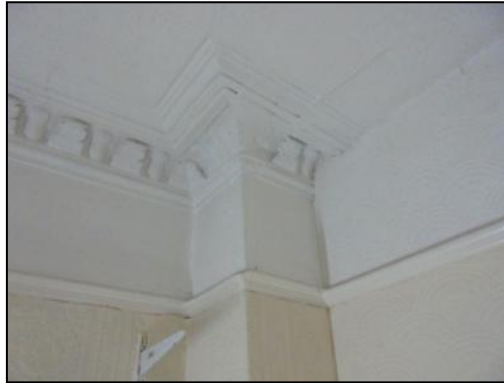
- 5.1.11 The rooms have a number of existing likely original mid-late Victorian features including coving with an acanthus leaf design that spreads out onto the ceiling, ceiling roses with matching design, moulded picture rail, and high skirting boards. There are two arches alcoves either side of the chimney stack at the southern end of the room 2.

- 5.1.12 There are two likely original matching mid-Victorian Classical style fireplaces at the opposite end of the each room. These have white marble surrounds and cast iron, round arch topped register grates. The likely original door architrave survives in room 2 but has been replaced in room 1.

Photo 7: Truncated coving and picture rail in room 1 on the first floor

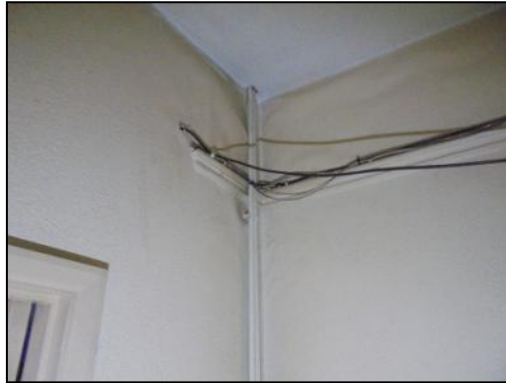
- 5.1.15 Picture rail and skirting board survives within the kitchen and hallway areas of the room, the former curving around the inside of the Gravesend corner. The likely original door architrave is present on the inside of the doorway leading from hallway 1. A right angle of picture rail at the corner of the chimney stack survives within the partition wall within the hallway area (Photo 8).

Photo 8: Picture rail turning a corner, now within a hallway outside room 3 on the first floor

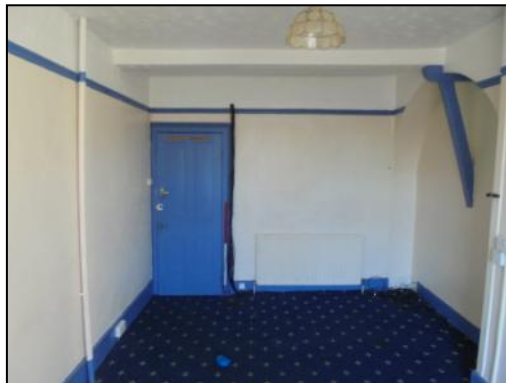
- 5.1.16 Room 4 has a large rounded alcove on the western side of the chimney. A likely original timber beam protrudes from the alcove and connects with a beam that runs along the ceiling (Photo 9). The fireplace has been covered and the skirting board has been filled in over the gap. A later doorway has been inserted into the alcove on the eastern side of the chimney. The room contains a number of likely original features, including picture rail, skirting board and architrave around both sides of the door. A timber sash window is present on the eastern elevation.

Photo 9: Alcove and beam within room 4 on the first floor, scale 1m

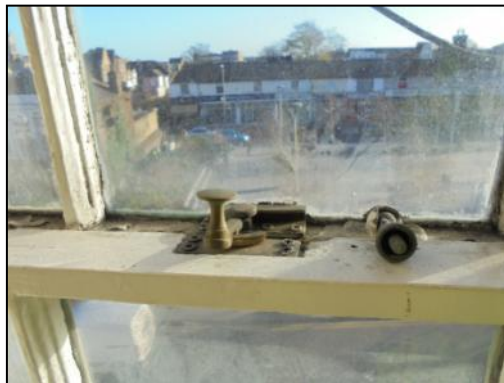
- 5.1.21 A likely original timber lathe and plaster partition wall separates rooms 8 & 9 from room 7 and another divides rooms 8 & 9. A 12 pane timber sash windows are present on the eastern elevation within recesses in the sloping ceiling on the eastern side. The windows retain brass 19th century lever catch and plates. The window in room 8 has an additional probable later lock (Photo 10). The eastern part of the main chimney is present on the northern wall of room 8. The interior door architraves are likely to be original; although the plain skirting boards are probable replacements.

Photo 10: Sash window lever catch, plate and lock on a window in room 8 on the second floor

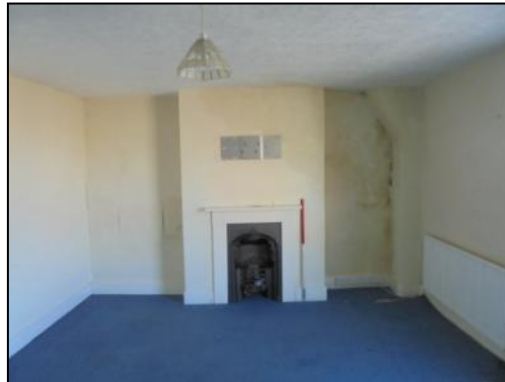
5.1.23 Room 10 retains an off centre mid-late Victorian, single piece cast iron register fire grate with a plain timber surround. Room 11 has a Regency style central late Victorian cast iron register fire grate in a, with a plain timber surround (Photo 11). Alcoves are present on both sides of the fire grates in both rooms. A vertical linear feature is present within the south-west corner of room 11, the function of this features is unclear although it is likely to be structural (Photo 11).

Photo 11: Regency style late Victorian fire grate in room 11 on the second floor, scale 1m

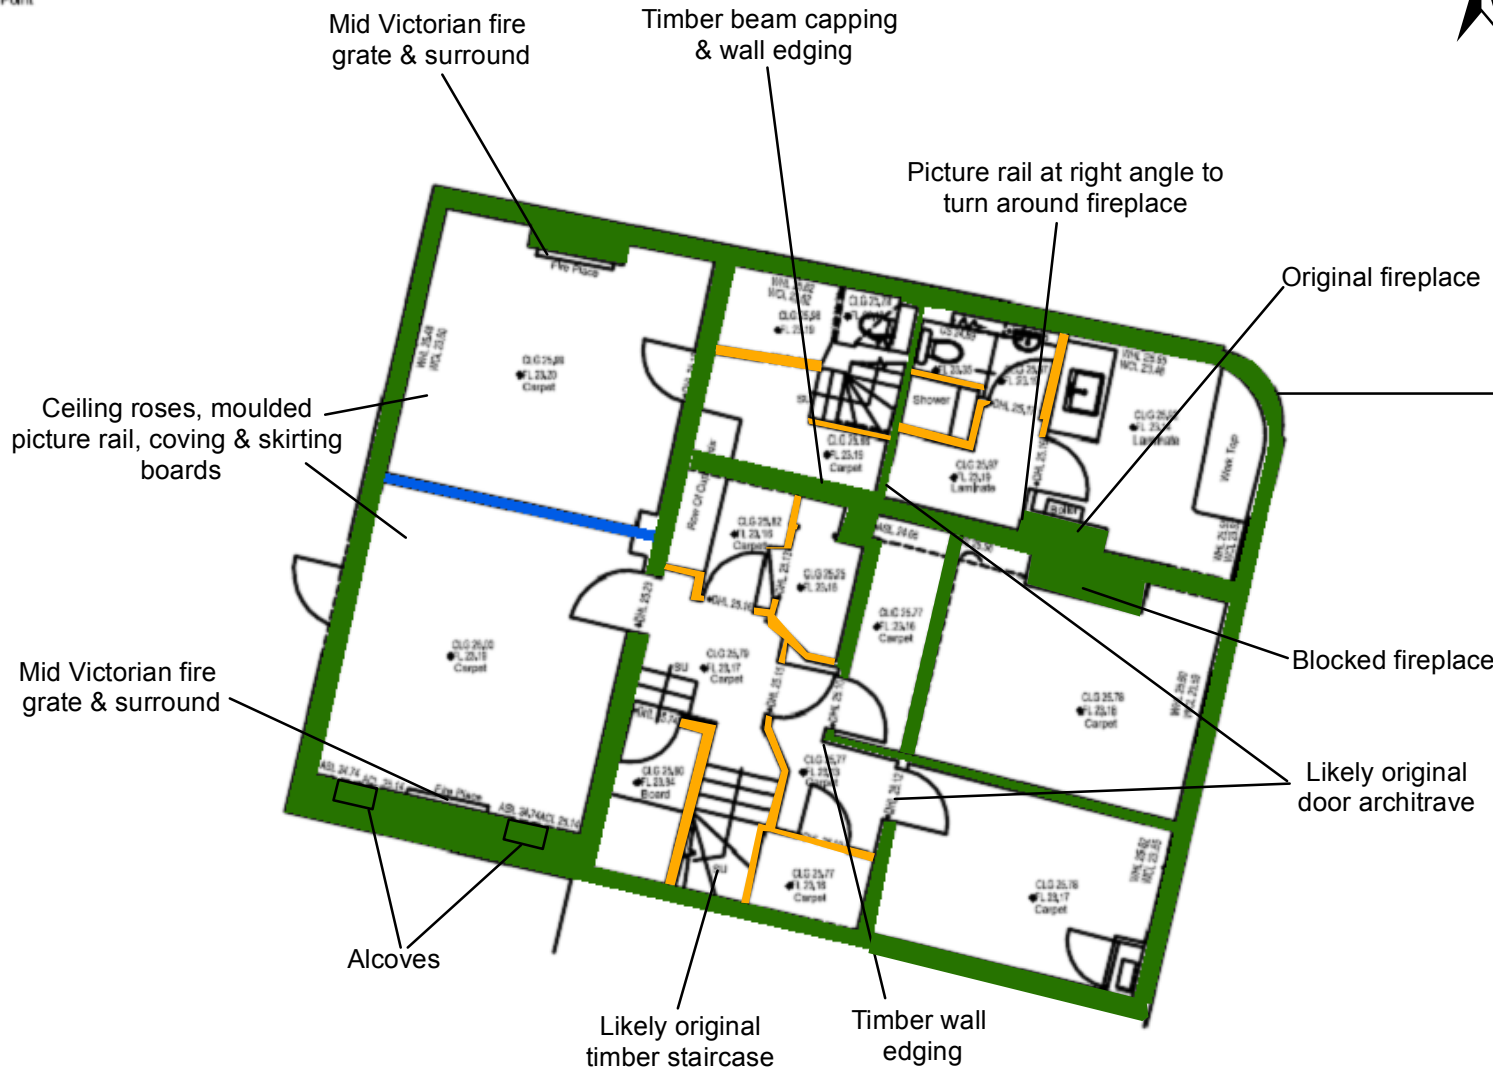
Figure 6: Annotated Existing First Floor Plans

The Historic Building Recording has identified that there is good survival of the original internal walls within the first and second floors of the building (See Figures 6 & 8). There is also considered to be a relatively good level of survival of likely original architectural features including architraves, ceiling roses, fire grates and surrounds. The historic building recording has also confirmed a good level of survival of the external features highlighted in the 1975 Historic England listing details. The extent of the survival of the underlying ground floor facade following its remodelling between c. 1930 and 1960 is unclear.

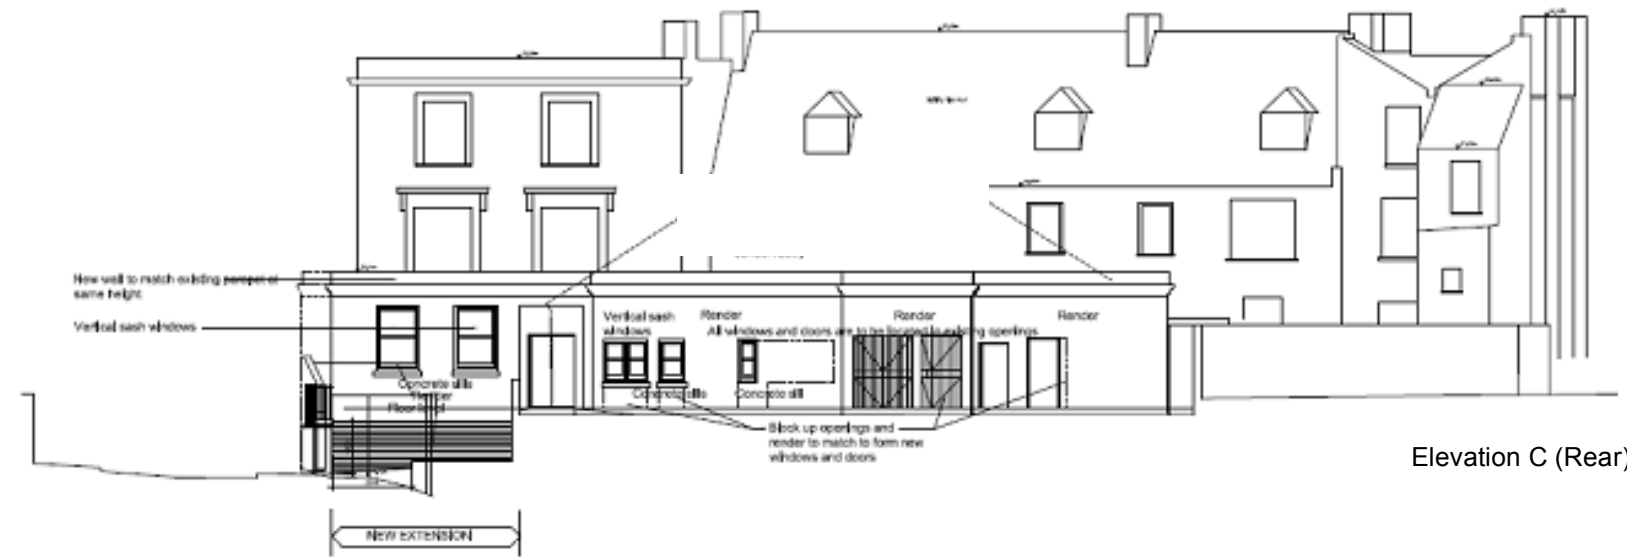
Elevation C (Rear)

Figure 11: Proposed Elevation Plans
