**Hindlip Hall,
Worcestershire**

**Geophysical Survey
and Archaeological
Evaluation**

Client: West Mercia Police and Crime
Commissioner

AB Heritage Project No:10800, OASIS ID
abherita1-254716 & 254720, Worcestershire
Archaeology & Archive Service Ref.
WSM67932 & WSM67933

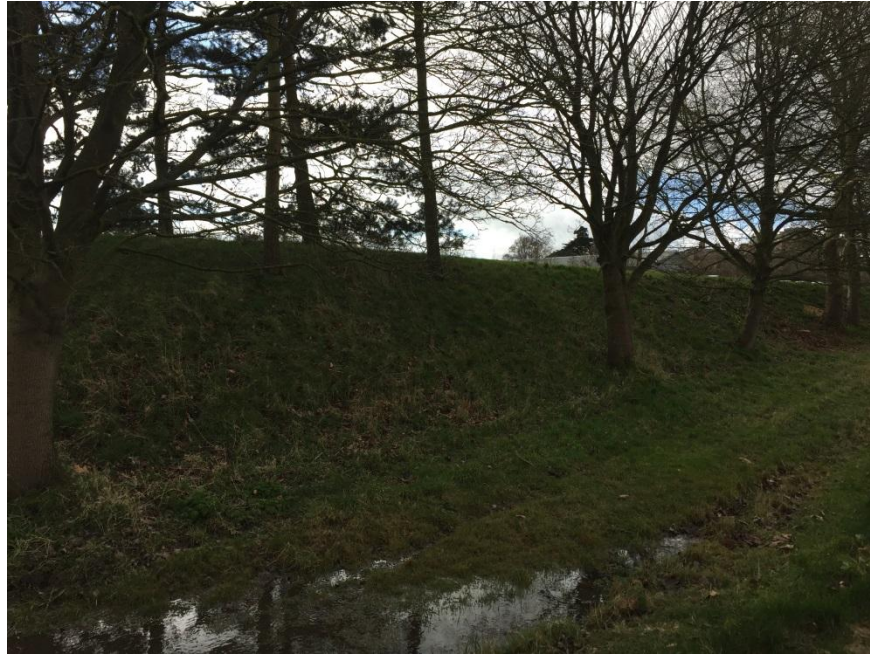
Plate 1: View of the area of banking for the sports ground in the north east corner, facing south west.

- 4.2.1 The site to the west is situated on the sports/dog training ground, which has been banked to create a flat playing surface and the area of banking was unable to be traversed (plate 1).
- 4.2.2 To the north of the site is the entrance road to Hindlip Hall and the area of landscaped ground running along its northern edge (Plate 2).
- 4.2.3 To the western side of the sports ground is an area of hard standing, which is currently being used for storage of police fleet vehicles (Plate 3).

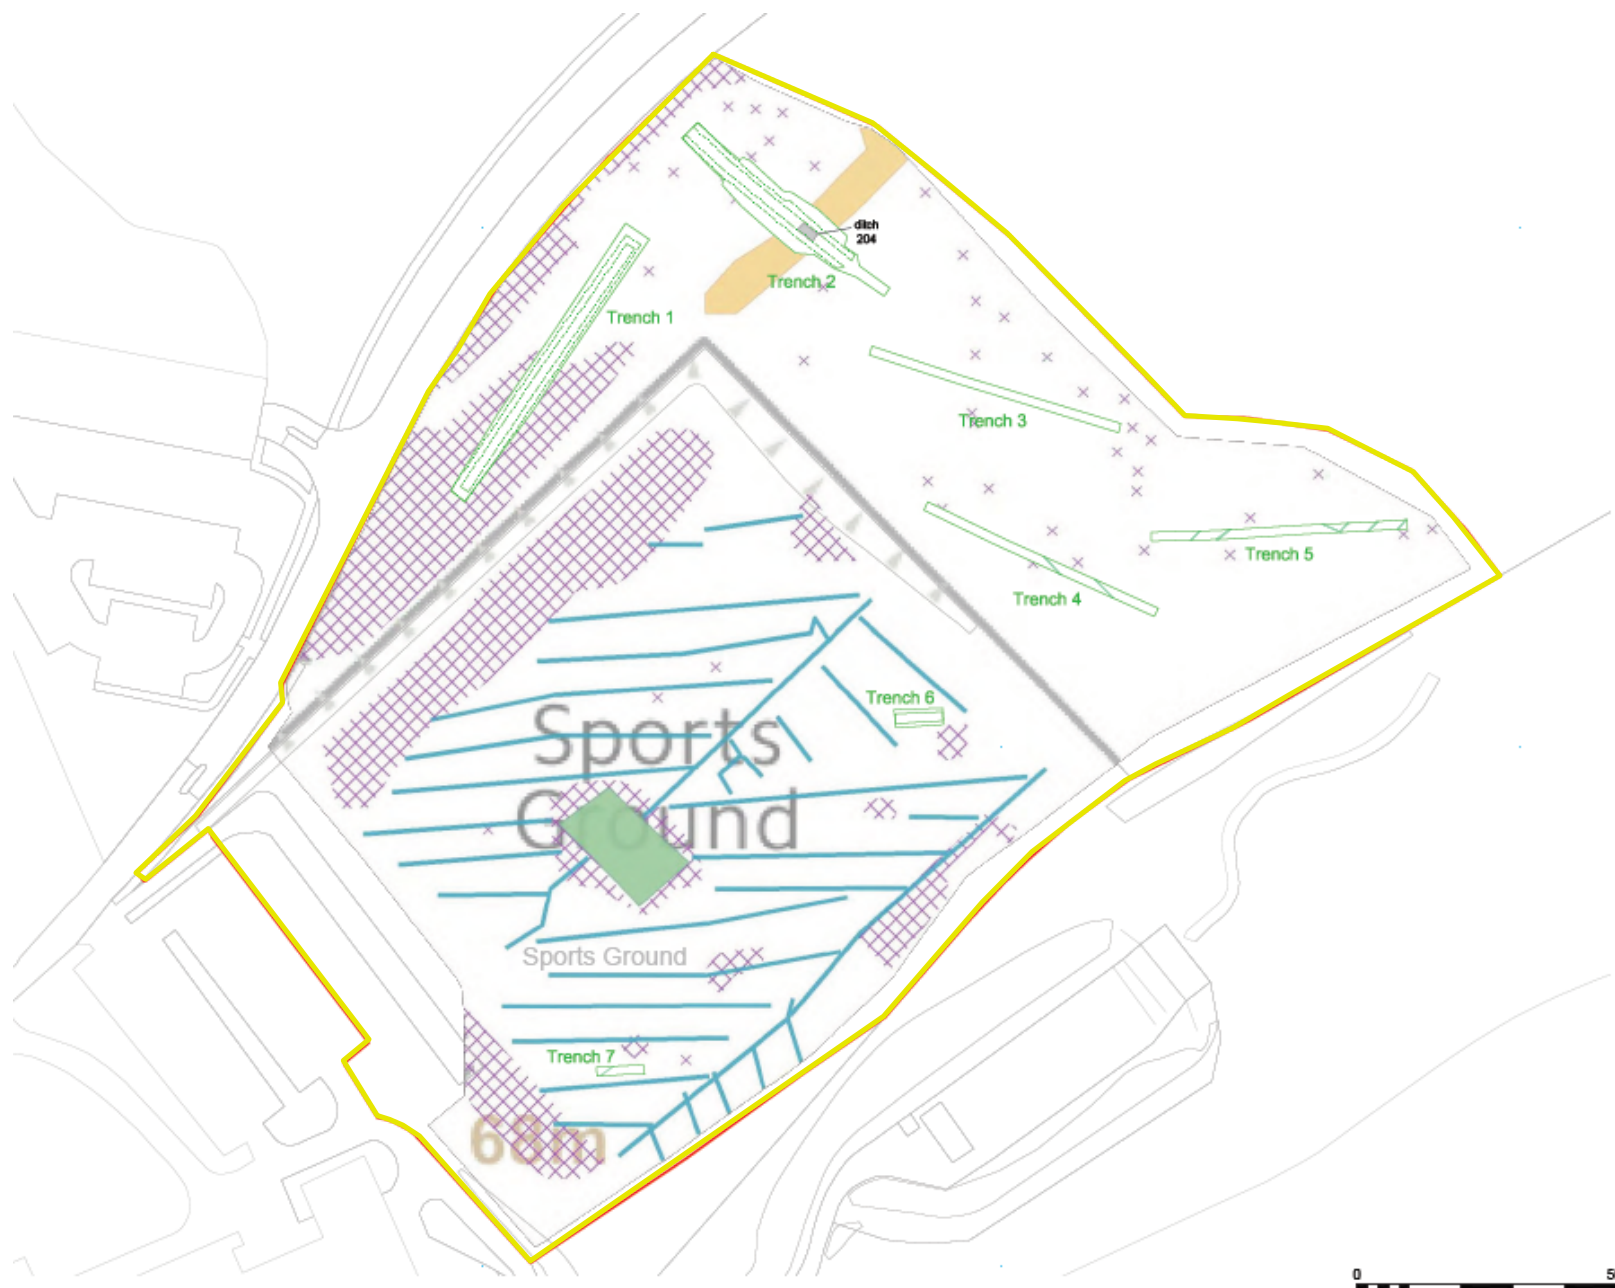
Figure 5: Trench Location Plan, Showing Modern Feature & Geophysical Survey Results

- 5.1.2 The evaluation comprised the excavation of seven trenches in the locations shown on the attached plan (Fig. 5). Trenches 1 to 5 measured 50m long and 1.8m wide, equating to a 4% sample of this 1.2ha area. Trenches 6 and 7 measured 10m in length and 1.8m in width. Trenches were set out on OS National Grid (NGR) co-ordinates using Leica GPS and surveyed in accordance with *CA Technical Manual 4: Survey Manual*.

- 5.2.1 This section provides an overview of the evaluation results (Figs. 5-7). Detailed summaries of the recorded contexts are to be found in Appendix 2.
- 5.2.2 The evaluation recorded an undated ditch within Trench 2 (Figs. 5 and 7). No archaeological finds, features or deposits were observed within the remaining trenches.

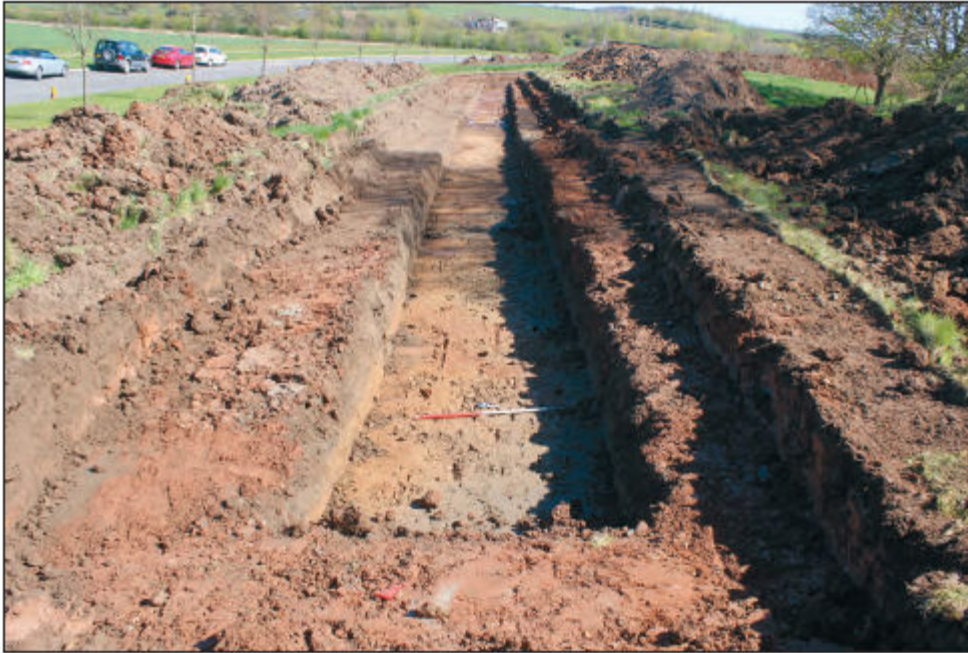
Figure 6: Trench 1, looking north-east (1m scale)

- 5.2.3 Trenches 1 and 2 were located within the northern part of the site, partially excavated through a modern embankment. These trenches were specifically located in order to try to capture the continuation of the Iron Age pit alignment identified in 2009. A broadly similar stratigraphic sequence was identified within both trenches. The natural geological substrate, which comprised mid grey red clay with small stone inclusions, was observed at between 1.33m (Trench 1) and 1.85m (Trench 2) below present ground level (bpgl). This was overlain by a buried soil layer, up to 0.4m in thickness, which comprised grey brown compact clay silt with small stone inclusions. This most likely represents the former topsoil. This was overlain by redeposited natural, comprising light brown red compact clay with stone inclusions, up to

0.74m thick. This material was presumably deposited during modern landscaping associated with the creation of a new site entrance to the immediate north-west of the site. This was in turn sealed by topsoil, up to 0.34m thick.
