Bond Memorial Church,
Adelaide Terrace,
Benwell, Newcastle
upon Tyne
Level 2-3 Historic
Building Recording

AB Heritage Project No:10871

## **Level 2-3 Historic Building Recording**

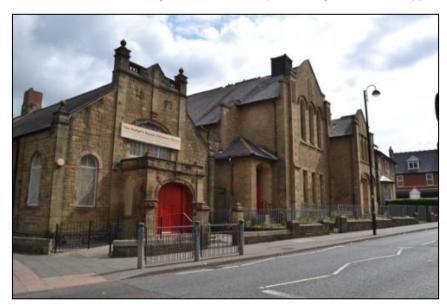
Photo 1: View of the Church complex from Adelaide Terrace

- 4.2.2 The eastern bay has two flanking arcaded doorways at ground floor level, the western of which has a modern ramp leading up to it, the eastern has ashlar steps. Three rectangular windows are present at first floor level. Two plain buttresses are located at either side of the bay. A single slit window is present at the apex of the elevation. A small porch with an additional doorway is present on the western side of the facade with ashlar steps. The doorways contain plain narrow planked doors with three light curved overlights. A number of ashlar blocks with the inscribed initials of the dignitaries that laid the foundation stones of the Church are present towards ground level on the southern facade (Photo 2). The base of the bell cote is present towards the front of the roof (Photo 1). The windows have been replaced.

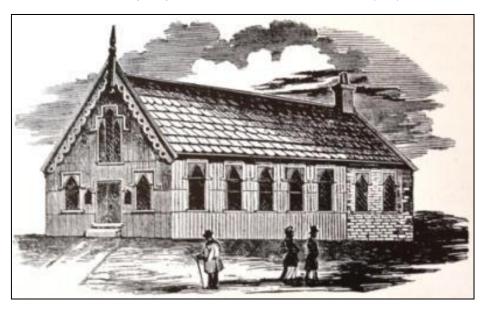
Plate 1: The former iron chapel (Tyne and Wear Archives ref. CNC45)

- 3.3.3 A new site was found close by between Bond Street and Neville Street (now Nichol Street) and a new iron chapel (Plate 1) was built on the site of the existing Church. This was paid for by Miss Charlotte Bond with the intention of building a memorial to her mother, also called Charlotte Bond. The iron chapel opened on the 20<sup>th</sup> November 1881 (ibid).

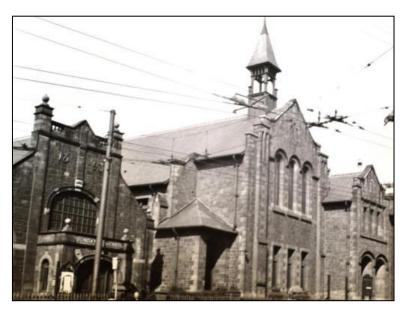
Plate 2: The Sunday School (left) and Church (right) from Adelaide Terrace c. 1950s (Tyne and Wear Archives ref. CNC45)

3.4.1 The new permanent Church (Plate 2) was constructed during 1898-99 on the site of the former iron chapel and was designed by the same architect as the adjacent Manse (Mr J.W. Dyson). It took one year to build with the foundations stones laid by numerous local dignitaries including the architect, all of whose initials are carved on stones on the southern elevation of the building. The opening ceremony took place on the 16<sup>th</sup> September 1899 (ibid).

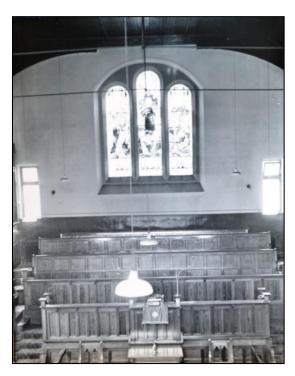
Plate 3: View of the interior of the north end of the Church c. 1950s (Tyne and Wear Archives ref. CNC45)

3.4.2 The outlay for the Church was £4,000 and it was designed to accommodate a community of 800. The seating was arranged on the ground floor and in two galleries; the Choir gallery was located behind the rostrum (Plate 3) and adjoined the Organ gallery and included three vestries. The interior was fitted with pitch pine woodwork and the building was heated with hot water radiators. The Church originally had a large bell cote located towards the front part of the roof (Plate 2). A large three light stained glass window costing £200 was installed behind the rostrum. This was created by local contractor Mr Thomas Hutchinson and depicts an illustration of the scripture 'Come unto Me all ye that are weary and heavy laden and I will give you rest' (Plate 3) (ibid).

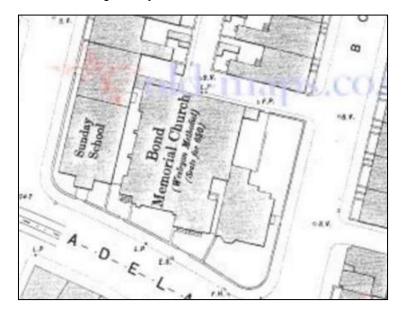
Plate 4: 50" OS map 1908 (Old-Maps)

3.4.3 The earliest historic map that depicts the Bond Memorial Church is the 50" OS Map of 1908. When compared to the modern versions of the OS map, the 1908 edition shows that the layout of the Church has changed very little since it was construction in 1898-99 (Plate 4).

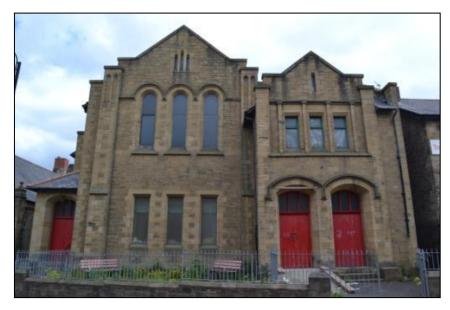
Photo 2: Southern facade of the Church

- 4.2.1 The southern gable elevation has two bays facing onto Adelaide Terrace. The western bay has three simple rectangular windows at first floor level and three upper floor windows forming a Romanesque arcade. The pitched gable is topped with ashlar slabs, as are the buttresses at either end of the bay. The buttresses have two niches towards roof level with ogee topped arches. Three slit windows are present at the apex of the pitched gable, the central being taller than the flanking slits (Photo 2).

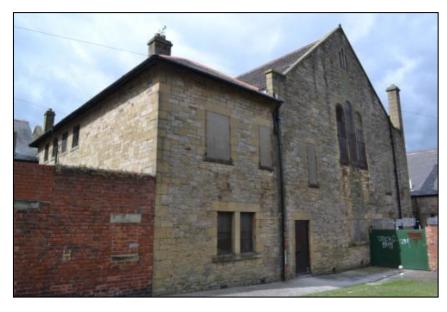
Photo 3: Northern and eastern elevations (scale 1m)

- 4.2.3 There was limited access to the western and eastern elevations due to the close proximity to the adjacent buildings. A modern brick wall links the Church on the western side with the adjacent Sunday School. A number of blocked square windows with ashlar dressings are present on the western elevation at ground floor and first floor level. A small courtyard is located adjacent to the eastern elevation. The sandstone northern elevation links the Church to the adjacent Manse. A dressed doorway and square window are present at first floor level with two ashlar steps. A brick wall is present on the western side of the courtyard. A doorway and small square window are present at ground floor level. There are two square windows present at first floor level. The eastern side of the building was not directly accessible during the site visit although four square dressed windows were visible at first floor level (Photo 3).

- 4.2.4 Two bays are present on the northern elevation. The main western bay has a ground floor doorway and three square windows. Two rectangular windows are present mid height with a three light stained glass window with rounded Romanesque arches present towards the apex of the roof. Three slit window are present at the apex of the facade, as on the southern elevation. The eastern bay has a two light window at ground floor level and a further two windows at first floor level. Three chimney stacks with simple pots are visible from the northern elevation (Photo 3).

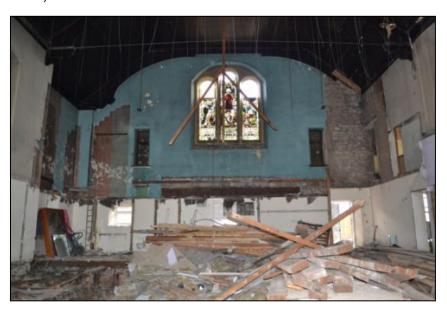
Photo 4: View of the north end of the Church interior from ground floor level

- 4.3.1 The ground floor space would have contained the main hall with a timber floor and a stage at the northern end, behind which later toilet facilities were located. A later sound insulated partition wall would have been located towards the southern end of the hall. A suspended ceiling would have been located at first floor level. Following the commencement of the demolition, the area is currently one large open space, with the majority of the flooring and suspended ceiling removed (Photo 4).
- 4.3.2 The brick foundations of the ground floor that would have supported the seating of the choir gallery and the flooring of the hall area are exposed. The original three light stained glass

window at the northern end of the hall remains largely intact but the upper parts have been damaged. Where the plaster has been removed, the sandstone blockwork is exposed, as are the brick dressings around the windows and the double skin brick arches over the doorways on the northern wall. There is the suggestion of a later staircase in the north-west corner of the hall (Photo 4).

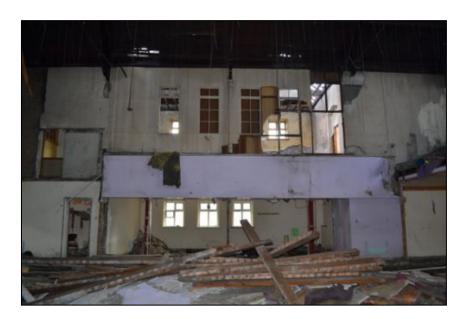
Photo 5: View of the east elevation of the Church interior from the ground floor level

4.3.3 The eastern partition wall is also a mixture of sandstone blocks and brickwork construction with the majority of the first floor created from timber partitions and fibre boards. A central first floor level carved timber pilaster is present on the eastern wall, supporting a timber corbel for one of the braces of the timber roof structure. RSJs support the central part of the partition at ground floor level (Photo 5). A small room in the north-east corner has a timber lathe partition wall, a blocked fireplace on the southern elevation (now partially dismantled), panelled ceiling and four light timber sash window on the northern elevation

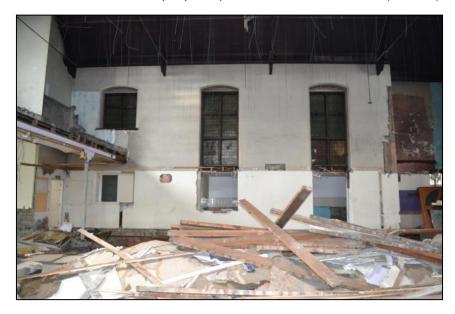
Photo 6: Western elevation of the Church interior from ground floor level (scale 1m)

4.3.4 Two large arched six light leaded windows are present at first floor level on the western elevation. A smaller square version is present at the southern end of the elevation, at gallery level. A ground floor window below was blocked during the alterations proposed in 1971 (See Appendix 2). A former kitchen is present at ground floor level on the western side of the hall Evidence for the site of a memorial plaque is present on the western wall (Photo 6).

4.3.5 Moulded cast iron columns, two with timber capitals support the horizontal RSJ of the gallery at the southern end of the hall. The timber frame of the gallery remains although the seating and panelling has been removed. The lathe and plaster ceiling remains on the underside of the gallery (Photo 6 & 7).

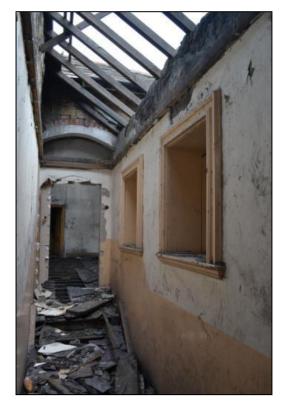
Photo 9: View of the first floor from the landing area

4.3.9 There was limited access to the first floor of the building due to the effects of water ingress following the removal of part of the roof prior to the site visit (Photo 9). It was possible to determine that a moderate amount of original architrave appears to survive at first floor level, including door and window architrave and skirting boards (Photo 9). The original lathe and plaster ceiling survives in the ground floor vestibule area and is visible beneath the floor at first floor level. A number of the first floor doorways have been reinforced with concrete lintels (Photo 9).

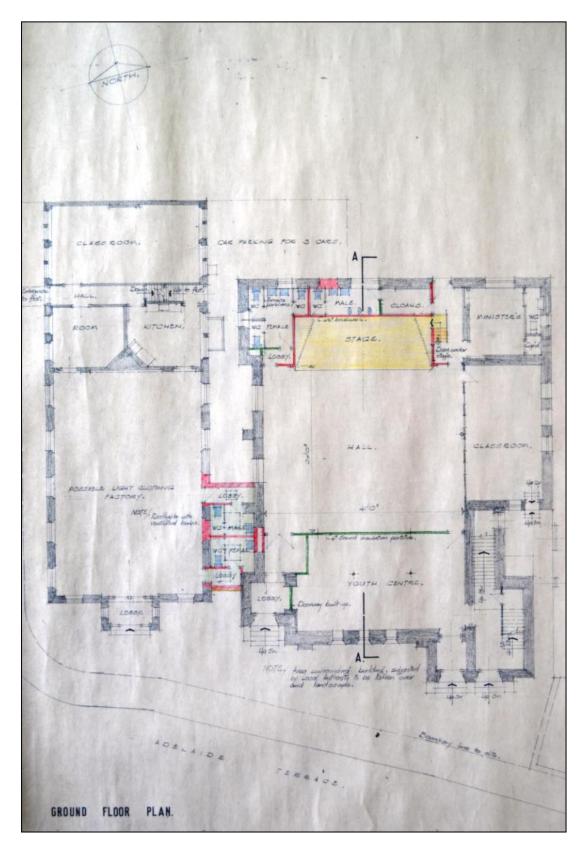
Appendix 2 Plans of alterations to Bond Memorial Church, 1971

- 3.4.7 Proposals were put forward in 1971 to create a stage in the location of the former Choir gallery as well as a suspended ceiling and sound insulated partition wall at the southern end of Church hall, in order to create a youth centre (Appendix 2).

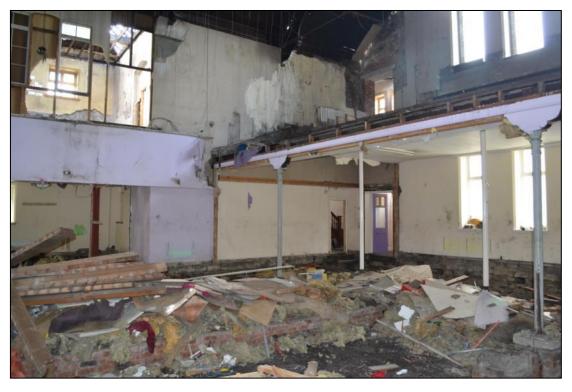
10871\_005 East Elevation and Gallery from Ground Floor Level

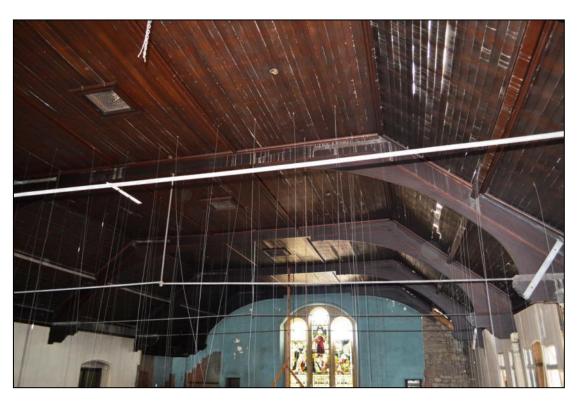
10871\_055 Ceiling from the Gallery

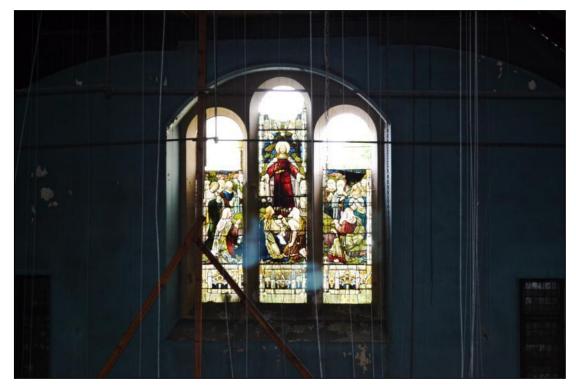
10871\_062 Stained Glass Window

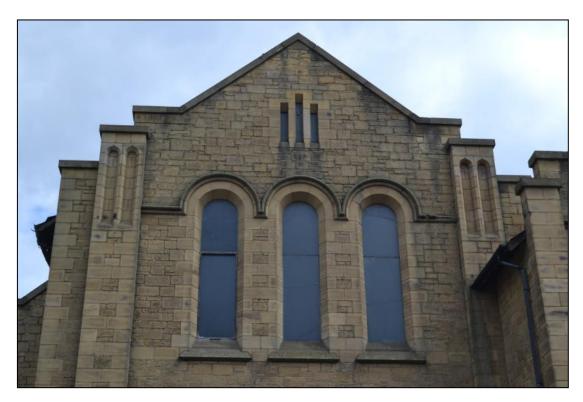
10871\_075 Details of Central Bay of South Elevation

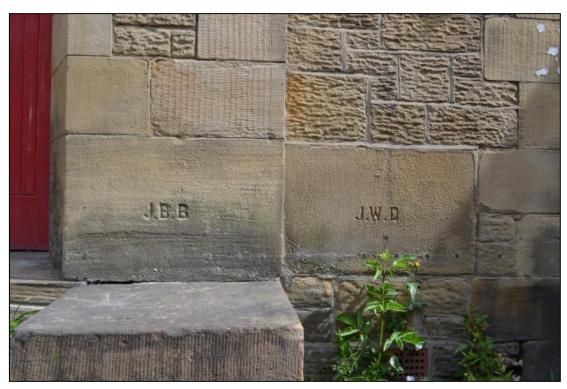
10871\_82 Details of Inscribed Initials on South Elevation
