**Chapelfield, St Mabyn,
Cornwall**

**Heritage Visual Impact
Assessment**

AB Heritage Project No:10798

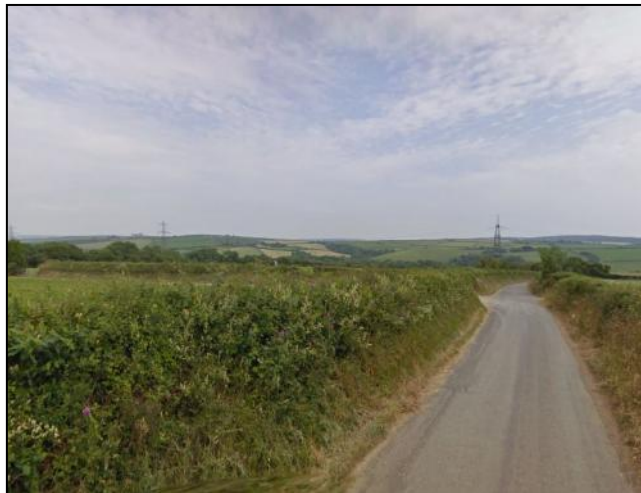
Photo 1: View from road c. 140m to the south-west of the poss. Barrow [AB 1] and c. 350m to the west of enclosure/round [AB 7], towards the proposed development site which is not visible.

- 4.2.6 It should be noted that due to distance and intervening tree cover the site was not intervisible with the proposed development site (Photo 1).

- 4.2.9 Overall, setting is considered to make a contribution towards the significance of the enclosure/round as a heritage feature, however, only to a low degree. Due to a range of factors the current significance of the enclosure/round is considered to mostly relate to the evidential and illustrative historic values of the heritage feature.
- 4.2.10 It should also be noted that the site visit confirmed, due to the distance from the proposed development site and the position of trees and buildings within the landscape to the west of the site, intervisibility with the heritage asset is likely to be limited or completely obscured (Photo 1)

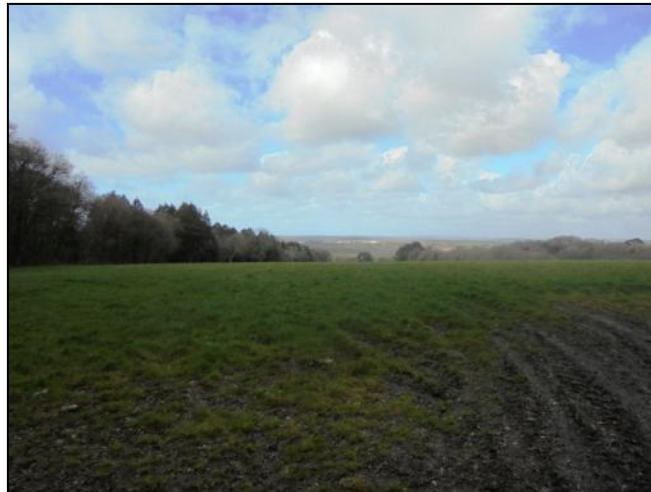
Photo 2: View from the east side of Pencarrow Rings Hillfort [AB 22] St Mabyn village is visible in the middle distance.

- 4.2.11 The Scheduled Ancient Monument of Pencarrow Rings hillfort [AB 22] is located c. 3.4km to the south of the proposed development site and now forms a part of the grounds associated with Pencarrow House & Garden [AB 114]. The hillfort is surrounded by dense woodland, which forms part of the setting of Pencarrow House [AB 114], and is intersected by the main entrance drive that leads to the house & garden complex [AB 114]. The site visit identified that the woodland surrounding the hillfort mostly obscures the views to and from the location of the development site, although there is very limited possible intervisibility between the trees; however, such limited views would be removed altogether once the trees have leaf cover (Photo 2).

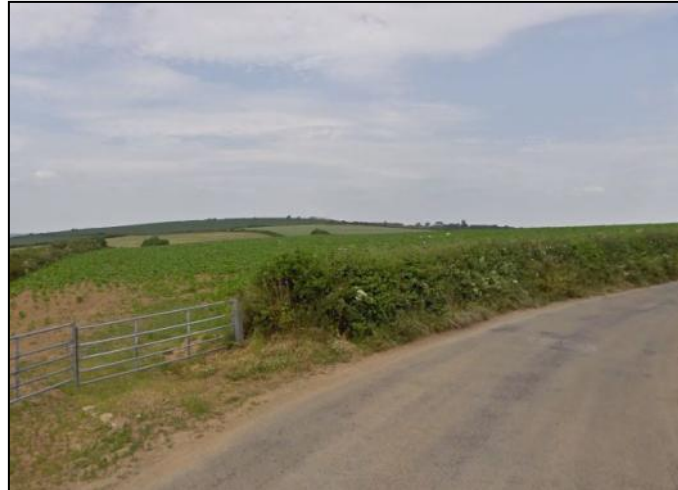
Photo 3: View from road c. 120m to the north of poss. barrow [AB 29]. The tower of St Mabena Church [AB 1] is visible in the centre-right distance.

- 4.2.15 It should be noted that the site visit confirmed that any intervisibility is completely obscured by the village of St Mabyn on the south side of the proposed development site, along with intervening trees in the vicinity (Photo 3).

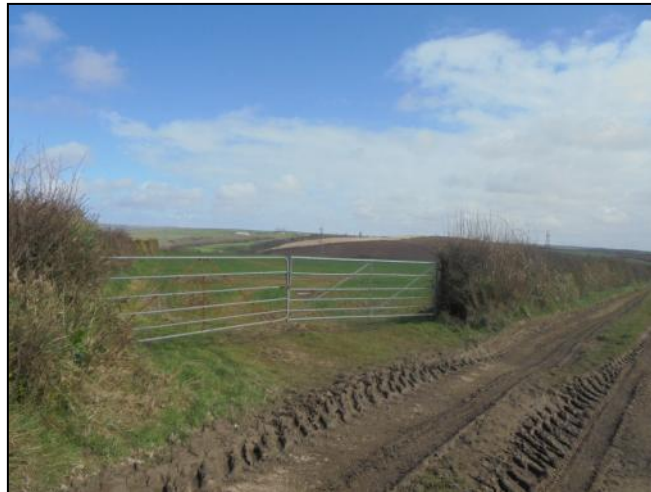
Photo 4: View from the SE corner of Killbury Hillfort [AB 41] towards St Mabyn. The proposed development site is visible on the centre horizon, to the left of the electricity pylon.

- 4.2.16 The Scheduled Ancient Monument of Killbury hillfort [AB 41] is located c. 2.2km to the west of the proposed development site. It is located within a landscape of irregular shaped fields. It is positioned on the top of a ridge between the valleys of the River Allen to the south and the River Amble to the north. A farm complex has been constructed within the south-west corner of the site. The site has limited visual prominence within the landscape, with the remaining ramparts barely distinguishable and obscured by adjacent hedge lines from the north and south. The intervisibility with the proposed development site is limited to the south-west corner of the hillfort (Photo 4).

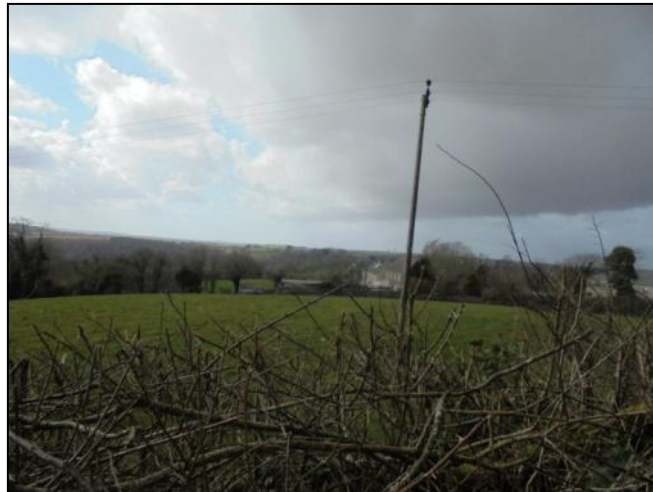
Photo 5: View from St Helena churchyard towards St Mabyn which is not visible

- 4.2.20 It should also be noted that there is no intervisibility between the proposed development site and either the church [AB 51] or the chapel [AB 172], due to the position of intervening trees, vegetation and buildings (Photo 5).

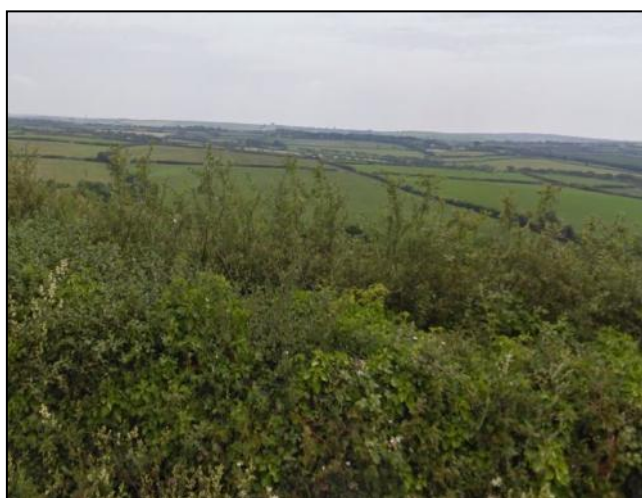
Photo 6: View from the cross [AB 58] towards St Mabyn. The tower of the church of St Mebena [AB 78] is visible on the centre horizon

- 4.2.21 The Scheduled Ancient Monument of a medieval wayside cross [AB 58] is located c. 500m to the north-east of Trewethern and c. 4.4km to the north-west of the proposed development site. Although the cross has been moved, it is thought to be close to its original position, on an exposed crossroads on a ridge c. 200m to the north-west of the River Amble. The views towards St Mabyn are obscured from the cross by the adjacent hedge line. Should the height of the hedge line be reduced, the tower of the church of St Mebena [AB 1] is the only distinguishable part of the village visible on the horizon to the south (Photo 6).

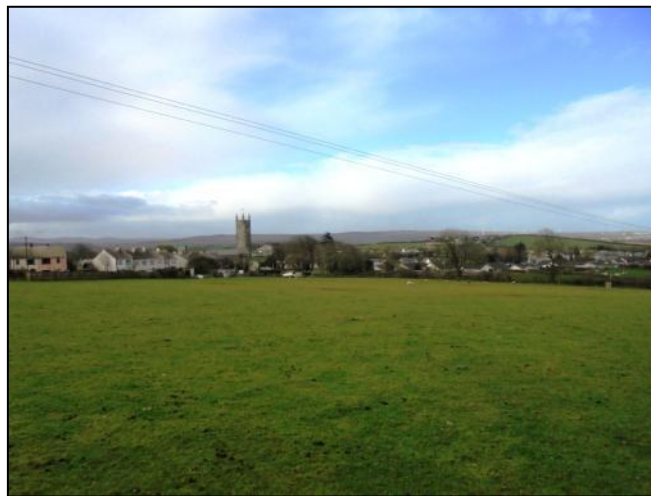
Photo 7: View of the church of St Mebena [AB 78] from the north-east corner of the proposed development site.

- 4.2.24 The church tower forms a prominent visual element within the surrounding landscape and is visible over a wide area, including the majority of the village and the entirety of the proposed development site, as is the roof of the nave. Although, a small portion of the northern part of the churchyard (including four of the above mentioned Grade II listed headstones) is only visible from the north-east part of the proposed development site (Photo 7).

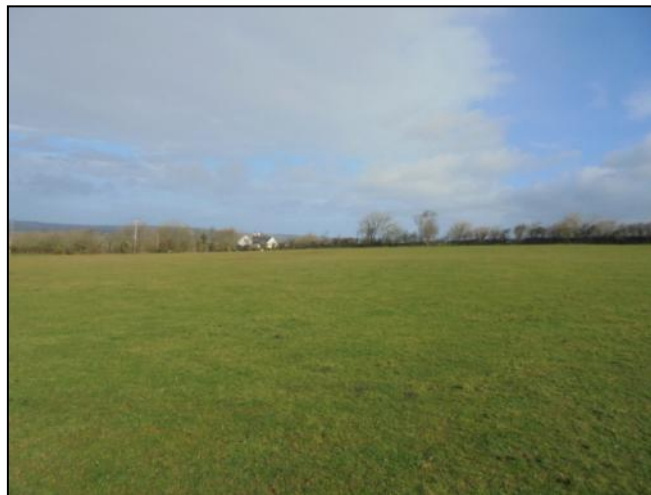
Photo 8: View from the proposed development site towards Treveglos & holy well [AB 89] that are not visible

- 4.2.29 It should however be noted that the site visit demonstrated that there is no intervisibility with the farmstead or the site of the holy well from the proposed development site due to the position of the intervening vegetation and buildings along the northern hedge line of the proposed development site (Photo 8).

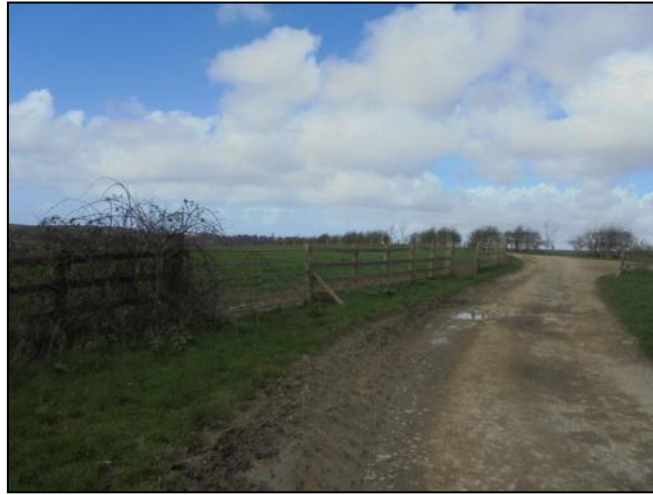
Photo 9: View from Trescowe Farmhouse [AB 99] towards St Mabyn. The proposed development site is not visible.

- 4.2.32 However, the site visit identified that the farmhouse has no intervisibility with the proposed development site, due to the position intervening vegetation along the surrounding hedge lines and further afield (Photo 9).

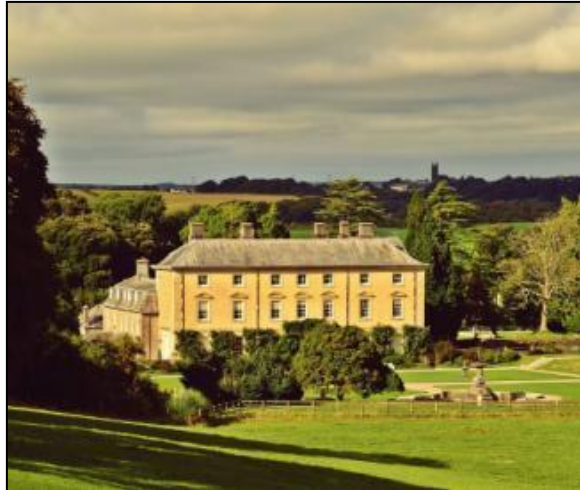
Photo 10: View of the village of St Mabyn from the grounds to the south of Pencarrow House [AB 114] (Google, 2016)

- 4.2.33 The Grade II* listed Pencarrow House and Grade II listed associated buildings are located with a Grade II* Park & Garden [AB 114] that are situated c. 1.9km to the south of the proposed development site. Pencarrow House and associated buildings are enclosed by trees to the north, east and west. The house has picturesque views from the south, designed to incorporate the tower of the church of St Mebena [AB 78] as a backdrop for the house, framed by strategic planting (NHLE, 2016). The landscape garden at Pencarrow is surrounded by woodland plantations amongst an agricultural landscape. The site visit identified that the village of St Mabyn is visible from part of the southern end of the landscape garden, although the distance from the proposed development site and the position of intervening vegetations within the surrounding landscape obscures the position of the proposed development site (Photo 10).

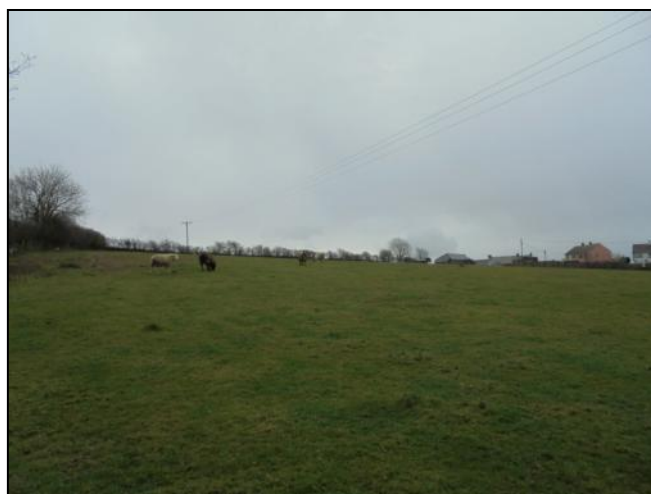
Photo 11: View across the proposed development site towards the former chapel [AB 141], the roof is visible on the centre-right horizon

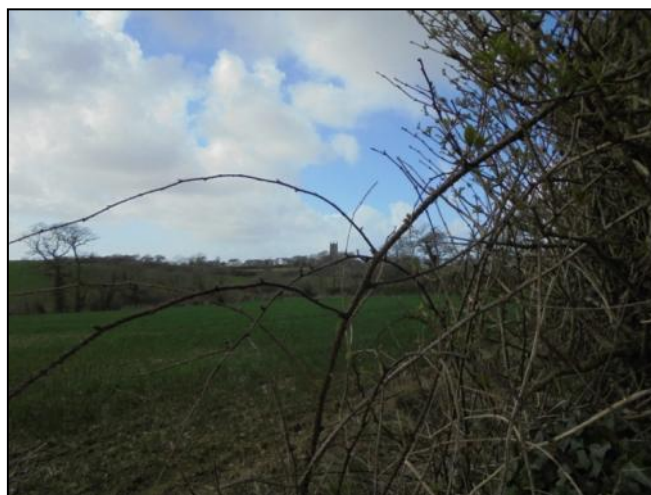
Photo 12: View from the road adjacent to Tredinnick Farmhouse [AB 171] towards the proposed development site that is not visible

- 4.2.38 The Grade II listed Tredinnick Farmhouse [AB 171] is located c. 500m to the south-east of the proposed development site. The farmhouse faces down a short drive to the south with a former farmyard to the north, consisting of converted farm buildings. Beyond the farmyard, the house is surrounded by a patchwork of irregular shaped fields. The site visit identified that any intervisibility with the proposed development site is obscured by the position of the hedge lines adjacent to the house and the intervening building on the southern side of the village of St Mabyn (Photo 12).

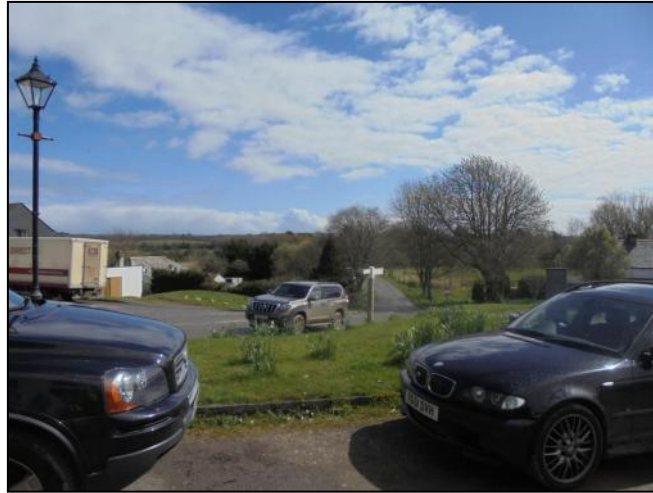
Photo 14: View from Chapel Amble Conservation Area [AB 179] towards the proposed development site that is not visible

- 4.2.43 The Chapel Amble Conservation Area [AB 179] is located c. 4.8km to the north-west of the proposed development site. The Conservation Area [AB 179] covers the historic core of the village of Chapel Amble, only the south-eastern part of which is located within the ZTV. The Conservation Area [AB 179] is surrounded by irregular shaped agricultural field and sparse farmstead settlements. The site visit identified that there is no intervisibility with the proposed development site due to the position of intervening vegetation and buildings (Photo 14).

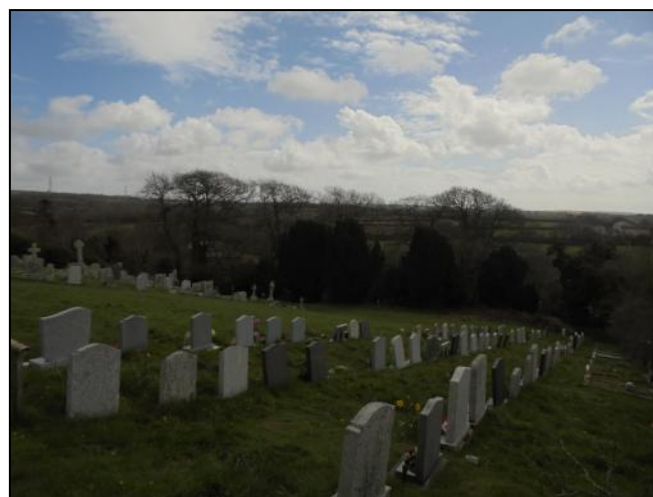
Photo 15: View from St Kew Conservation Area [AB 180] towards the proposed development site that is not visible

- 4.2.45 The St Kew Conservation Area **[AB 180]** is located c. 2.2km to the north of the proposed development site. Only central part of the northern section of the St Kew Conservation Area **[AB 180]** is located within the ZTV. The Conservation Area is focused on the historic core of the village. The site visit identified that there is only limited visibility of the village of St Mabyn, of which the proposed development site was not apparent.
